Manhole Inspection Report

Date:	04/19/2018	Weather:		Coding:	RZMACP
MH#:	M-103-001	Owner:	NA	Len. Surveyed:	3.9
P.O.#:		Surveyor:	Jen Costello	Rim to Invert:	5.0
Customer:		Cert. #:	U-907-5518	Wall Material:	Concrete (reinforced)

Street:	41st Ave. 173' East of Howard St.	Project:	Hobart, IN
City:	Hobart, IN	GPS Northing:	2891280.947
Location:		GPS Easting:	2891280.947
Drain Area:	Northwest	GPS Accuracy:	Sub-Meter
Cover Shape:	Circular	Evidence of Surcharge:	No
Cover Size:	23.0	Potential for Runoff:	None
Comments:

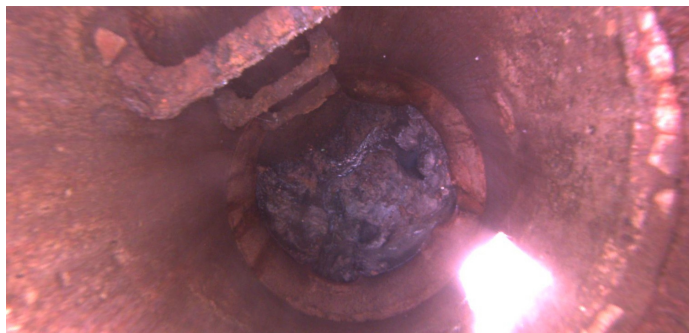
Code: **MGO**
Description: **General Observation**

Distance (ft): **.0**
Structural Grade: **0**
O&M Grade: **0**
Clock Start/From:
Clock To:
1st Value:
2nd Value:
Value Percent:
Step: **NO**
Remarks: **ACCESS mh**

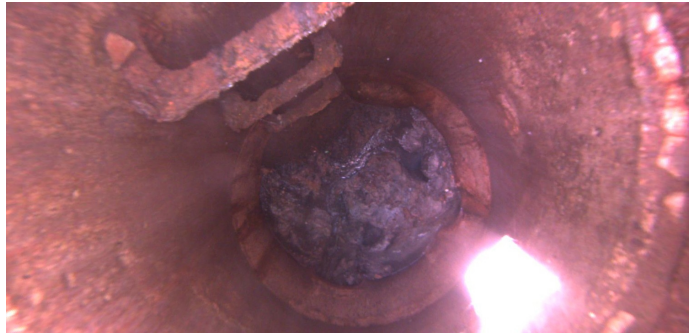
Code:	SRI
Description:	Surface Roughness Increased
Distance (ft):	.0
Structural Grade:	1
O&M Grade:	0
Clock Start/From:	12
Clock To:	12
1st Value:	
2nd Value:	
Value Percent:	
Step:	NO
Remarks:

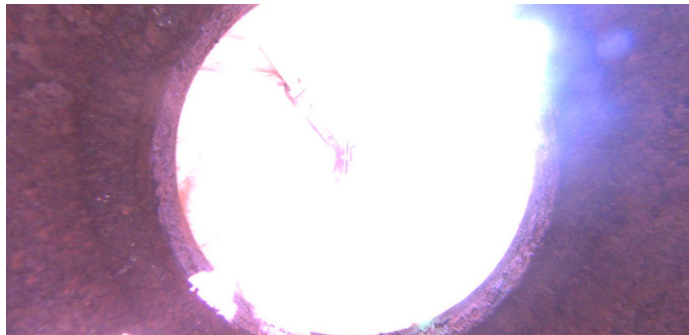
Code:	MGP
Description:	General Photo
Distance (ft):	1.1
Structural Grade:	0
O&M Grade:	0
Clock Start/From:	
Clock To:	
1st Value:	
2nd Value:	
Value Percent:	
Step:	NO
Remarks:	underside of frame

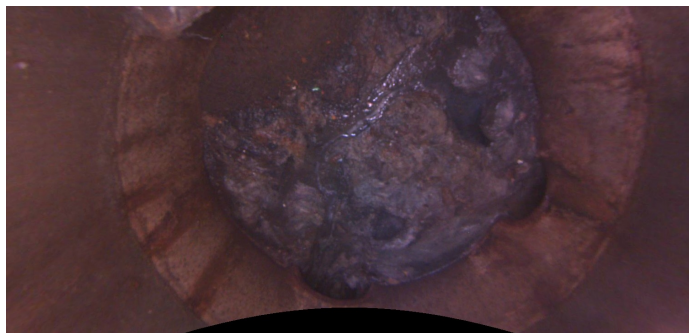
Code:	IW
Description:	Infil Weeper
Distance (ft):	1.6
Structural Grade:	0
O&M Grade:	2
Clock Start/From:	12
Clock To:	12
1st Value:	
2nd Value:	
Value Percent:	
Step:	NO
Remarks:

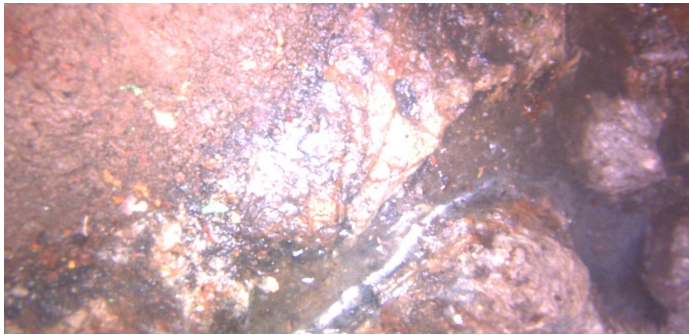
Code:	MGO
Description:	General Observation
Distance (ft):	3.9
Structural Grade:	0
O&M Grade:	0
Clock Start/From:	
Clock To:	
1st Value:	
2nd Value:	
Value Percent:	
Step:	NO
Remarks:	end survey
