Manhole Inspection Report

Date:	04/18/2018	Weather:		Coding:	RZMACP
MH#:	M-103-005	Owner:	NA	Len. Surveyed:	5.6
P.O.#:		Surveyor:	John Kuglmaier	Rim to Invert:	6.8
Customer:		Cert. #:	U-1215-07002349	Wall Material:	Concrete (reinforced)

Street:	39th Ave. and Colborne St. to the S	Project:	Hobart, IN
City:	Hobart, IN	GPS Northing:	2891352.12
Location:		GPS Easting:	2891352.12
Drain Area:	Northwest	GPS Accuracy:	Sub-Meter
Cover Shape:	Circular	Evidence of Surcharge:	Yes
Cover Size:	23.0	Potential for Runoff:	None
Comments:

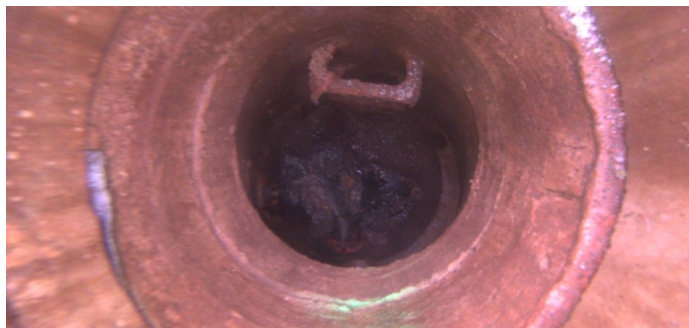
Code: **MGP**
Description: **General Photo**

Distance (ft): **.0**
Structural Grade: **0**
O&M Grade: **0**
Clock Start/From:
Clock To:
1st Value:
2nd Value:
Value Percent:
Step: **NO**
Remarks:

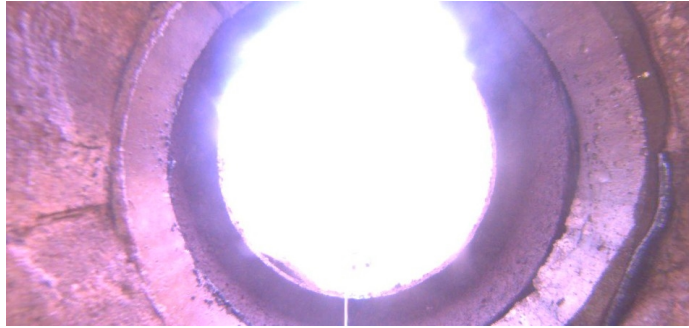
Code: **MGP**
Description: **General Photo**

Distance (ft): **2.2**
Structural Grade: **0**
O&M Grade: **0**
Clock Start/From:
Clock To:
1st Value:
2nd Value:
Value Percent:
Step: **NO**
Remarks:

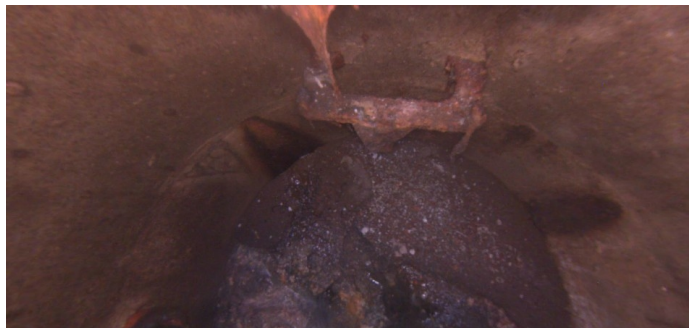
Code: **IS**
Description: **Infil Stain**

Distance (ft): **3.3**
Structural Grade: **0**
O&M Grade: **0**
Clock Start/From: **11**
Clock To:
1st Value:
2nd Value:
Value Percent:
Step: **NO**
Remarks:

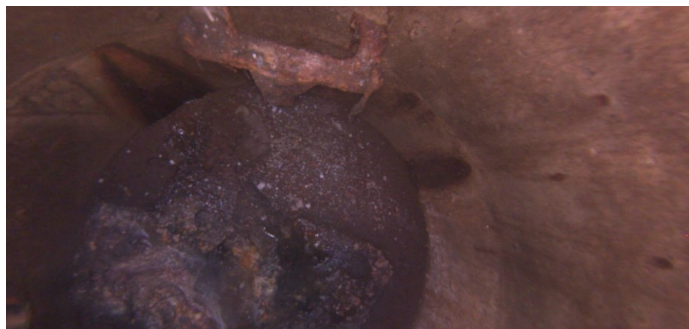
Code: **IS**
Description: **Infil Stain**

Distance (ft): **3.3**
Structural Grade: **0**
O&M Grade: **0**
Clock Start/From: **2**
Clock To:
1st Value:
2nd Value:
Value Percent:
Step: **NO**
Remarks:

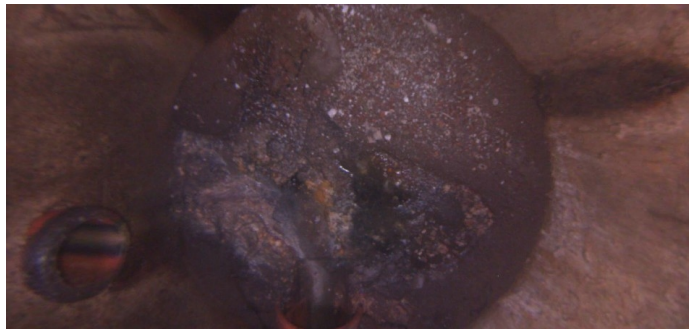
Code:	DAZ
Description:	Deposits Attached Other
Distance (ft):	3.8
Structural Grade:	0
O&M Grade:	2
Clock Start/From:	12
Clock To:	12
1st Value:	
2nd Value:	
Value Percent:	10.000
Step:	NO
Remarks:	Mixed materials

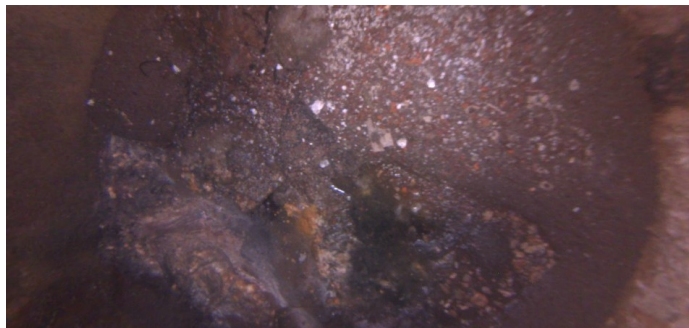
Code:	MGO
Description:	General Observation
Distance (ft):	4.8
Structural Grade:	0
O&M Grade:	0
Clock Start/From:	
Clock To:	
1st Value:	
2nd Value:	
Value Percent:	
Step:	NO
Remarks:	Ins. Comp.
