Manhole Inspection Report

Date:	04/18/2018	Weather:		Coding:	RZMACP
MH#:	M-103-006	Owner:	NA	Len. Surveyed:	8.8
P.O.#:		Surveyor:	Jen Costello	Rim to Invert:	10.4
Customer:		Cert. #:	U-907-5518	Wall Material:	Concrete (reinforced)

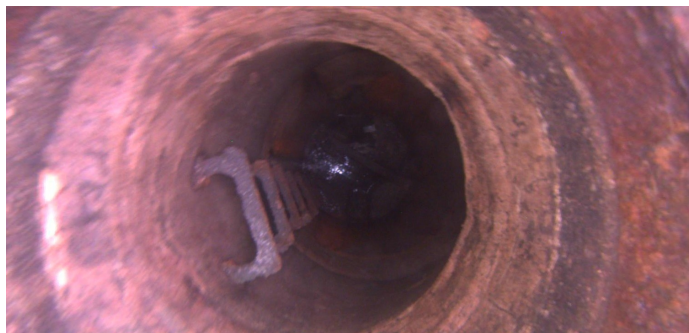
Code: **MGO**
Description: **General Observation**

Distance (ft): **.0**
Structural Grade: **0**
O&M Grade: **0**
Clock Start/From:
Clock To:
1st Value:
2nd Value:
Value Percent:
Step: **NO**
Remarks: **access MH**

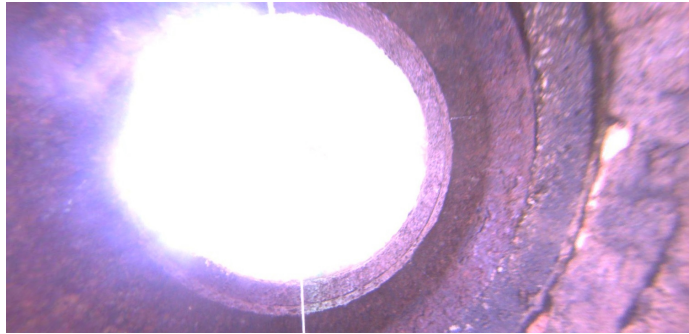
Code:	MGP
Description:	General Photo
Distance (ft):	1.6
Structural Grade:	0
O&M Grade:	0
Clock Start/From:	
Clock To:	
1st Value:	
2nd Value:	
Value Percent:	
Step:	NO
Remarks:	UNDERSIDE OF FRAME

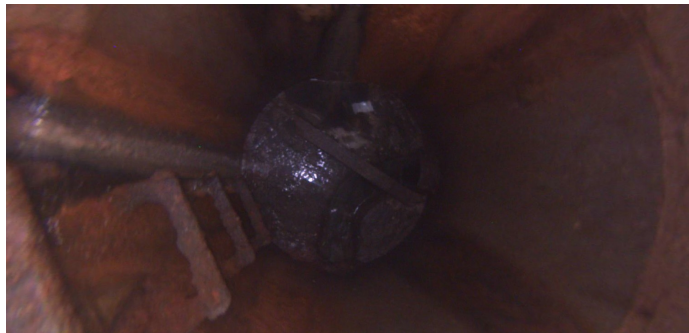
Code:	IW
Description:	Infil Weeper
Distance (ft):	4.1
Structural Grade:	0
O&M Grade:	2
Clock Start/From:	12
Clock To:	12
1st Value:	
2nd Value:	
Value Percent:	
Step:	NO
Remarks:

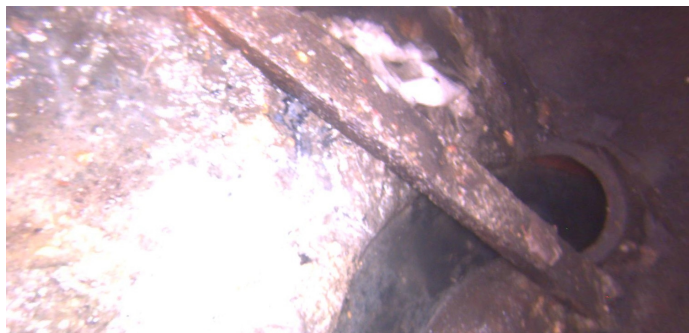
Code:	OBZ
Description:	Obstacle Other
Distance (ft):	8.8
Structural Grade:	0
O&M Grade:	2
Clock Start/From:	12
Clock To:	3
1st Value:	
2nd Value:	
Value Percent:	5.000
Step:	NO
Remarks:	BOARD
