# Manhole Inspection Report

Date:	04/18/2018	Weather:		Coding:	RZMACP
MH#:	M-103-008	Owner:	NA	Len. Surveyed:	7.5
P.O.#:		Surveyor:	Jen Costello	Rim to Invert:	8.7
Customer:		Cert. #:	U-907-5518	Wall Material:	Concrete (reinforced)

Street:	Howard St. 166' South of 39th Ave.	Project:	Hobart, IN
City:	Hobart, IN	GPS Northing:	2890927.158
Location:		GPS Easting:	2890927.158
Drain Area:	Northwest	GPS Accuracy:	Sub-Meter
Cover Shape:	Circular	Evidence of Surcharge:	No
Cover Size:	23.0	Potential for Runoff:	None
Comments:

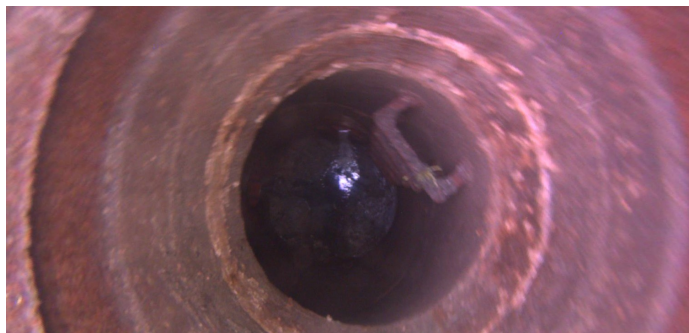
Code: **MGO**  
Description: **General Observation**

Distance (ft): **.0**  
Structural Grade: **0**  
O&M Grade: **0**  
Clock Start/From:  
Clock To:  
1st Value:  
2nd Value:  
Value Percent:  
Step: **NO**  
Remarks: **access MH**

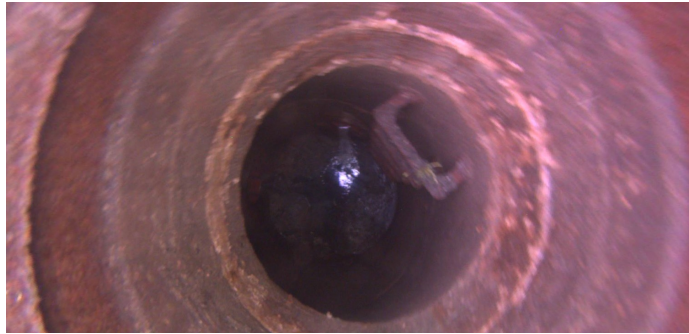
Code:	<b>SAV</b>
Description:	<b>Surface Aggregate Visible</b>
Distance (ft):	<b>.0</b>
Structural Grade:	<b>3</b>
O&M Grade:	<b>0</b>
Clock Start/From:	<b>12</b>
Clock To:	<b>12</b>
1st Value:	
2nd Value:	
Value Percent:	
Step:	<b>NO</b>
Remarks:

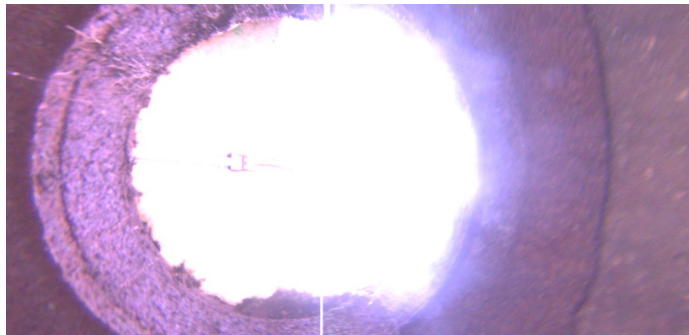
Code:	<b>MGP</b>
Description:	<b>General Photo</b>
Distance (ft):	<b>1.5</b>
Structural Grade:	<b>0</b>
O&M Grade:	<b>0</b>
Clock Start/From:	
Clock To:	
1st Value:	
2nd Value:	
Value Percent:	
Step:	<b>NO</b>
Remarks:	<b>UNDERSIDE OF FRAME</b>

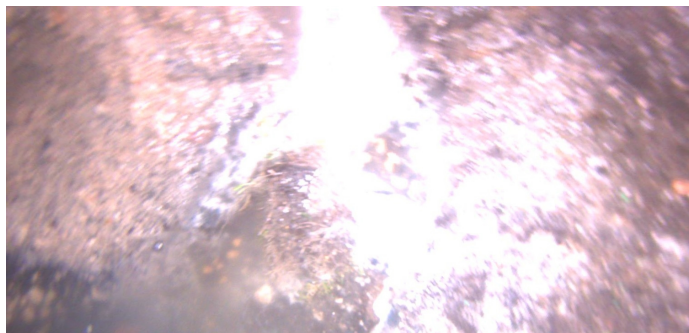
Code:	<b>MGO</b>
Description:	<b>General Observation</b>
Distance (ft):	<b>7.5</b>
Structural Grade:	<b>0</b>
O&M Grade:	<b>0</b>
Clock Start/From:	
Clock To:	
1st Value:	
2nd Value:	
Value Percent:	
Step:	<b>NO</b>
Remarks:	<b>END SURVEY</b>
