Manhole Inspection Report

| MH#: | M-103-011 | Owner: | NA | Len. Surveyed: | 4.4 |

| Street: | 40th Ave. 168' East of Howard St. | Project: | Hobart, IN |

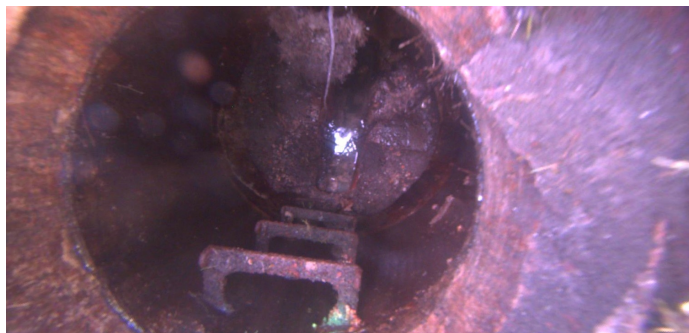
Code: **MGO**
Description: **General Observation**

Distance (ft): **.0**
Structural Grade: **0**
O&M Grade: **0**
Clock Start/From:
Clock To:
1st Value:
2nd Value:
Value Percent:
Step: **NO**
Remarks: **ACCESS MH**

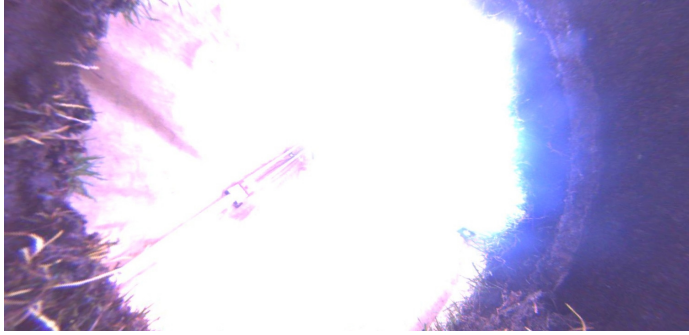
| Code: | MGP |
| Description: | General Photo |
| Distance (ft): | 1.2 |
| Remarks: | UNDERSIDE OF FRAME |
