Manhole Inspection Report

Date:	10/05/2022	Weather:		Coding:	RZMACP
MH#:	M-103-012	Owner:	NA	Len. Surveyed:	2.2
P.O.#:		Surveyor:	Jen Costello	Rim to Invert:	2.8
Customer:		Cert. #:	U-907-5518	Wall Material:	Brick

Street:	41st Ave. 167' East of Willow St.	Project:	Hobart, IN
City:	Hobart, IN	GPS Northing:	2293218.248
Location:	Other	GPS Easting:	2890939.463
Drain Area:	Northwest	GPS Accuracy:	Sub-Meter
Cover Shape:	Circular	Evidence of Surcharge:	No
Cover Size:	24.0	Potential for Runoff:	None
Comments:

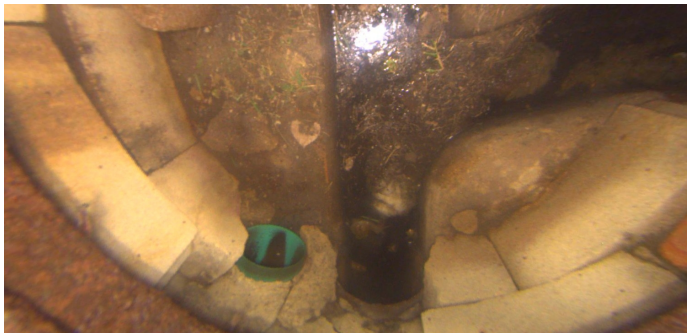
Code: **MGO**
Description: **General Observation**

Distance (ft): **.0**
Structural Grade: **0**
O&M Grade: **0**
Clock Start/From:
Clock To:
1st Value:
2nd Value:
Value Percent:
Step: **NO**
Remarks: **access mh**

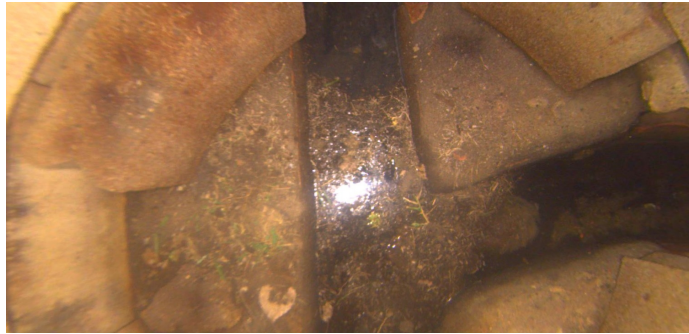
Code: **DB**
Description: **Displaced Brick**

Distance (ft): **.4**
Structural Grade: **3**
O&M Grade: **0**
Clock Start/From: **12**
Clock To: **12**
1st Value:
2nd Value:
Value Percent:
Step: **NO**
Remarks:

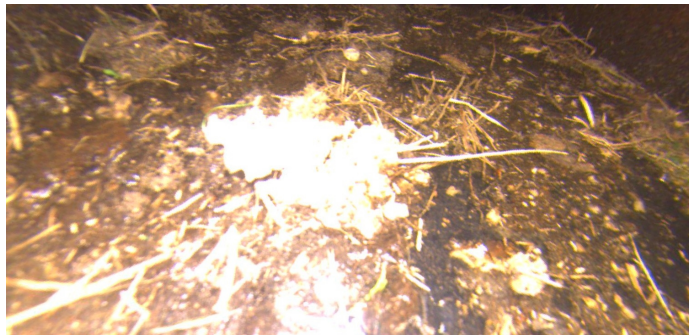
Code: **DSF**
Description: **Deposits Settled Fine**

Distance (ft): **2.2**
Structural Grade: **0**
O&M Grade: **5**
Clock Start/From: **4**
Clock To: **8**
1st Value:
2nd Value:
Value Percent: **40.000**
Step: **NO**
Remarks:

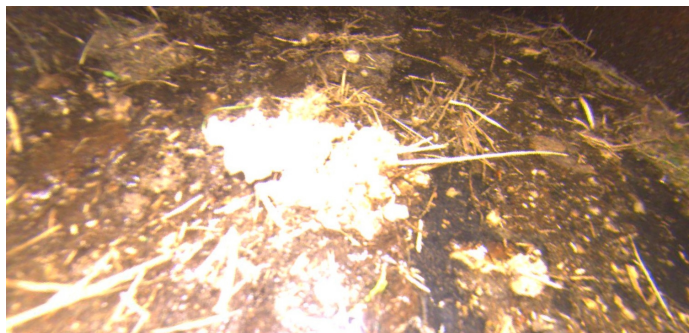
Code: **MGO**
Description: **General Observation**

Distance (ft): **2.2**
Structural Grade: **0**
O&M Grade: **0**
Clock Start/From:
Clock To:
1st Value:
2nd Value:
Value Percent:
Step: **NO**
Remarks: **end of survey**
