# Manhole Inspection Report

Date:	<b>10/04/2022</b>	Weather:		Coding:	<b>RZMACP</b>
MH#:	<b>M-103-015</b>	Owner:	<b>NA</b>	Len. Surveyed:	<b>8.0</b>
P.O.#:		Surveyor:	<b>Jen Costello</b>	Rim to Invert:	<b>9.0</b>
Customer:		Cert. #:	<b>U-907-5518</b>	Wall Material:	<b>Concrete (cast in place)</b>

Street:	<b>Alley between I-65 and Willow St. 7</b>	Project:	<b>Hobart, IN</b>
City:	<b>Hobart, IN</b>	GPS Northing:	<b>2293808.883</b>
Location:	<b>Local Rural Streets</b>	GPS Easting:	<b>2890646.833</b>
Drain Area:	<b>Northwest</b>	GPS Accuracy:	<b>Sub-Meter</b>
Cover Shape:	<b>Circular</b>	Evidence of Surcharge:	<b>No</b>
Cover Size:	<b>24.0</b>	Potential for Runoff:	<b>None</b>
Comments:

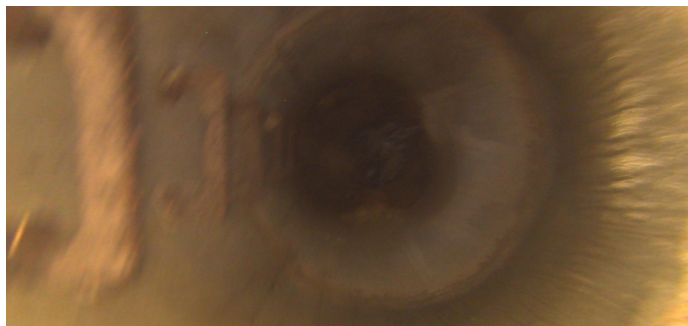
Code: **MGO**  
Description: **General Observation**

Distance (ft): **.0**  
Structural Grade: **0**  
O&M Grade: **0**  
Clock Start/From:  
Clock To:  
1st Value:  
2nd Value:  
Value Percent:  
Step: **NO**  
Remarks: **access mh**

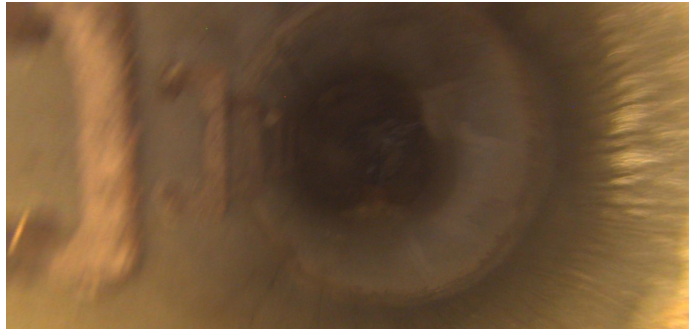
Code: **SRI**  
Description: **Surface Roughness Increased**

Distance (ft): **.0**  
Structural Grade: **1**  
O&M Grade: **0**  
Clock Start/From: **12**  
Clock To: **12**  
1st Value:  
2nd Value:  
Value Percent:  
Step: **NO**  
Remarks:

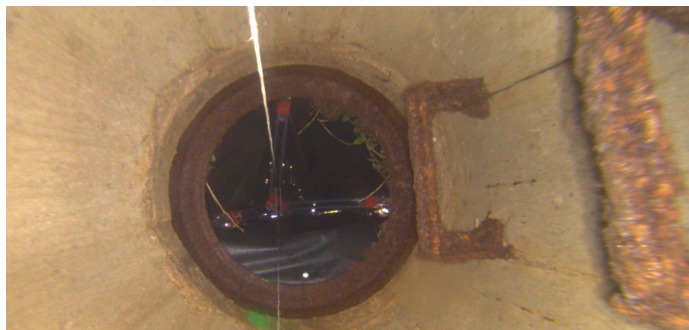
Code: **MGO**  
Description: **General Observation**

Distance (ft): **2.7**  
Structural Grade: **0**  
O&M Grade: **0**  
Clock Start/From:  
Clock To:  
1st Value:  
2nd Value:  
Value Percent:  
Step: **NO**  
Remarks: **underside of frame**

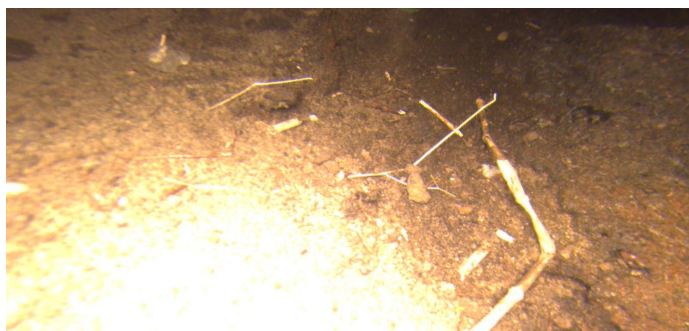
Code: **DSF**  
Description: **Deposits Settled Fine**

Distance (ft): **8.0**  
Structural Grade: **0**  
O&M Grade: **2**  
Clock Start/From: **12**  
Clock To: **12**  
1st Value:  
2nd Value:  
Value Percent: **5.000**  
Step: **NO**  
Remarks:

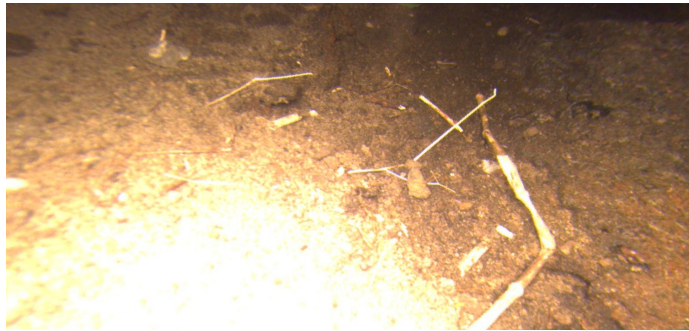
Code:	<b>MGO</b>
Description:	<b>General Observation</b>
Distance (ft):	<b>8.0</b>
Structural Grade:	<b>0</b>
O&M Grade:	<b>0</b>
Clock Start/From:	
Clock To:	
1st Value:	
2nd Value:	
Value Percent:	
Step:	<b>NO</b>
Remarks:	<b>end of survey</b>

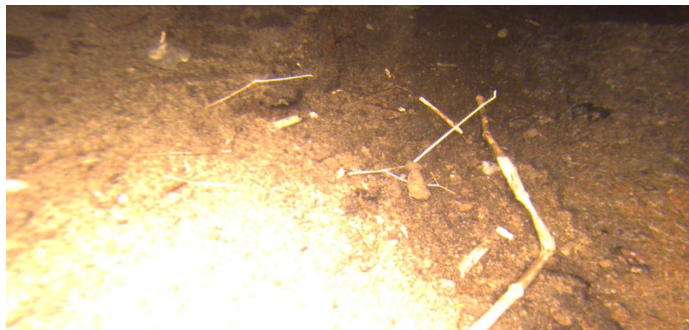
Code:	<b>SRI</b>
Description:	<b>Surface Roughness Increased</b>
Distance (ft):	<b>8.0</b>
Structural Grade:	<b>1</b>
O&M Grade:	<b>0</b>
Clock Start/From:	<b>12</b>
Clock To:	<b>12</b>
1st Value:	
2nd Value:	
Value Percent:	
Step:	<b>NO</b>
Remarks:
