Manhole Inspection Report

Date:	04/18/2018	Weather:		Coding:	RZMACP
MH#:	M-103-019	Owner:	NA	Len. Surveyed:	5.9
P.O.#:		Surveyor:	John Kuglmaier	Rim to Invert:	7.4
Customer:		Cert. #:	U-1215-07002349	Wall Material:	Concrete (reinforced)

Street:	Missouri St. 72' North of 41st Ave.	Project:	Hobart, IN
City:	Hobart, IN	GPS Northing:	2890111.386
Location:		GPS Easting:	2890111.386
Drain Area:	Northwest	GPS Accuracy:	Sub-Meter
Cover Shape:	Circular	Evidence of Surcharge:	No
Cover Size:	23.0	Potential for Runoff:	None
Comments:

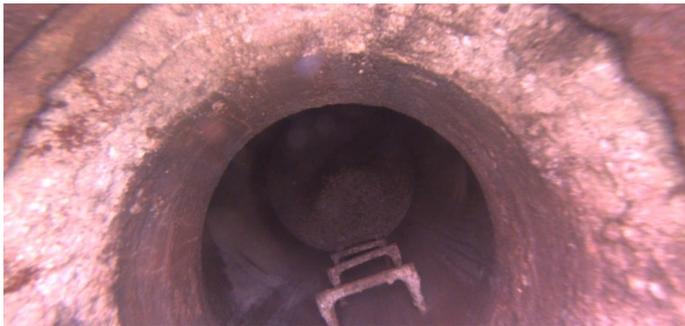
Code: **MGP**
Description: **General Photo**

Distance (ft): **.0**
Structural Grade: **0**
O&M Grade: **0**
Clock Start/From:
Clock To:
1st Value:
2nd Value:
Value Percent:
Step: **NO**
Remarks:

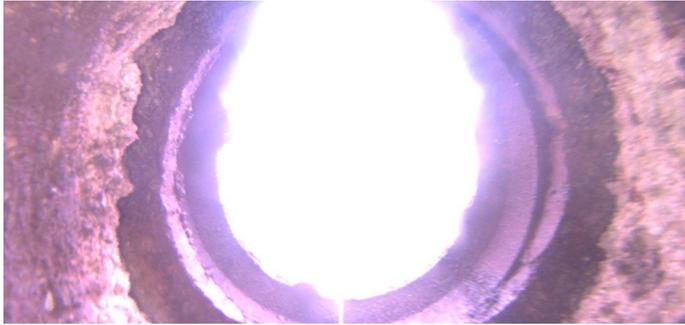
Code: **MGP**
Description: **General Photo**

Distance (ft): **2.1**
Structural Grade: **0**
O&M Grade: **0**
Clock Start/From:
Clock To:
1st Value:
2nd Value:
Value Percent:
Step: **NO**
Remarks:

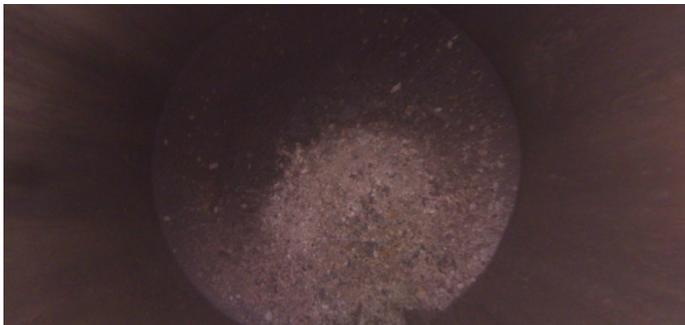
Code: **DSF**
Description: **Deposits Settled Fine**

Distance (ft): **4.5**
Structural Grade: **0**
O&M Grade: **2**
Clock Start/From: **12**
Clock To: **12**
1st Value:
2nd Value:
Value Percent: **5.000**
Step: **NO**
Remarks:

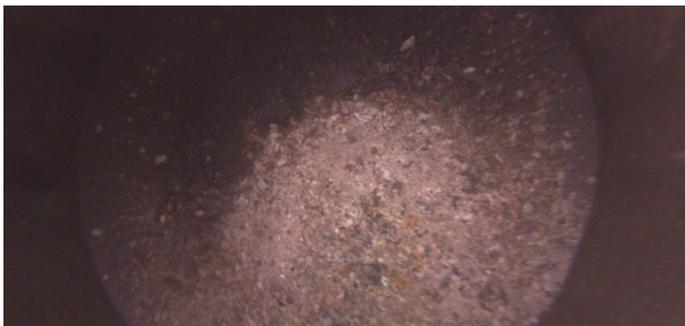
Code: **MGO**
Description: **General Observation**

Distance (ft): **5.3**
Structural Grade: **0**
O&M Grade: **0**
Clock Start/From:
Clock To:
1st Value:
2nd Value:
Value Percent:
Step: **NO**
Remarks: **Ins. Comp.**
