Manhole Inspection Report

Date:	04/18/2018	Weather:		Coding:	RZMACP
MH#:	M-103-020	Owner:	NA	Len. Surveyed:	11.4
P.O.#:		Surveyor:	John Kuglmaier	Rim to Invert:	13.9
Customer:		Cert. #:	U-1215-07002349	Wall Material:	Concrete (reinforced)

Street:	Missouri St. 257' South of 40th Ave.	Project:	Hobart, IN
City:	Hobart, IN	GPS Northing:	2890107.746
Location:		GPS Easting:	2890107.746
Drain Area:	Northwest	GPS Accuracy:	Sub-Meter
Cover Shape:	Circular	Evidence of Surcharge:	No
Cover Size:	23.0	Potential for Runoff:	None
Comments:

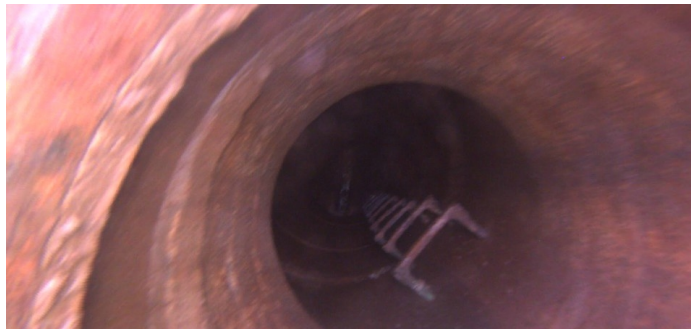
Code: **MGP**
Description: **General Photo**

Distance (ft): **.0**
Structural Grade: **0**
O&M Grade: **0**
Clock Start/From:
Clock To:
1st Value:
2nd Value:
Value Percent:
Step: **NO**
Remarks:

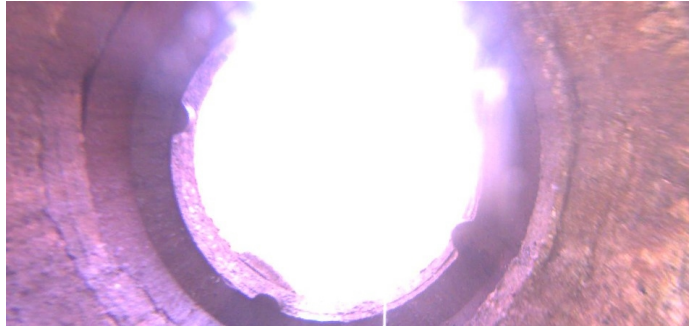
Code: **MGP**
Description: **General Photo**

Distance (ft): **2.0**
Structural Grade: **0**
O&M Grade: **0**
Clock Start/From:
Clock To:
1st Value:
2nd Value:
Value Percent:
Step: **NO**
Remarks:

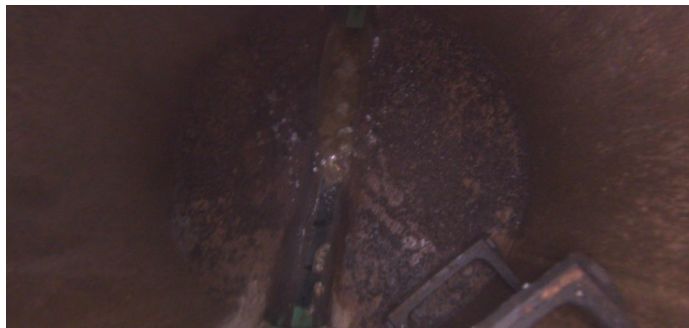
Code: **DSF**
Description: **Deposits Settled Fine**

Distance (ft): **10.3**
Structural Grade: **0**
O&M Grade: **2**
Clock Start/From: **12**
Clock To: **12**
1st Value:
2nd Value:
Value Percent: **5.000**
Step: **NO**
Remarks:

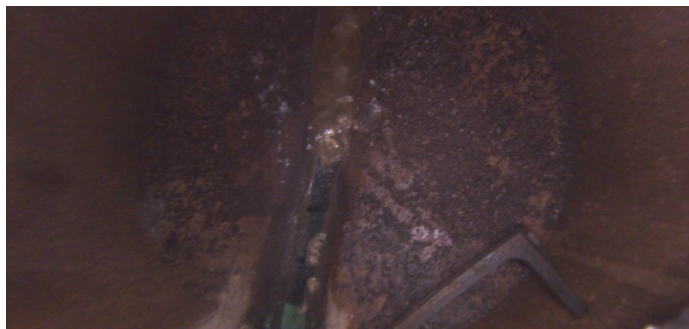
Code: **MGO**
Description: **General Observation**

Distance (ft): **10.8**
Structural Grade: **0**
O&M Grade: **0**
Clock Start/From:
Clock To:
1st Value:
2nd Value:
Value Percent:
Step: **NO**
Remarks: **Ins. Comp.**
