Manhole Inspection Report

Date:	04/18/2018	Weather:		Coding:	RZMACP
MH#:	M-103-021	Owner:	NA	Len. Surveyed:	11.4
P.O.#:		Surveyor:	John Kuglmaier	Rim to Invert:	13.3
Customer:		Cert. #:	U-1215-07002349	Wall Material:	Concrete (reinforced)

Street:	Missouri St. 40' North of 40th Ave.	Project:	Hobart, IN
City:	Hobart, IN	GPS Northing:	2890101.104
Location:		GPS Easting:	2890101.104
Drain Area:	Northwest	GPS Accuracy:	Sub-Meter
Cover Shape:	Circular	Evidence of Surcharge:	Yes
Cover Size:	23.0	Potential for Runoff:	None
Comments:

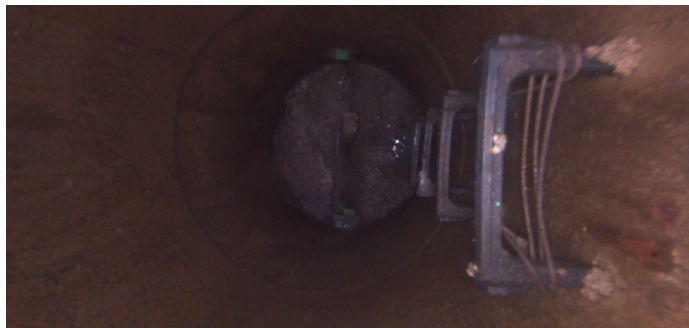
Code: **OBZ**
Description: **Obstacle Other**

Distance (ft): **6.5**
Structural Grade: **0**
O&M Grade: **2**
Clock Start/From: **2**
Clock To: **4**
1st Value:
2nd Value:
Value Percent: **5.000**
Step: **YES**
Remarks: **Rope**

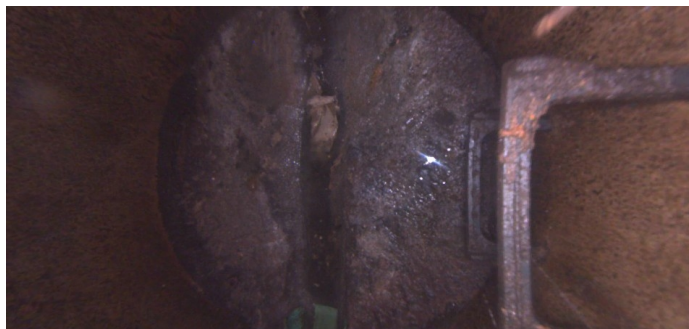
Code: **DAZ**
Description: **Deposits Attached Other**

Distance (ft): **10.5**
Structural Grade: **0**
O&M Grade: **2**
Clock Start/From: **12**
Clock To: **12**
1st Value:
2nd Value:
Value Percent: **10.000**
Step: **NO**
Remarks: **Mixed materials**

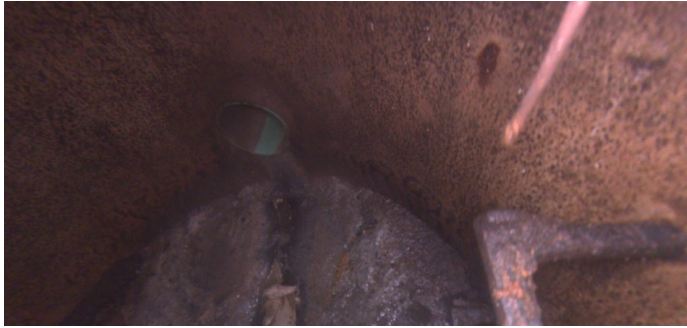
Code: **OBZ**
Description: **Obstacle Other**

Distance (ft): **10.5**
Structural Grade: **0**
O&M Grade: **2**
Clock Start/From: **2**
Clock To: **4**
1st Value:
2nd Value:
Value Percent: **5.000**
Step: **NO**
Remarks: **Rope**

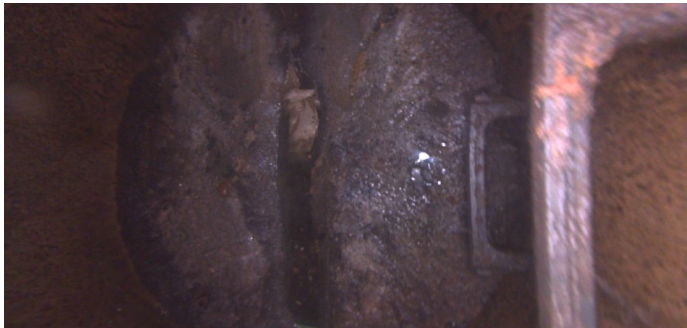
Code: **MGO**
Description: **General Observation**

Distance (ft): **10.8**
Structural Grade: **0**
O&M Grade: **0**
Clock Start/From:
Clock To:
1st Value:
2nd Value:
Value Percent:
Step: **NO**
Remarks: **Ins. Comp.**
