Manhole Inspection Report

Date:	04/18/2018	Weather:		Coding:	RZMACP
MH#:	M-103-022	Owner:	NA	Len. Surveyed:	12.1
P.O.#:		Surveyor:	John Kuglmaier	Rim to Invert:	13.0
Customer:		Cert. #:	U-1215-07002349	Wall Material:	Concrete (reinforced)

Street:	Missouri St. 350' South of 39th Ave.	Project:	Hobart, IN
City:	Hobart, IN	GPS Northing:	2890095.135
Location:		GPS Easting:	2890095.135
Drain Area:	Northwest	GPS Accuracy:	Sub-Meter
Cover Shape:	Circular	Evidence of Surcharge:	No
Cover Size:	23.0	Potential for Runoff:	None
Comments:

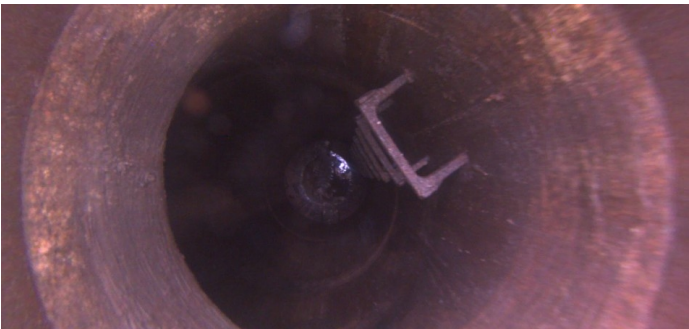
Code: **MGP**
Description: **General Photo**

Distance (ft): **.0**
Structural Grade: **0**
O&M Grade: **0**
Clock Start/From:
Clock To:
1st Value:
2nd Value:
Value Percent:
Step: **NO**
Remarks:

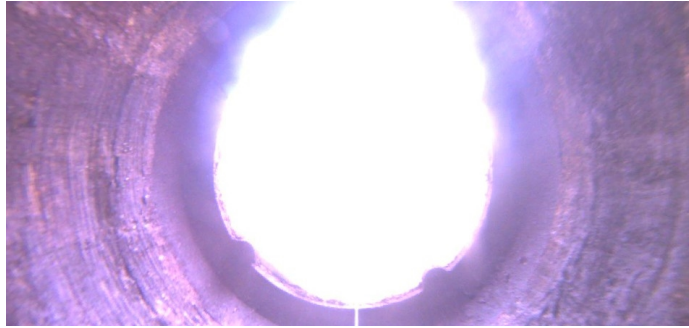
Code: **MGP**
Description: **General Photo**

Distance (ft): **2.4**
Structural Grade: **0**
O&M Grade: **0**
Clock Start/From:
Clock To:
1st Value:
2nd Value:
Value Percent:
Step: **NO**
Remarks:

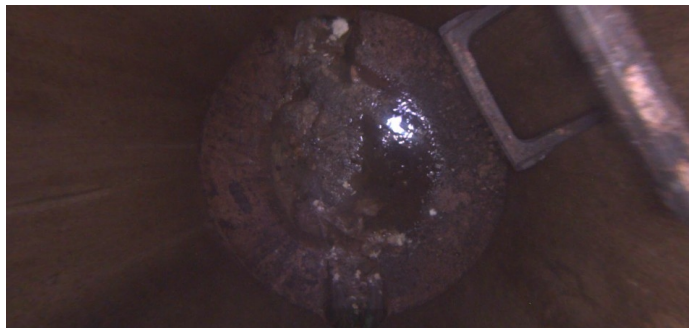
Code: **DAZ**
Description: **Deposits Attached Other**

Distance (ft): **9.6**
Structural Grade: **0**
O&M Grade: **2**
Clock Start/From: **12**
Clock To: **12**
1st Value:
2nd Value:
Value Percent: **5.000**
Step: **NO**
Remarks: **Mixed materials**

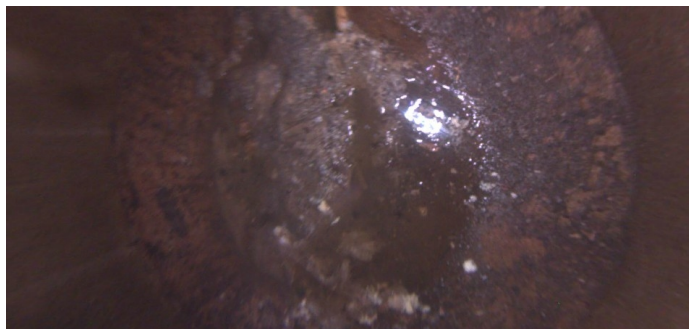
Code: **MGO**
Description: **General Observation**

Distance (ft): **10.9**
Structural Grade: **0**
O&M Grade: **0**
Clock Start/From:
Clock To:
1st Value:
2nd Value:
Value Percent:
Step: **NO**
Remarks: **Ins. Comp.**
