Manhole Inspection Report

Date:	04/18/2018	Weather:		Coding:	RZMACP
MH#:	M-103-023	Owner:	NA	Len. Surveyed:	8.6
P.O.#:		Surveyor:	John Kuglmaier	Rim to Invert:	10.0
Customer:		Cert. #:	U-1215-07002349	Wall Material:	Concrete (reinforced)

Street:	Intersection of Missouri St. and 39th	Project:	Hobart, IN
City:	Hobart, IN	GPS Northing:	2890091.001
Location:		GPS Easting:	2890091.001
Drain Area:	Northwest	GPS Accuracy:	Sub-Meter
Cover Shape:	Circular	Evidence of Surcharge:	No
Cover Size:	23.0	Potential for Runoff:	None
Comments:

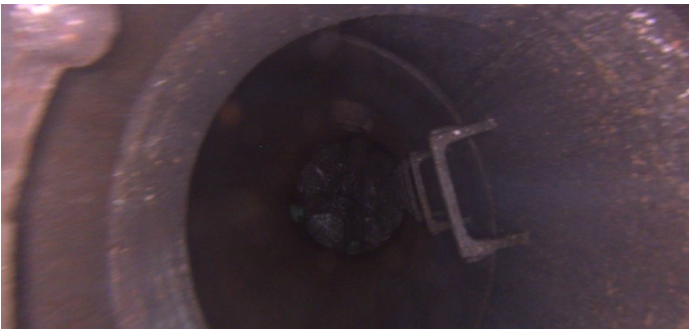
Code: **MGP**
 Description: **General Photo**

Distance (ft): **.0**
 Structural Grade: **0**
 O&M Grade: **0**
 Clock Start/From:
 Clock To:
 1st Value:
 2nd Value:
 Value Percent:
 Step: **NO**
 Remarks:

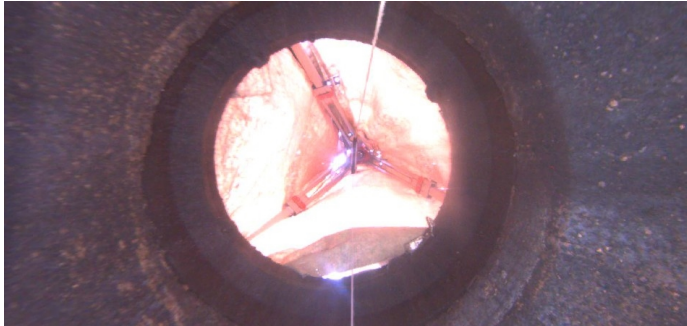
Code:	MGP
Description:	General Photo
Distance (ft):	2.3
Structural Grade:	0
O&M Grade:	0
Clock Start/From:	
Clock To:	
1st Value:	
2nd Value:	
Value Percent:	
Step:	NO
Remarks:

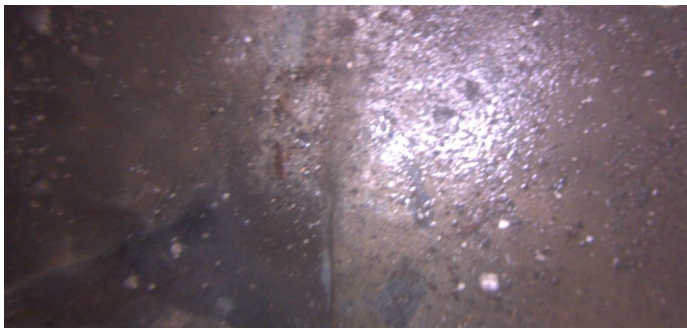
Code:	MGO
Description:	General Observation
Distance (ft):	8.5
Structural Grade:	0
O&M Grade:	0
Clock Start/From:	
Clock To:	
1st Value:	
2nd Value:	
Value Percent:	
Step:	NO
Remarks:	Ins. Comp.
