Manhole Inspection Report

Date:	04/18/2018	Weather:		Coding:	RZMACP
MH#:	M-103-024	Owner:	NA	Len. Surveyed:	10.4
P.O.#:		Surveyor:	John Kuglmaier	Rim to Invert:	11.5
Customer:		Cert. #:	U-1215-07002349	Wall Material:	Concrete (reinforced)

Street:	39th Ave. 189' East of Missouri St.	Project:	Hobart, IN
City:	Hobart, IN	GPS Northing:	2890286.149
Location:		GPS Easting:	2890286.149
Drain Area:	Northwest	GPS Accuracy:	Sub-Meter
Cover Shape:	Circular	Evidence of Surcharge:	Yes
Cover Size:	23.0	Potential for Runoff:	None
Comments:

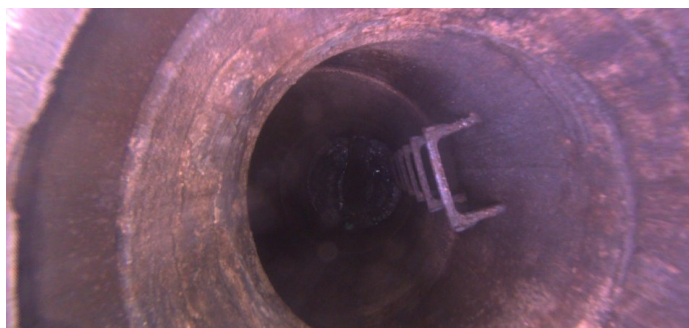
Code: **MGP**
Description: **General Photo**

Distance (ft): **.0**
Structural Grade: **0**
O&M Grade: **0**
Clock Start/From:
Clock To:
1st Value:
2nd Value:
Value Percent:
Step: **NO**
Remarks:

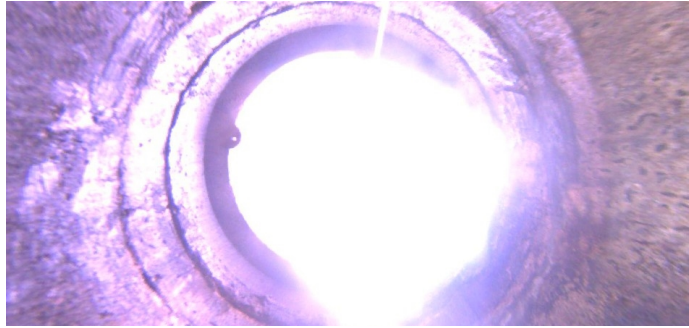
Code: **MGP**
Description: **General Photo**

Distance (ft): **2.6**
Structural Grade: **0**
O&M Grade: **0**
Clock Start/From:
Clock To:
1st Value:
2nd Value:
Value Percent:
Step: **NO**
Remarks:

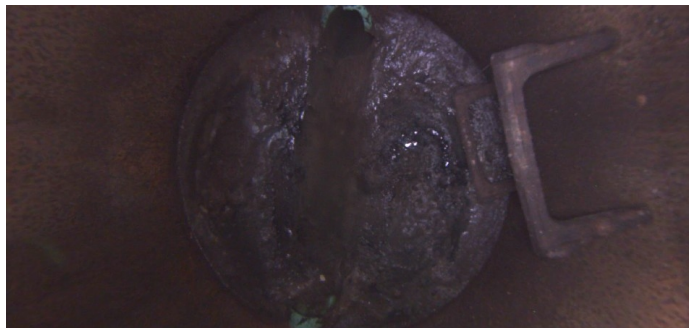
Code: **DSF**
Description: **Deposits Settled Fine**

Distance (ft): **8.0**
Structural Grade: **0**
O&M Grade: **2**
Clock Start/From: **12**
Clock To: **12**
1st Value:
2nd Value:
Value Percent: **10.000**
Step: **NO**
Remarks:

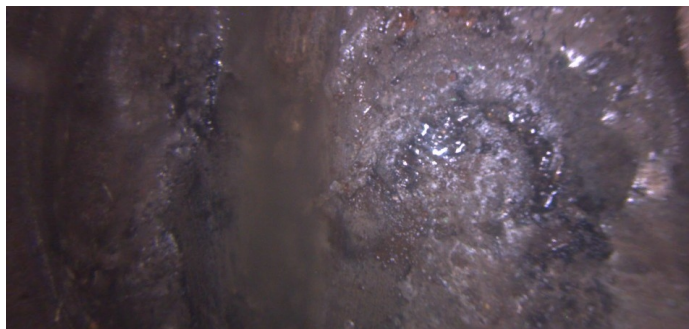
Code: **MGO**
Description: **General Observation**

Distance (ft): **9.7**
Structural Grade: **0**
O&M Grade: **0**
Clock Start/From:
Clock To:
1st Value:
2nd Value:
Value Percent:
Step: **NO**
Remarks: **Ins. Comp.**
