Manhole Inspection Report

Date:	04/18/2018	Weather:		Coding:	RZMACP
MH#:	M-103-025	Owner:	NA	Len. Surveyed:	8.2
P.O.#:		Surveyor:	John Kuglmaier	Rim to Invert:	9.4
Customer:		Cert. #:	U-1215-07002349	Wall Material:	Concrete (reinforced)

Street:	Missouri St. 174' West of Willow St.	Project:	Hobart, IN
City:	Hobart, IN	GPS Northing:	2890590.341
Location:		GPS Easting:	2890590.341
Drain Area:	Northwest	GPS Accuracy:	Sub-Meter
Cover Shape:	Circular	Evidence of Surcharge:	No
Cover Size:	23.0	Potential for Runoff:	None
Comments:

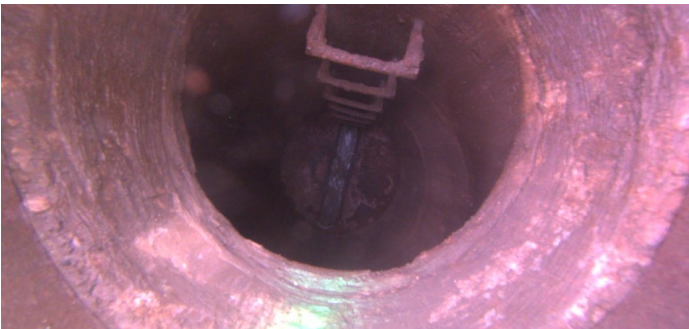
Code:
MGP

Description:
General Photo

Distance (ft):
.0

Structural Grade:
0

O&M Grade:
0

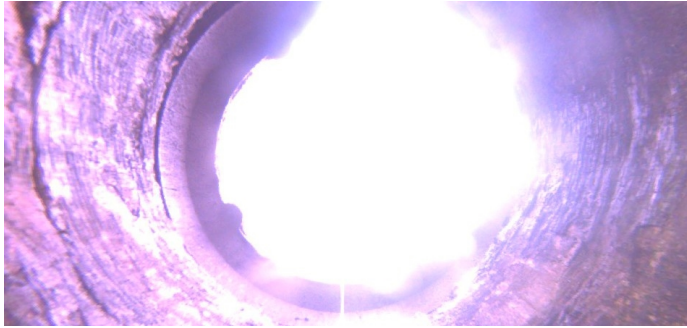
Code: **MGP**
Description: **General Photo**

Distance (ft): **2.4**
Structural Grade: **0**
O&M Grade: **0**
Clock Start/From:
Clock To:
1st Value:
2nd Value:
Value Percent:
Step: **NO**
Remarks:

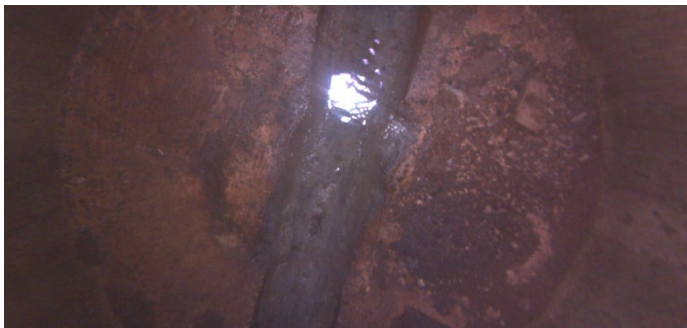
Code: **MGO**
Description: **General Observation**

Distance (ft): **7.0**
Structural Grade: **0**
O&M Grade: **0**
Clock Start/From:
Clock To:
1st Value:
2nd Value:
Value Percent:
Step: **NO**
Remarks: **Ins. Comp.**
