Manhole Inspection Report

Date:	04/18/2018	Weather:		Coding:	RZMACP
MH#:	M-103-026	Owner:	NA	Len. Surveyed:	6.6
P.O.#:		Surveyor:	John Kuglmaier	Rim to Invert:	8.9
Customer:		Cert. #:	U-1215-07002349	Wall Material:	Concrete (reinforced)

Street:	Intersection of 39th Ave. and Willow	Project:	Hobart, IN
City:	Hobart, IN	GPS Northing:	2890763.045
Location:		GPS Easting:	2890763.045
Drain Area:	Northwest	GPS Accuracy:	Sub-Meter
Cover Shape:	Circular	Evidence of Surcharge:	Yes
Cover Size:	23.0	Potential for Runoff:	None
Comments:

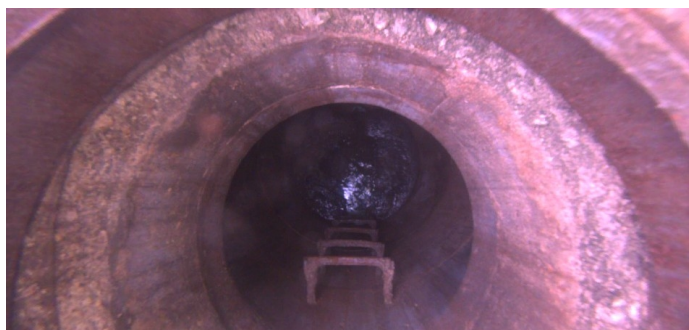
Code: **MGP**
Description: **General Photo**

Distance (ft): **.0**
Structural Grade: **0**
O&M Grade: **0**
Clock Start/From:
Clock To:
1st Value:
2nd Value:
Value Percent:
Step: **NO**
Remarks:

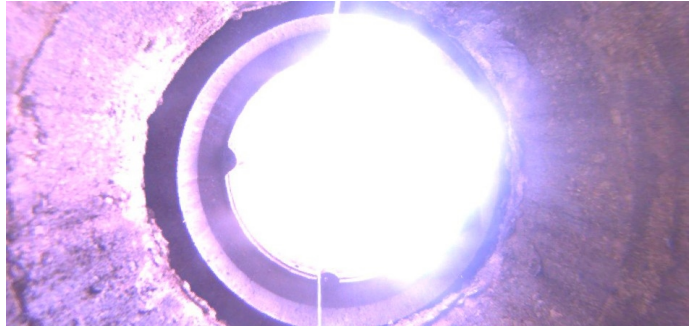
Code: **MGP**
Description: **General Photo**

Distance (ft): **2.5**
Structural Grade: **0**
O&M Grade: **0**
Clock Start/From:
Clock To:
1st Value:
2nd Value:
Value Percent:
Step: **NO**
Remarks:

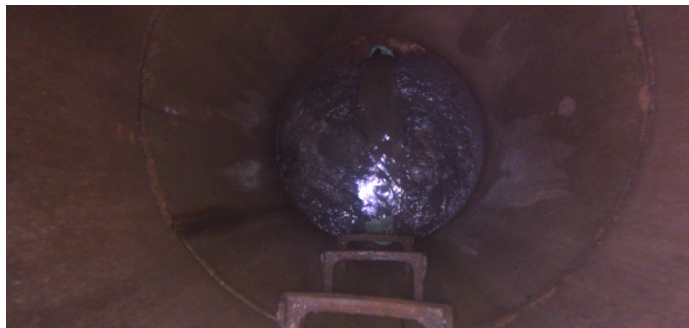
Code: **IS**
Description: **Infil Stain**

Distance (ft): **3.3**
Structural Grade: **0**
O&M Grade: **0**
Clock Start/From: **8**
Clock To:
1st Value:
2nd Value:
Value Percent:
Step: **NO**
Remarks:

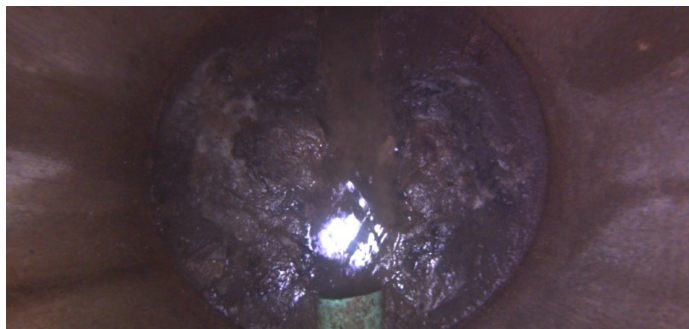
Code: **DAZ**
Description: **Deposits Attached Other**

Distance (ft): **5.9**
Structural Grade: **0**
O&M Grade: **2**
Clock Start/From: **12**
Clock To: **12**
1st Value:
2nd Value:
Value Percent: **10.000**
Step: **NO**
Remarks: **Mixed materials**
