Manhole Inspection Report

Date:	04/19/2018	Weather:		Coding:	RZMACP
MH#:	M-103-027	Owner:	NA	Len. Surveyed:	9.4
P.O.#:		Surveyor:	John Kuglmaier	Rim to Invert:	10.5
Customer:		Cert. #:	U-1215-07002349	Wall Material:	Concrete (reinforced)

Street:	Intersection of 39th Ave. and Howar	Project:	Hobart, IN
City:	Hobart, IN	GPS Northing:	2891099.094
Location:		GPS Easting:	2891099.094
Drain Area:	Northwest	GPS Accuracy:	Sub-Meter
Cover Shape:	Circular	Evidence of Surcharge:	Yes
Cover Size:	23.0	Potential for Runoff:	None
Comments:

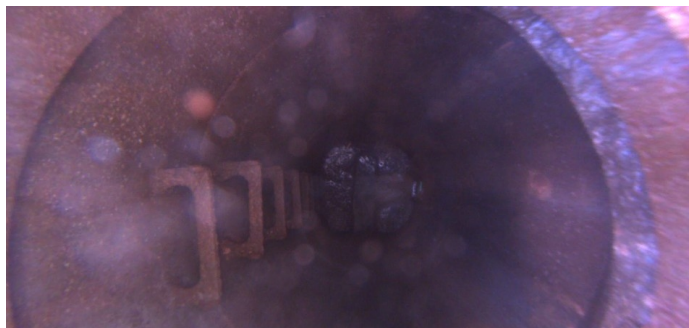
Code: **MGP**
Description: **General Photo**

Distance (ft): **.0**
Structural Grade: **0**
O&M Grade: **0**
Clock Start/From:
Clock To:
1st Value:
2nd Value:
Value Percent:
Step: **NO**
Remarks:

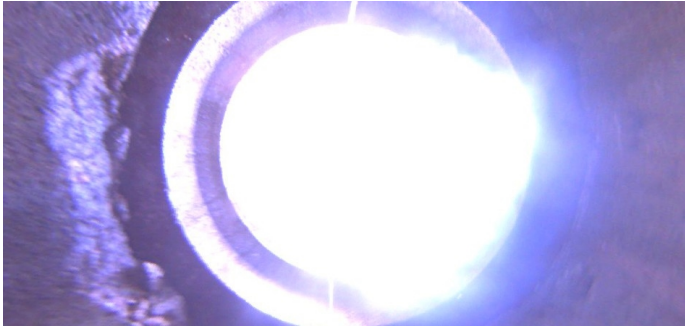
Code: **MGP**
Description: **General Photo**

Distance (ft): **2.6**
Structural Grade: **0**
O&M Grade: **0**
Clock Start/From:
Clock To:
1st Value:
2nd Value:
Value Percent:
Step: **NO**
Remarks:

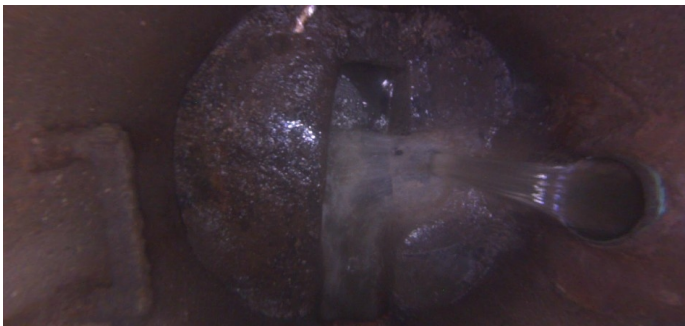
Code: **DAZ**
Description: **Deposits Attached Other**

Distance (ft): **7.4**
Structural Grade: **0**
O&M Grade: **2**
Clock Start/From: **12**
Clock To: **12**
1st Value:
2nd Value:
Value Percent: **5.000**
Step: **NO**
Remarks: **Mixed materials**

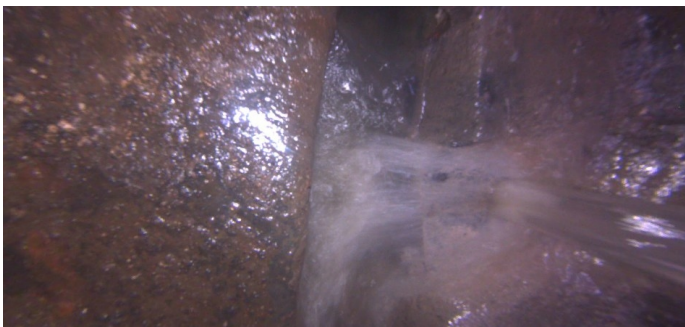
Code: **MGO**
Description: **General Observation**

Distance (ft): **9.0**
Structural Grade: **0**
O&M Grade: **0**
Clock Start/From:
Clock To:
1st Value:
2nd Value:
Value Percent:
Step: **NO**
Remarks: **Ins. Comp.**
