Manhole Inspection Report

Date:	04/16/2018	Weather:		Coding:	RZMACP
MH#:	M-103-028	Owner:	NA	Len. Surveyed:	10.2
P.O.#:		Surveyor:	John Kuglmaier	Rim to Invert:	12.3
Customer:		Cert. #:	U-1215-07002349	Wall Material:	Concrete (reinforced)

Street:	Howard St. 151' North of 39th Ave.	Project:	Hobart, IN
City:	Hobart, IN	GPS Northing:	2891092.914
Location:		GPS Easting:	2891092.914
Drain Area:	Northwest	GPS Accuracy:	Sub-Meter
Cover Shape:	Circular	Evidence of Surcharge:	Yes
Cover Size:	23.0	Potential for Runoff:	None
Comments:

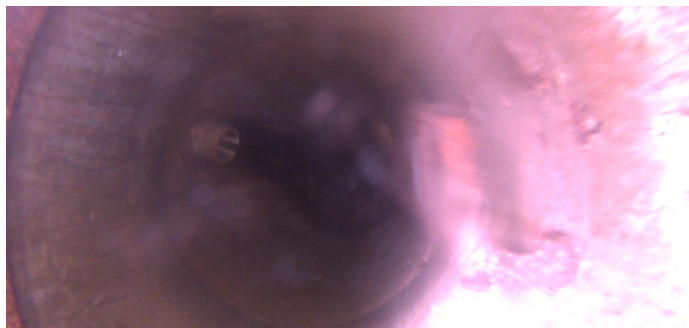
Code: **MGP**
Description: **General Photo**

Distance (ft): **.0**
Structural Grade: **0**
O&M Grade: **0**
Clock Start/From:
Clock To:
1st Value:
2nd Value:
Value Percent:
Step: **NO**
Remarks:

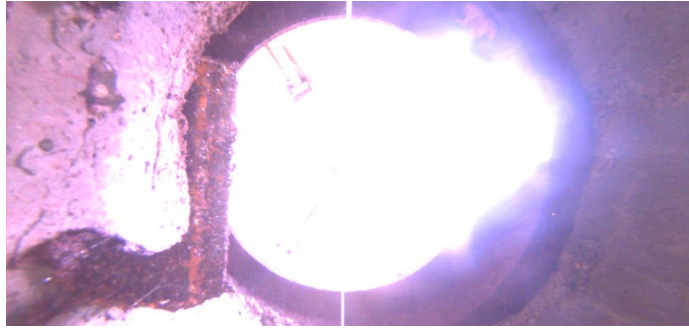
Code: **MGP**
Description: **General Photo**

Distance (ft): **2.2**
Structural Grade: **0**
O&M Grade: **0**
Clock Start/From:
Clock To:
1st Value:
2nd Value:
Value Percent:
Step: **NO**
Remarks:

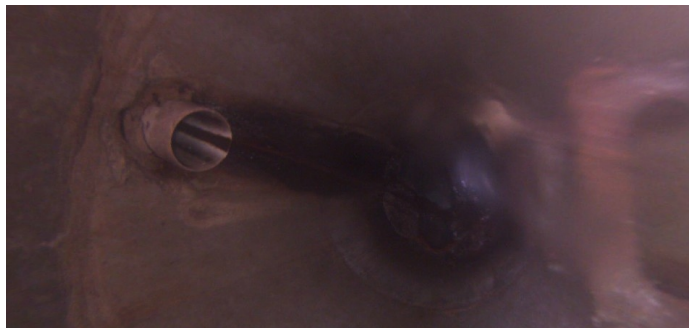
Code: **RMC**
Description: **Roots Medium Connection**

Distance (ft): **2.8**
Structural Grade: **0**
O&M Grade: **3**
Clock Start/From: **10**
Clock To:
1st Value:
2nd Value:
Value Percent: **5.000**
Step: **NO**
Remarks:

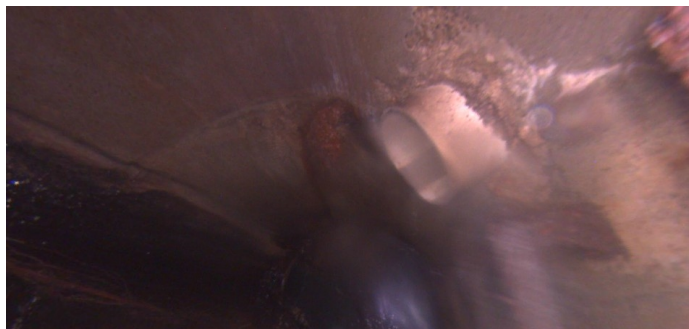
Code: **IS**
Description: **Infil Stain**

Distance (ft): **5.7**
Structural Grade: **0**
O&M Grade: **0**
Clock Start/From: **12**
Clock To:
1st Value:
2nd Value:
Value Percent:
Step: **NO**
Remarks:

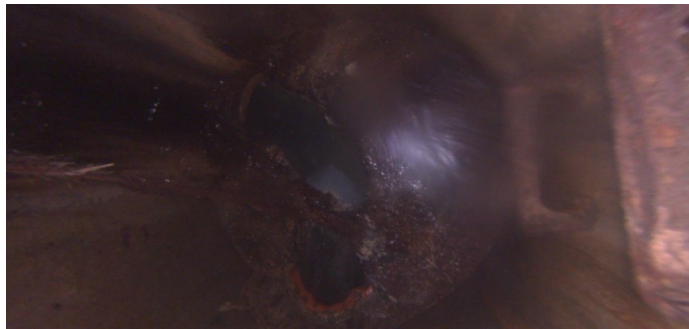
Code:	DAZ
Description:	Deposits Attached Other
Distance (ft):	8.1
Structural Grade:	0
O&M Grade:	2
Clock Start/From:	12
Clock To:	12
1st Value:	
2nd Value:	
Value Percent:	5.000
Step:	NO
Remarks:	Mixed materials

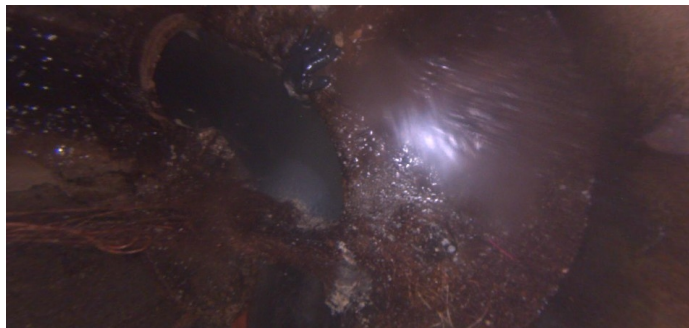
Code:	MGO
Description:	General Observation
Distance (ft):	9.6
Structural Grade:	0
O&M Grade:	0
Clock Start/From:	
Clock To:	
1st Value:	
2nd Value:	
Value Percent:	
Step:	NO
Remarks:	Ins. Comp.
