Manhole Inspection Report

Date:	04/16/2018	Weather:		Coding:	RZMACP
MH#:	M-103-029	Owner:	NA	Len. Surveyed:	13.9
P.O.#:		Surveyor:	John Kuglmaier	Rim to Invert:	16.0
Customer:		Cert. #:	U-1215-07002349	Wall Material:	Concrete (reinforced)

Street:	Alley between 38th and 39th Ave 15	Project:	Hobart, IN
City:	Hobart, IN	GPS Northing:	0.0
Location:		GPS Easting:	0.0
Drain Area:	Northwest	GPS Accuracy:	Nearest Meter
Cover Shape:	Circular	Evidence of Surcharge:	Yes
Cover Size:	23.0	Potential for Runoff:	None
Comments:

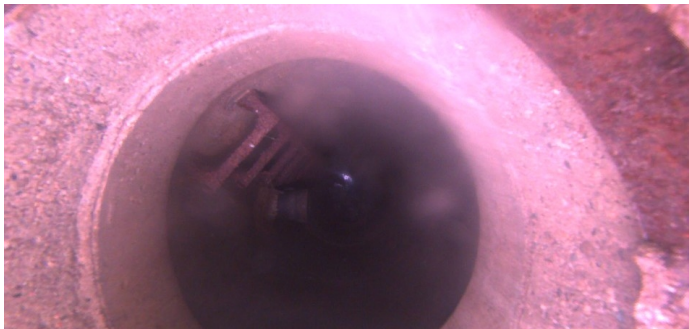
Code: **MGP**
Description: **General Photo**

Distance (ft): **.0**
Structural Grade: **0**
O&M Grade: **0**
Clock Start/From:
Clock To:
1st Value:
2nd Value:
Value Percent:
Step: **NO**
Remarks:

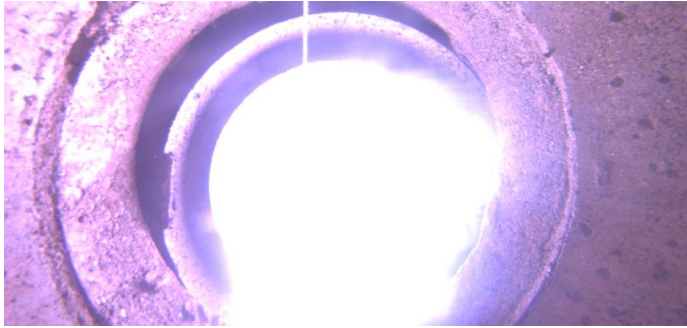
Code: **MGP**
Description: **General Photo**

Distance (ft): **2.3**
Structural Grade: **0**
O&M Grade: **0**
Clock Start/From:
Clock To:
1st Value:
2nd Value:
Value Percent:
Step: **NO**
Remarks:

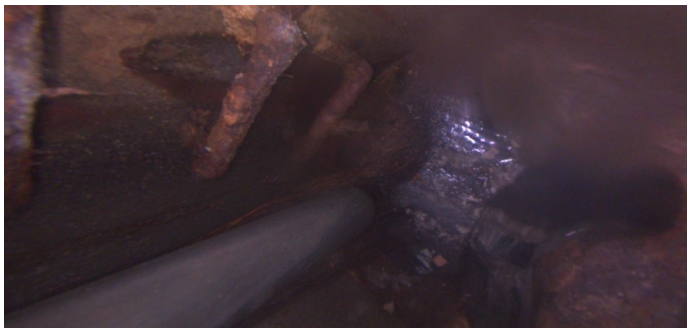
Code: **RMJ**
Description: **Roots Medium Joint**

Distance (ft): **11.4**
Structural Grade: **0**
O&M Grade: **3**
Clock Start/From: **8**
Clock To:
1st Value:
2nd Value:
Value Percent: **10.000**
Step: **NO**
Remarks:

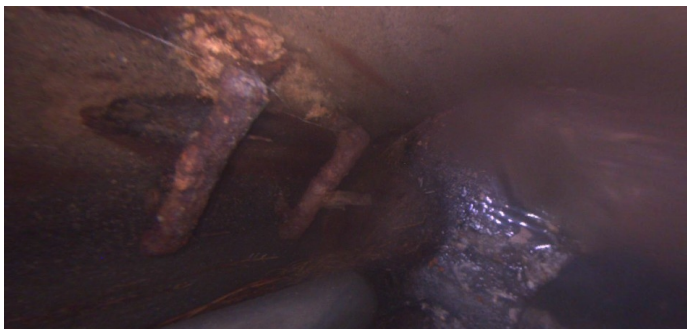
Code: **IS**
Description: **Infil Stain**

Distance (ft): **11.8**
Structural Grade: **0**
O&M Grade: **0**
Clock Start/From: **10**
Clock To:
1st Value:
2nd Value:
Value Percent:
Step: **NO**
Remarks:

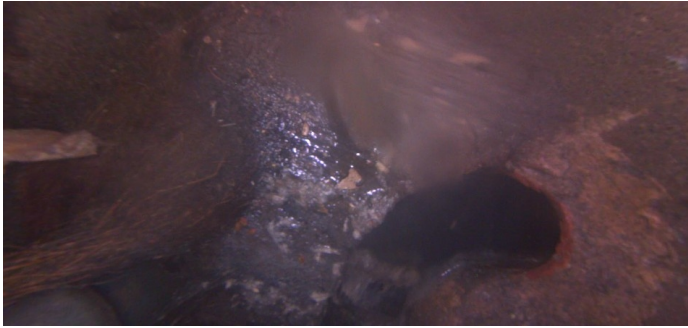
Code: **MGO**
Description: **General Observation**

Distance (ft): **12.9**
Structural Grade: **0**
O&M Grade: **0**
Clock Start/From:
Clock To:
1st Value:
2nd Value:
Value Percent:
Step: **NO**
Remarks: **Ins. Comp.**
