# Manhole Inspection Report

Date:	10/04/2022	Weather:		Coding:	RZMACP
MH#:	M-103-030	Owner:	NA	Len. Surveyed:	12.9
P.O.#:		Surveyor:	Jen Costello	Rim to Invert:	14.0
Customer:		Cert. #:	U-907-5518	Wall Material:	Concrete (reinforced)

Street:	Alley Howard St. and Colborne St. 2	Project:	Missing GPS
City:	Hobart, IN	GPS Northing:	0.0
Location:		GPS Easting:	0.0
Drain Area:	Northwest	GPS Accuracy:	
Cover Shape:	Circular	Evidence of Surcharge:	
Cover Size:	24.0	Potential for Runoff:	
Comments:

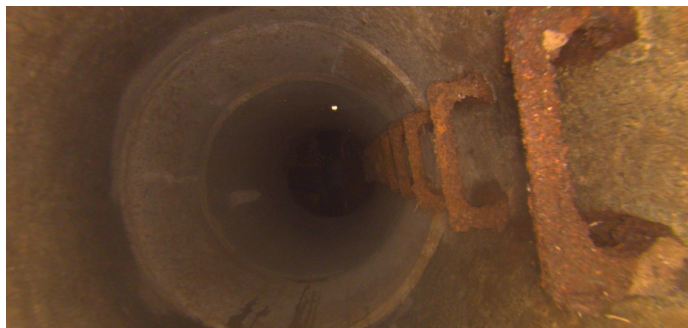
Code: **MGO**  
Description: **General Observation**

Distance (ft): **.0**  
Structural Grade: **0**  
O&M Grade: **0**  
Clock Start/From:  
Clock To:  
1st Value:  
2nd Value:  
Value Percent:  
Step: **NO**  
Remarks: **access mh**

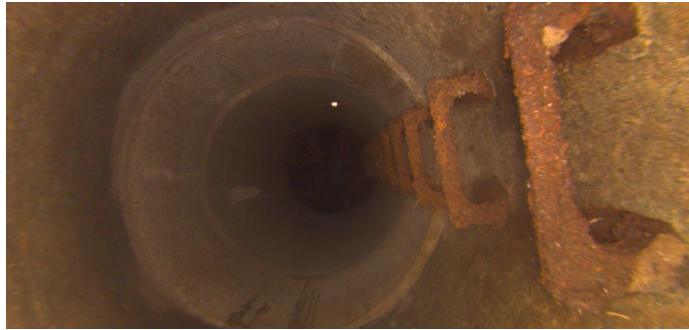
Code: **SAV**  
Description: **Surface Aggregate Visible**

Distance (ft): **.0**  
Structural Grade: **3**  
O&M Grade: **0**  
Clock Start/From: **12**  
Clock To: **12**  
1st Value:  
2nd Value:  
Value Percent:  
Step: **NO**  
Remarks:

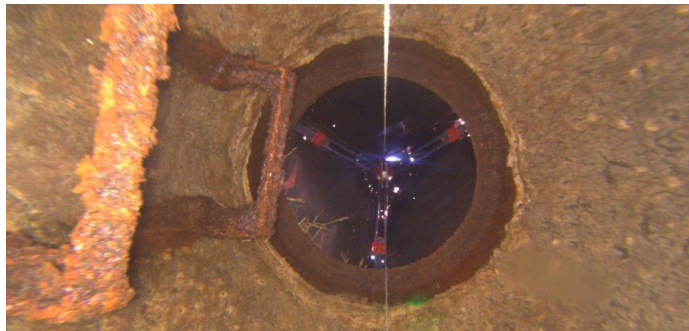
Code: **MGO**  
Description: **General Observation**

Distance (ft): **2.8**  
Structural Grade: **0**  
O&M Grade: **0**  
Clock Start/From:  
Clock To:  
1st Value:  
2nd Value:  
Value Percent:  
Step: **NO**  
Remarks: **underside of frame**

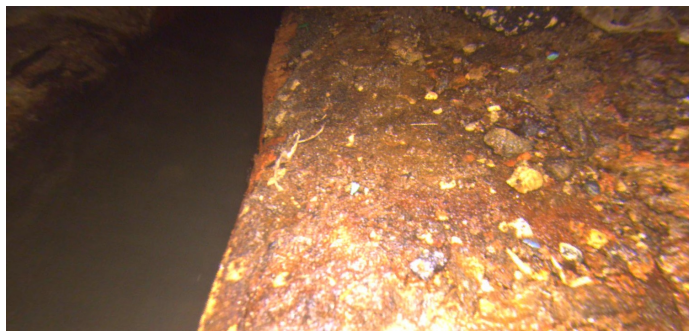
Code: **DSGV**  
Description: **Deposits Settled Gravel**

Distance (ft): **12.9**  
Structural Grade: **0**  
O&M Grade: **2**  
Clock Start/From: **12**  
Clock To: **12**  
1st Value:  
2nd Value:  
Value Percent: **5.000**  
Step: **NO**  
Remarks:

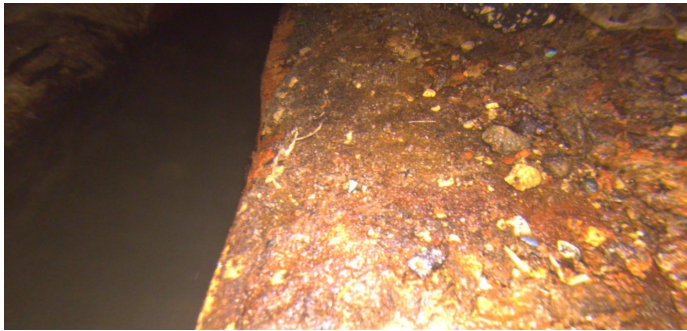
Code:	<b>SAV</b>
Description:	<b>Surface Aggregate Visible</b>
Distance (ft):	<b>12.9</b>
Structural Grade:	<b>3</b>
O&M Grade:	<b>0</b>
Clock Start/From:	<b>12</b>
Clock To:	<b>12</b>
1st Value:	
2nd Value:	
Value Percent:	
Step:	<b>NO</b>
Remarks:

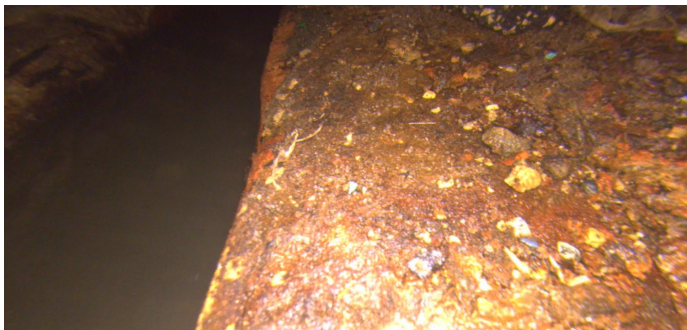
Code:	<b>MGO</b>
Description:	<b>General Observation</b>
Distance (ft):	<b>12.9</b>
Structural Grade:	<b>0</b>
O&M Grade:	<b>0</b>
Clock Start/From:	
Clock To:	
1st Value:	
2nd Value:	
Value Percent:	
Step:	<b>NO</b>
Remarks:	<b>end of survey</b>
