Manhole Inspection Report

Date:	04/16/2018	Weather:		Coding:	RZMACP
MH#:	M-103-033	Owner:	NA	Len. Surveyed:	9.0
P.O.#:		Surveyor:	John Kuglmaier	Rim to Invert:	13.0
Customer:		Cert. #:	U-1215-07002349	Wall Material:	Concrete (reinforced)

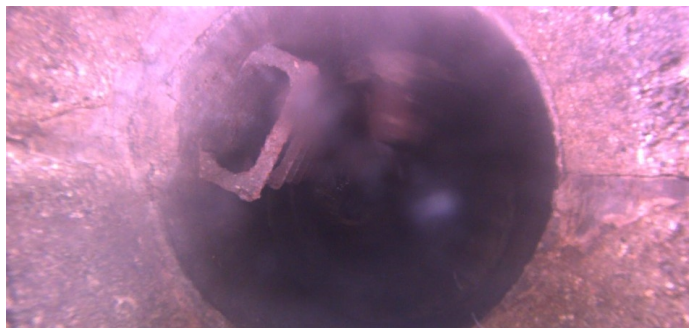
Code: **MGP**
 Description: **General Photo**

Distance (ft): **.0**
 Structural Grade: **0**
 O&M Grade: **0**
 Clock Start/From:
 Clock To:
 1st Value:
 2nd Value:
 Value Percent:
 Step: **NO**
 Remarks:

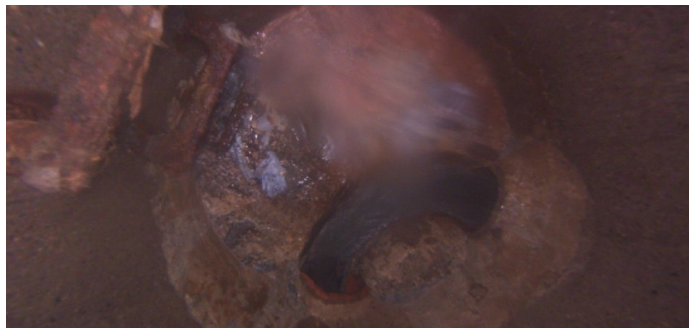
Code: **DAZ**
Description: **Deposits Attached Other**

Distance (ft): **8.6**
Structural Grade: **0**
O&M Grade: **2**
Clock Start/From: **12**
Clock To: **12**
1st Value:
2nd Value:
Value Percent: **5.000**
Step: **NO**
Remarks: **Mixed materials**

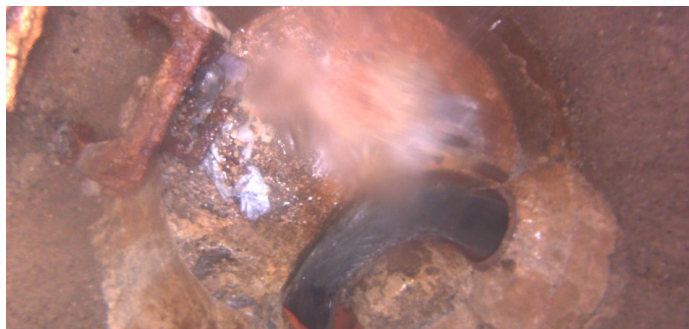
Code: **MGO**
Description: **General Observation**

Distance (ft): **9.0**
Structural Grade: **0**
O&M Grade: **0**
Clock Start/From:
Clock To:
1st Value:
2nd Value:
Value Percent:
Step: **NO**
Remarks: **Ins. Comp.**
