Manhole Inspection Report

Date:	04/18/2018	Weather:		Coding:	RZMACP
MH#:	M-103-101	Owner:	NA	Len. Surveyed:	4.2
P.O.#:		Surveyor:	John Kuglmaier	Rim to Invert:	7.0
Customer:		Cert. #:	U-1215-07002349	Wall Material:	Concrete (reinforced)

Street:	Maple St. 575' South of 39th Ave.	Project:	Hobart, IN
City:	Hobart, IN	GPS Northing:	2889769.466
Location:		GPS Easting:	2889769.466
Drain Area:	Northwest	GPS Accuracy:	Sub-Meter
Cover Shape:	Circular	Evidence of Surcharge:	No
Cover Size:	23.0	Potential for Runoff:	None
Comments:

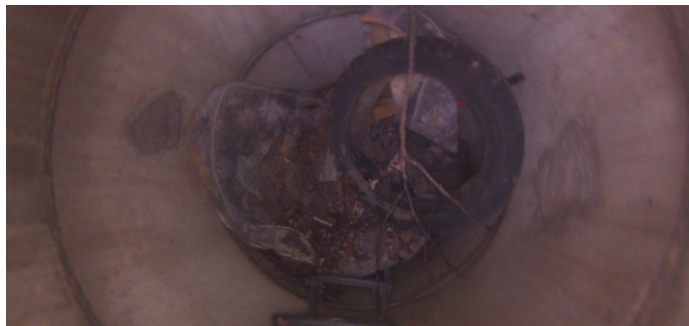
Code:	OBZ
Description:	Obstacle Other
Distance (ft):	1.8
Structural Grade:	0
O&M Grade:	5
Clock Start/From:	12
Clock To:	12
1st Value:	
2nd Value:	
Value Percent:	35.000
Step:	NO
Remarks:	Mixed materials

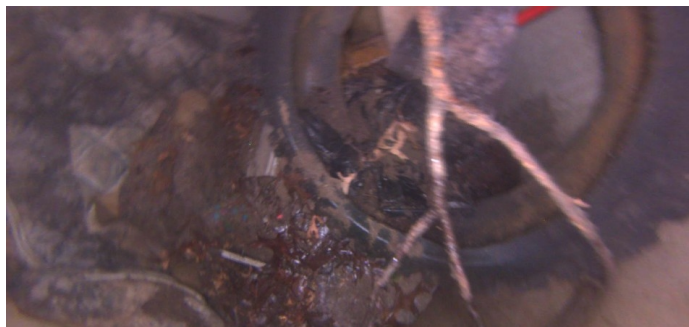
Code:	MSA
Description:	Abandoned Survey
Distance (ft):	3.7
Structural Grade:	0
O&M Grade:	0
Clock Start/From:	
Clock To:	
1st Value:	
2nd Value:	
Value Percent:	
Step:	NO
Remarks:	Debris
