Manhole Inspection Report

Date:	04/18/2018	Weather:		Coding:	RZMACP
MH#:	M-103-102	Owner:	NA	Len. Surveyed:	7.0
P.O.#:		Surveyor:	John Kuglmaier	Rim to Invert:	8.2
Customer:		Cert. #:	U-1215-07002349	Wall Material:	Concrete (reinforced)

Street:	Maple St. 293' South of 39th Ave.	Project:	Hobart, IN
City:	Hobart, IN	GPS Northing:	2889777.048
Location:		GPS Easting:	2889777.048
Drain Area:	Northwest	GPS Accuracy:	Sub-Meter
Cover Shape:	Circular	Evidence of Surcharge:	No
Cover Size:	23.0	Potential for Runoff:	None
Comments:

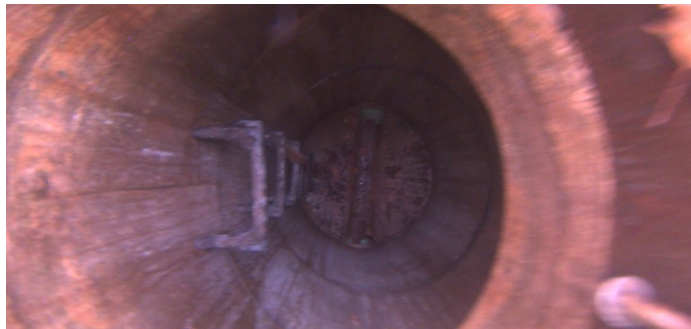
Code: **MGP**
Description: **General Photo**

Distance (ft): **.0**
Structural Grade: **0**
O&M Grade: **0**
Clock Start/From:
Clock To:
1st Value:
2nd Value:
Value Percent:
Step: **NO**
Remarks:

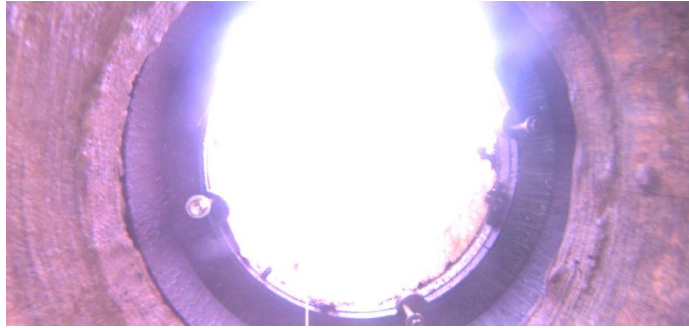
Code:	MGP
Description:	General Photo
Distance (ft):	1.8
Structural Grade:	0
O&M Grade:	0
Clock Start/From:	
Clock To:	
1st Value:	
2nd Value:	
Value Percent:	
Step:	NO
Remarks:

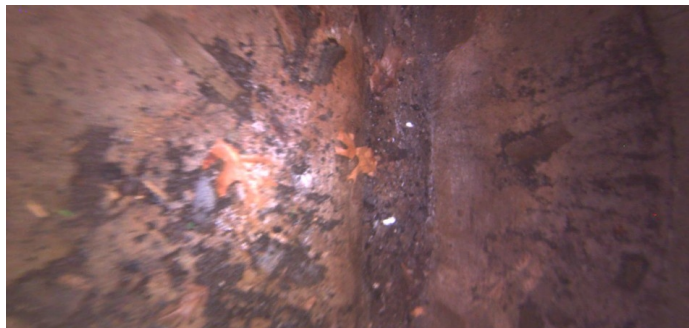
Code:	MGO
Description:	General Observation
Distance (ft):	6.5
Structural Grade:	0
O&M Grade:	0
Clock Start/From:	
Clock To:	
1st Value:	
2nd Value:	
Value Percent:	
Step:	NO
Remarks:	Ins. Comp.
