Manhole Inspection Report

Date:	04/18/2018	Weather:		Coding:	RZMACP
MH#:	M-103-103	Owner:	NA	Len. Surveyed:	6.3
P.O.#:		Surveyor:	John Kuglmaier	Rim to Invert:	7.6
Customer:		Cert. #:	U-1215-07002349	Wall Material:	Concrete (reinforced)

Street:	Maple St. 156' South of 39th Ave.	Project:	Hobart, IN
City:	Hobart, IN	GPS Northing:	2889779.447
Location:		GPS Easting:	2889779.447
Drain Area:	Northwest	GPS Accuracy:	Sub-Meter
Cover Shape:	Circular	Evidence of Surcharge:	No
Cover Size:	23.0	Potential for Runoff:	None
Comments:

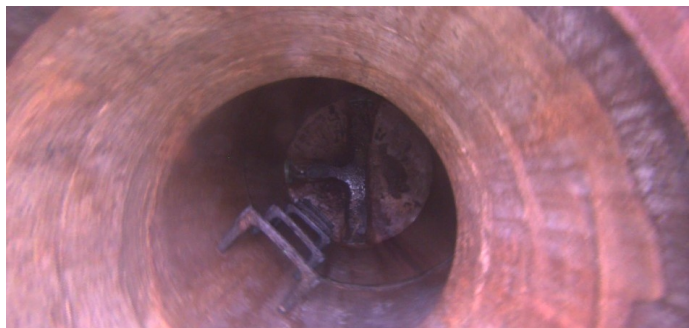
Code: **MGP**
Description: **General Photo**

Distance (ft): **.0**
Structural Grade: **0**
O&M Grade: **0**
Clock Start/From:
Clock To:
1st Value:
2nd Value:
Value Percent:
Step: **NO**
Remarks:

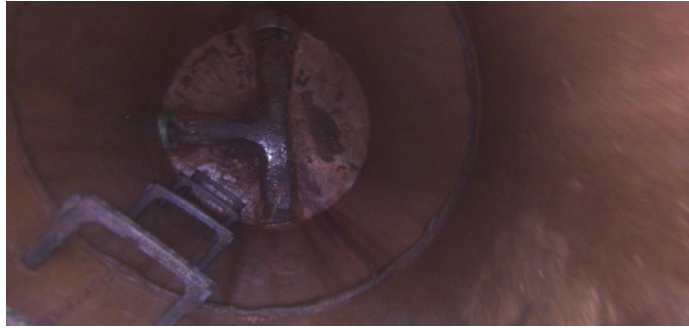
Code: **IS**
Description: **Infil Stain**

Distance (ft): **1.7**
Structural Grade: **0**
O&M Grade: **0**
Clock Start/From: **5**
Clock To:
1st Value:
2nd Value:
Value Percent:
Step: **NO**
Remarks:

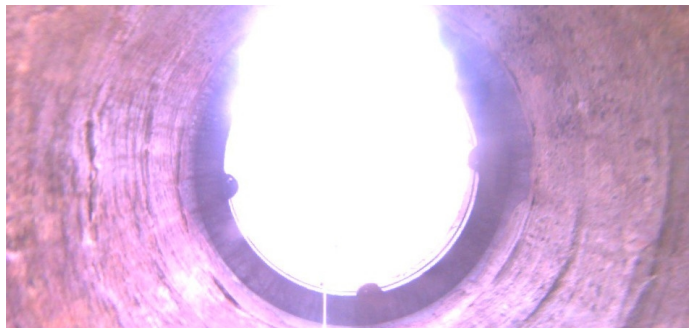
Code: **MGP**
Description: **General Photo**

Distance (ft): **2.4**
Structural Grade: **0**
O&M Grade: **0**
Clock Start/From:
Clock To:
1st Value:
2nd Value:
Value Percent:
Step: **NO**
Remarks:

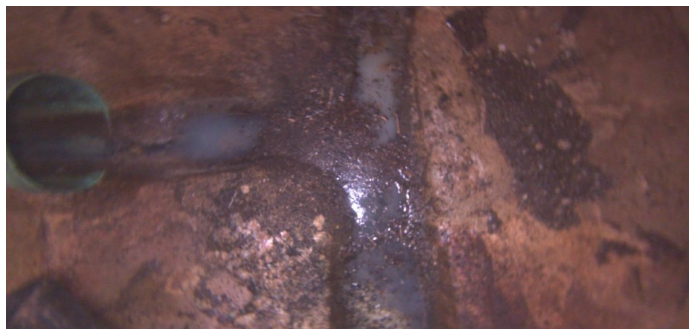
Code: **MGO**
Description: **General Observation**

Distance (ft): **5.7**
Structural Grade: **0**
O&M Grade: **0**
Clock Start/From:
Clock To:
1st Value:
2nd Value:
Value Percent:
Step: **NO**
Remarks: **Ins. Comp.**
