Manhole Inspection Report

Date:	04/18/2018	Weather:		Coding:	RZMACP
MH#:	M-103-106	Owner:	NA	Len. Surveyed:	16.6
P.O.#:		Surveyor:	John Kuglmaier	Rim to Invert:	18.5
Customer:		Cert. #:	U-1215-07002349	Wall Material:	Concrete (reinforced)

Street:	39th Ave. 111' West of Maple St.	Project:	Hobart, IN
City:	Hobart, IN	GPS Northing:	2889667.892
Location:		GPS Easting:	2889667.892
Drain Area:	Northwest	GPS Accuracy:	Sub-Meter
Cover Shape:	Circular	Evidence of Surcharge:	No
Cover Size:	23.0	Potential for Runoff:	None
Comments:

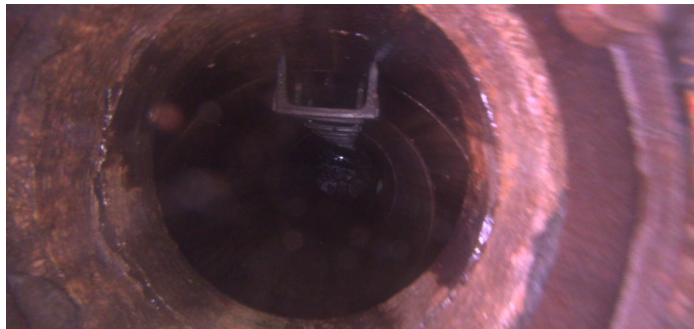
Code: **MGP**
 Description: **General Photo**

Distance (ft): **.0**
 Structural Grade: **0**
 O&M Grade: **0**
 Clock Start/From:
 Clock To:
 1st Value:
 2nd Value:
 Value Percent:
 Step: **NO**
 Remarks:

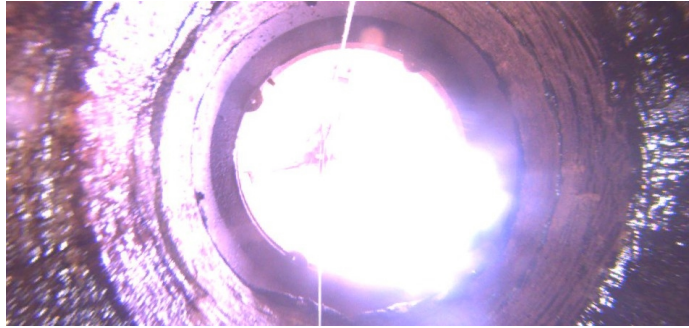
Code: **MGP**
Description: **General Photo**

Distance (ft): **2.6**
Structural Grade: **0**
O&M Grade: **0**
Clock Start/From:
Clock To:
1st Value:
2nd Value:
Value Percent:
Step: **NO**
Remarks:

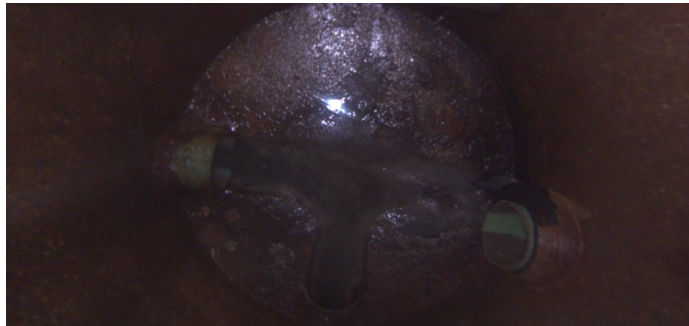
Code: **DSF**
Description: **Deposits Settled Fine**

Distance (ft): **14.9**
Structural Grade: **0**
O&M Grade: **2**
Clock Start/From: **12**
Clock To: **12**
1st Value:
2nd Value:
Value Percent: **5.000**
Step: **NO**
Remarks:

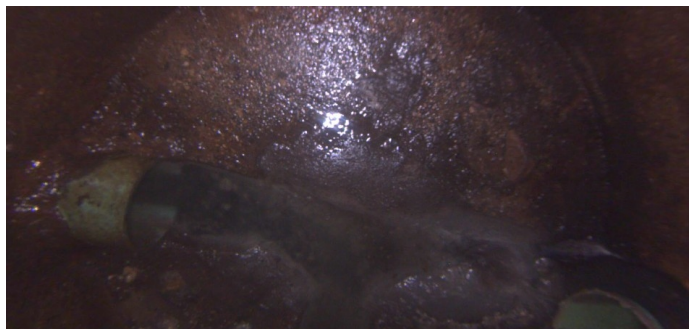
Code: **MGO**
Description: **General Observation**

Distance (ft): **16.1**
Structural Grade: **0**
O&M Grade: **0**
Clock Start/From:
Clock To:
1st Value:
2nd Value:
Value Percent:
Step: **NO**
Remarks: **Ins. Comp.**
