Manhole Inspection Report

Date:	04/18/2018	Weather:		Coding:	RZMACP
MH#:	M-103-108	Owner:	NA	Len. Surveyed:	8.8
P.O.#:		Surveyor:	John Kuglmaier	Rim to Invert:	8.9
Customer:		Cert. #:	U-1215-07002349	Wall Material:	Concrete (reinforced)

Street:	Intersection of 39th Ave. and Alaba	Project:	Hobart, IN
City:	Hobart, IN	GPS Northing:	2889440.689
Location:		GPS Easting:	2889440.689
Drain Area:	Northwest	GPS Accuracy:	Sub-Meter
Cover Shape:	Circular	Evidence of Surcharge:	No
Cover Size:	23.0	Potential for Runoff:	None
Comments:

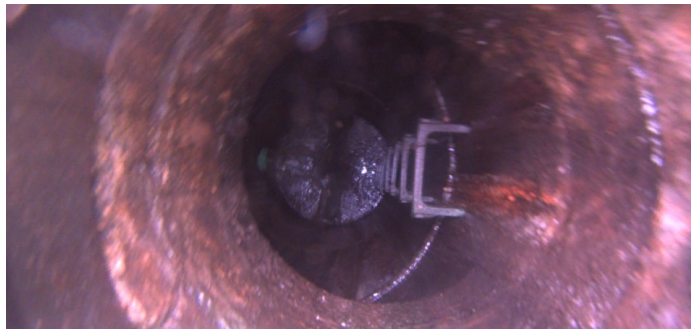
Code: **MGP**
Description: **General Photo**

Distance (ft): **.0**
Structural Grade: **0**
O&M Grade: **0**
Clock Start/From:
Clock To:
1st Value:
2nd Value:
Value Percent:
Step: **NO**
Remarks:

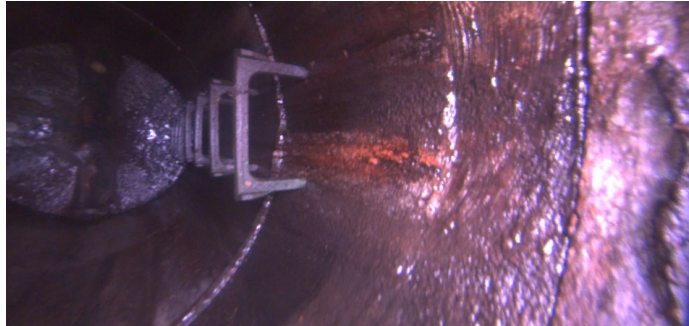
Code: **IS**
Description: **Infil Stain**

Distance (ft): **1.0**
Structural Grade: **0**
O&M Grade: **0**
Clock Start/From: **3**
Clock To:
1st Value:
2nd Value:
Value Percent:
Step: **NO**
Remarks:

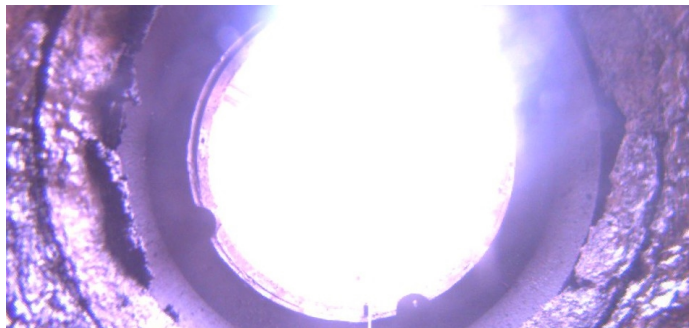
Code: **MGP**
Description: **General Photo**

Distance (ft): **2.0**
Structural Grade: **0**
O&M Grade: **0**
Clock Start/From:
Clock To:
1st Value:
2nd Value:
Value Percent:
Step: **NO**
Remarks:

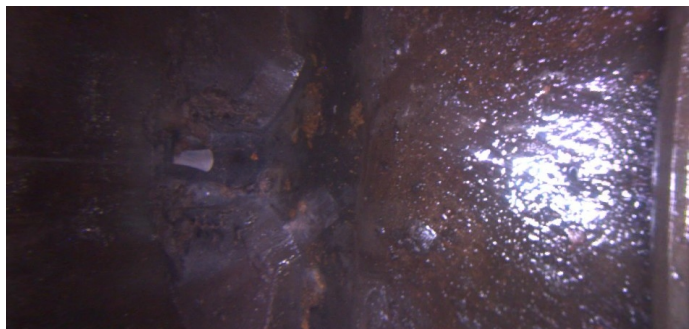
Code: **MGO**
Description: **General Observation**

Distance (ft): **8.1**
Structural Grade: **0**
O&M Grade: **0**
Clock Start/From:
Clock To:
1st Value:
2nd Value:
Value Percent:
Step: **NO**
Remarks: **Ins. Comp.**
