# Manhole Inspection Report

| MH#: | <b>M-103-114</b> | Owner: | <b>NA</b> | Len. Surveyed: | <b>4.2</b> |

| Street: | <b>39th Ave. 218' West of Swift St.</b> | Project: | <b>Hobart, IN</b> |

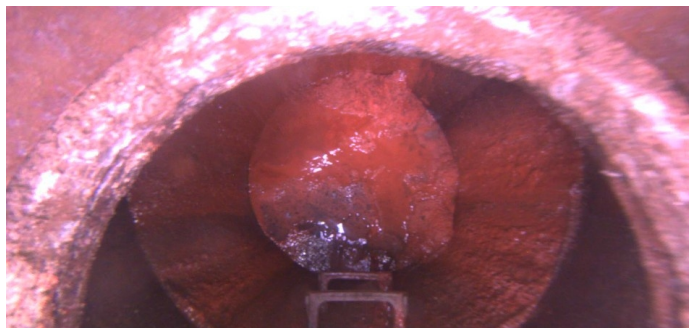
Code: **MGP**  
Description: **General Photo**

Distance (ft): **.0**  
Structural Grade: **0**  
O&M Grade: **0**  
Clock Start/From:  
Clock To:  
1st Value:  
2nd Value:  
Value Percent:  
Step: **NO**  
Remarks:

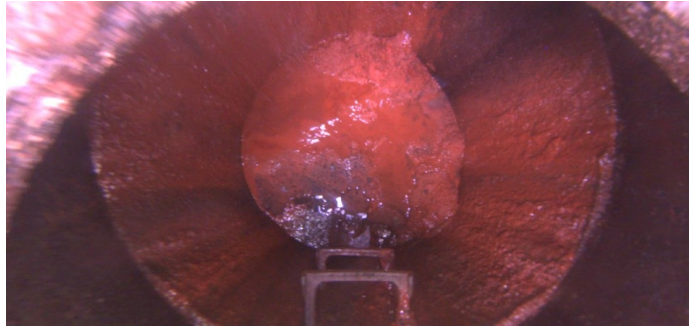
Code: **IS**  
Description: **Infil Stain**

Distance (ft): **.4**  
Structural Grade: **0**  
O&M Grade: **0**  
Clock Start/From: **12**  
Clock To: **12**  
1st Value:  
2nd Value:  
Value Percent:  
Step: **NO**  
Remarks:

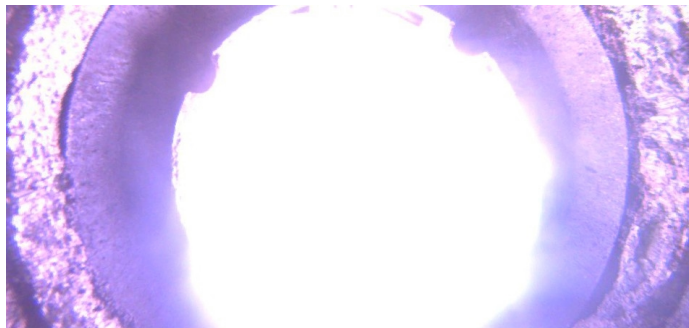
Code: **MGP**  
Description: **General Photo**

Distance (ft): **1.8**  
Structural Grade: **0**  
O&M Grade: **0**  
Clock Start/From:  
Clock To:  
1st Value:  
2nd Value:  
Value Percent:  
Step: **NO**  
Remarks:

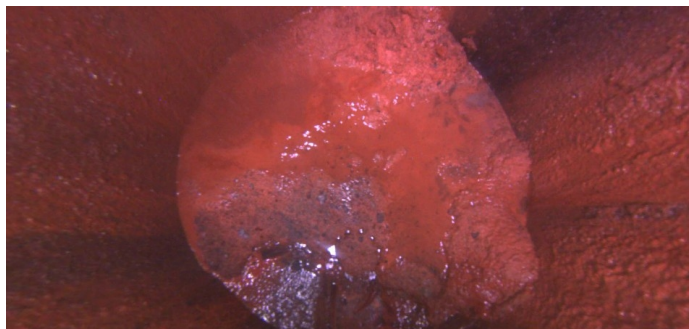
Code: **DAZ**  
Description: **Deposits Attached Other**

Distance (ft): **2.3**  
Structural Grade: **0**  
O&M Grade: **3**  
Clock Start/From: **12**  
Clock To: **12**  
1st Value:  
2nd Value:  
Value Percent: **15.000**  
Step: **NO**  
Remarks: **Mixed materials**

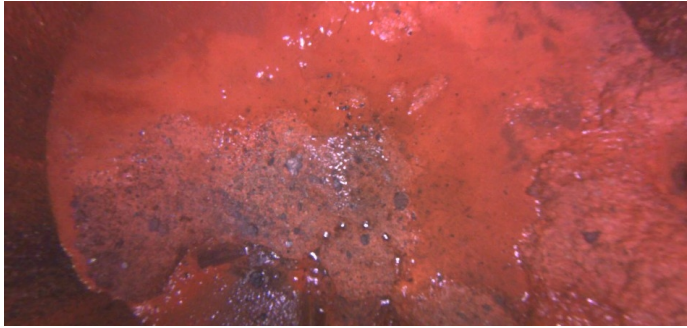
| Code: | <b>MGO</b> |
| Description: | <b>General Observation</b> |
| Distance (ft): | <b>3.6</b> |
| Remarks: | <b>Ins. Comp.</b> |
