Manhole Inspection Report

Date:	04/16/2018	Weather:		Coding:	RZMACP
MH#:	M-103-122	Owner:	NA	Len. Surveyed:	13.8
P.O.#:		Surveyor:	Jen Costello	Rim to Invert:	15.4
Customer:		Cert. #:	U-907-5518	Wall Material:	Concrete (reinforced)

Street:	Intersection of 38th Ave alley betwe	Project:	Hobart, IN
City:	Hobart, IN	GPS Northing:	2889591.268
Location:		GPS Easting:	2889591.268
Drain Area:	Northwest	GPS Accuracy:	Sub-Meter
Cover Shape:	Circular	Evidence of Surcharge:	No
Cover Size:	23.0	Potential for Runoff:	None
Comments:

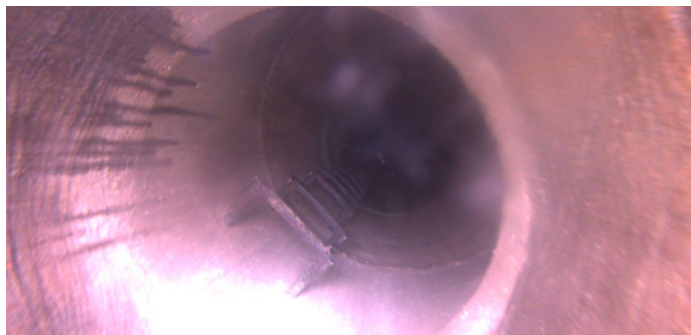
Code: **MGO**
Description: **General Observation**

Distance (ft): **.0**
Structural Grade: **0**
O&M Grade: **0**
Clock Start/From:
Clock To:
1st Value:
2nd Value:
Value Percent:
Step: **NO**
Remarks: **ACCESS MH**

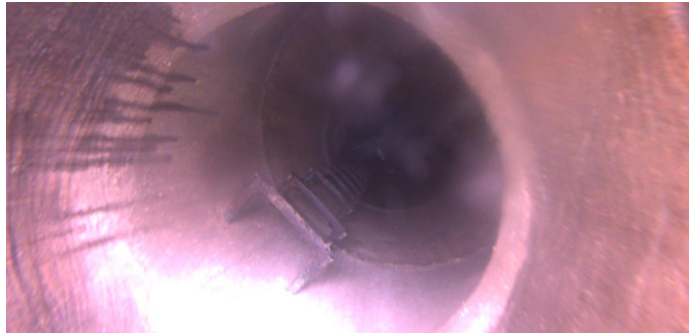
Code: **IW**
Description: **Infil Weeper**

Distance (ft): **.0**
Structural Grade: **0**
O&M Grade: **2**
Clock Start/From: **9**
Clock To: **11**
1st Value:
2nd Value:
Value Percent:
Step: **NO**
Remarks:

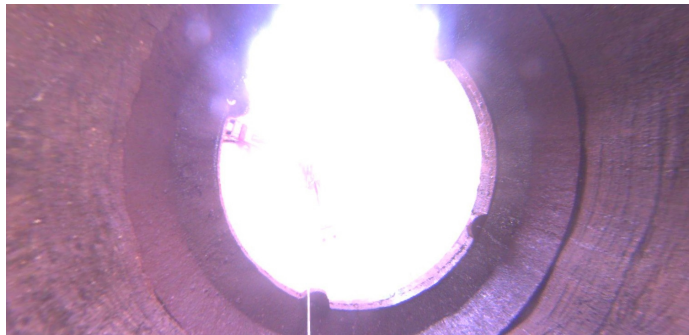
Code: **MGP**
Description: **General Photo**

Distance (ft): **1.3**
Structural Grade: **0**
O&M Grade: **0**
Clock Start/From:
Clock To:
1st Value:
2nd Value:
Value Percent:
Step: **NO**
Remarks: **UNDERSIDE OF FRAME**

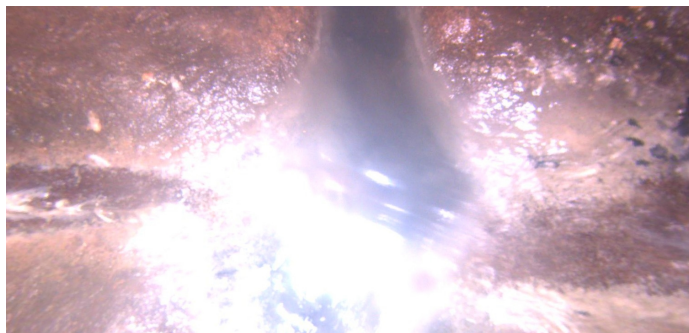
Code: **MGO**
Description: **General Observation**

Distance (ft): **13.8**
Structural Grade: **0**
O&M Grade: **0**
Clock Start/From:
Clock To:
1st Value:
2nd Value:
Value Percent:
Step: **NO**
Remarks: **END SURVEY**
