Manhole Inspection Report

Date:	04/16/2018	Weather:		Coding:	RZMACP
MH#:	M-103-124	Owner:	NA	Len. Surveyed:	7.7
P.O.#:		Surveyor:	John Kuglmaier	Rim to Invert:	9.1
Customer:		Cert. #:	U-1215-07002349	Wall Material:	Concrete (reinforced)

Street:	Alley between Alabama St. and Map	Project:	Hobart, IN
City:	Hobart, IN	GPS Northing:	2889590.182
Location:		GPS Easting:	2889590.182
Drain Area:	Northwest	GPS Accuracy:	Sub-Meter
Cover Shape:	Circular	Evidence of Surcharge:	Yes
Cover Size:	23.0	Potential for Runoff:	None
Comments:

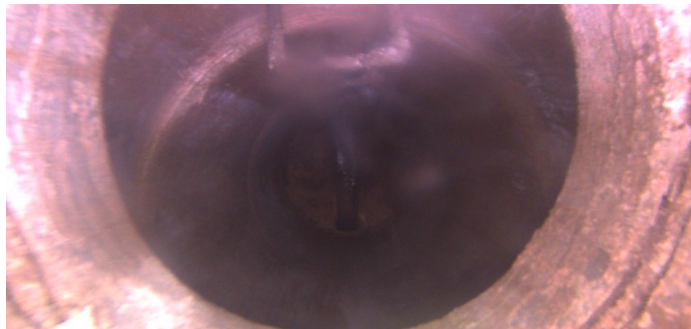
Code: **MGP**
Description: **General Photo**

Distance (ft): **.0**
Structural Grade: **0**
O&M Grade: **0**
Clock Start/From:
Clock To:
1st Value:
2nd Value:
Value Percent:
Step: **NO**
Remarks:

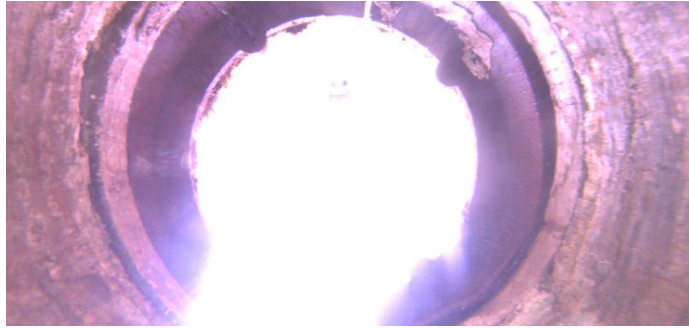
Code: **MGP**
Description: **General Photo**

Distance (ft): **1.9**
Structural Grade: **0**
O&M Grade: **0**
Clock Start/From:
Clock To:
1st Value:
2nd Value:
Value Percent:
Step: **NO**
Remarks:

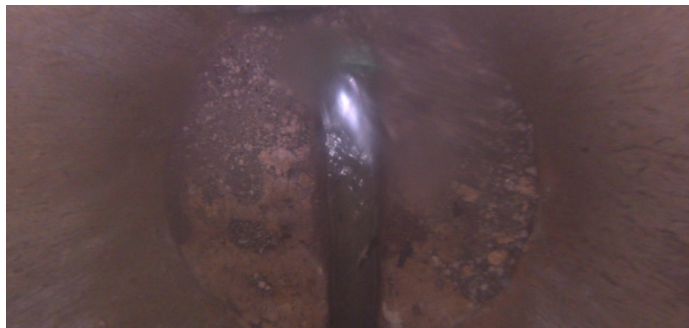
Code: **DAZ**
Description: **Deposits Attached Other**

Distance (ft): **5.8**
Structural Grade: **0**
O&M Grade: **2**
Clock Start/From: **12**
Clock To: **12**
1st Value:
2nd Value:
Value Percent: **5.000**
Step: **NO**
Remarks: **Mixed materials**

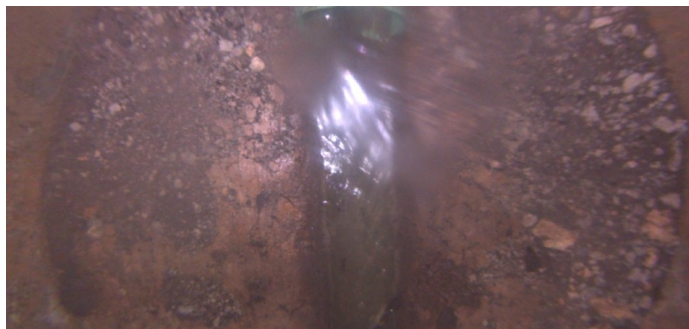
Code: **MGO**
Description: **General Observation**

Distance (ft): **6.8**
Structural Grade: **0**
O&M Grade: **0**
Clock Start/From:
Clock To:
1st Value:
2nd Value:
Value Percent:
Step: **NO**
Remarks: **Ins. Comp.**
