Manhole Inspection Report

Date:	04/16/2018	Weather:		Coding:	RZMACP
MH#:	M-103-129	Owner:	NA	Len. Surveyed:	7.0
P.O.#:		Surveyor:	John Kuglmaier	Rim to Invert:	9.0
Customer:		Cert. #:	U-1215-07002349	Wall Material:	Concrete (reinforced)

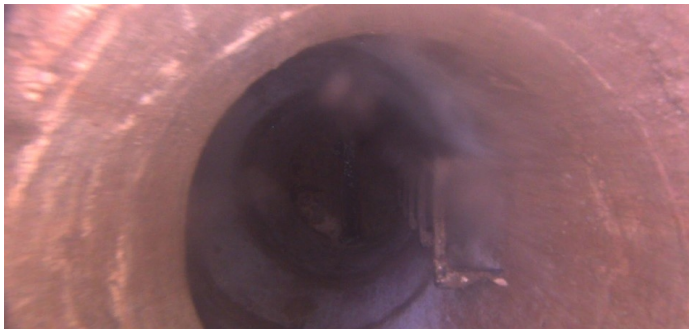
Code: **MGP**
Description: **General Photo**

Distance (ft): **.0**
Structural Grade: **0**
O&M Grade: **0**
Clock Start/From:
Clock To:
1st Value:
2nd Value:
Value Percent:
Step: **NO**
Remarks:

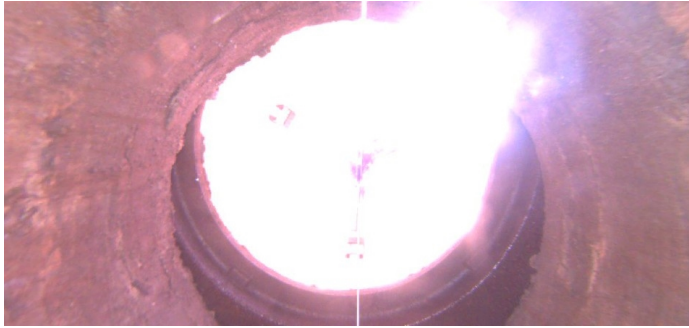
Code: **MGP**
Description: **General Photo**

Distance (ft): **2.1**
Structural Grade: **0**
O&M Grade: **0**
Clock Start/From:
Clock To:
1st Value:
2nd Value:
Value Percent:
Step: **NO**
Remarks:

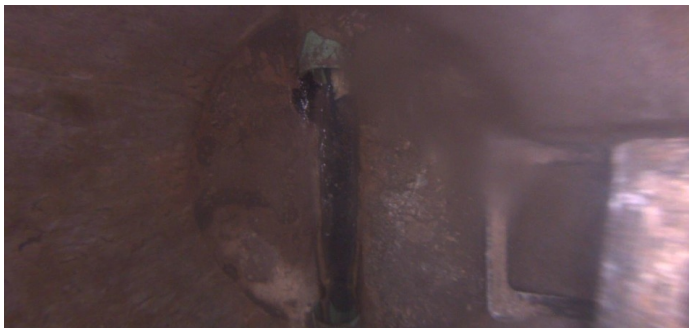
Code: **DSF**
Description: **Deposits Settled Fine**

Distance (ft): **5.3**
Structural Grade: **0**
O&M Grade: **2**
Clock Start/From: **12**
Clock To: **12**
1st Value:
2nd Value:
Value Percent: **5.000**
Step: **NO**
Remarks:

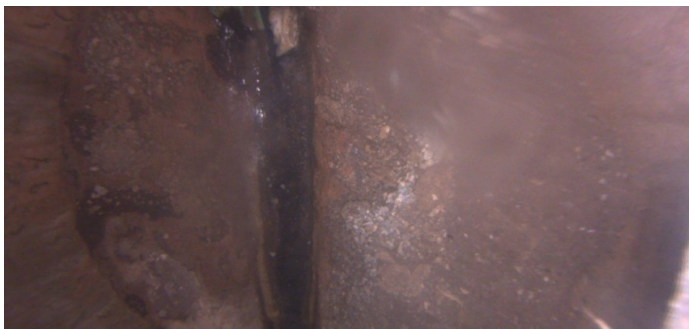
Code: **MGO**
Description: **General Observation**

Distance (ft): **6.6**
Structural Grade: **0**
O&M Grade: **0**
Clock Start/From:
Clock To:
1st Value:
2nd Value:
Value Percent:
Step: **NO**
Remarks: **Ins. Comp.**
