Manhole Inspection Report

Date:	04/16/2018	Weather:		Coding:	RZMACP
MH#:	M-103-130	Owner:	NA	Len. Surveyed:	6.3
P.O.#:		Surveyor:	John Kuglmaier	Rim to Invert:	7.4
Customer:		Cert. #:	U-1215-07002349	Wall Material:	Concrete (reinforced)

Street:	Alley between Swift St. and Alabam	Project:	Hobart, IN
City:	Hobart, IN	GPS Northing:	2889256.386
Location:		GPS Easting:	2889256.386
Drain Area:	Northwest	GPS Accuracy:	Sub-Meter
Cover Shape:	Circular	Evidence of Surcharge:	No
Cover Size:	23.0	Potential for Runoff:	None
Comments:

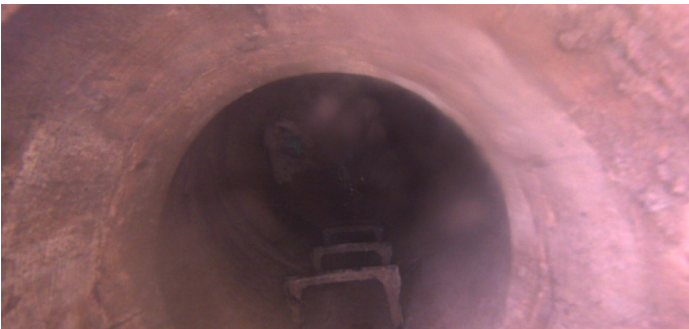
Code: **MGP**
Description: **General Photo**

Distance (ft): **.0**
Structural Grade: **0**
O&M Grade: **0**
Clock Start/From:
Clock To:
1st Value:
2nd Value:
Value Percent:
Step: **NO**
Remarks:

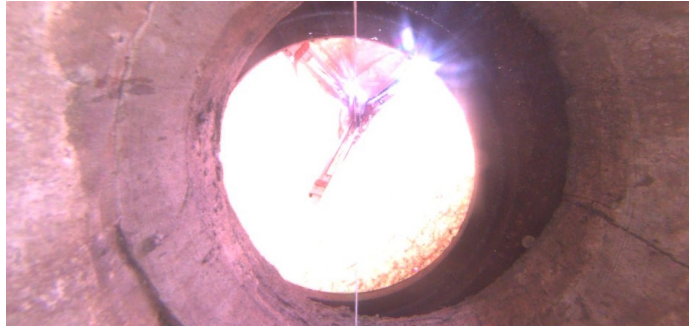
Code: **MGP**
Description: **General Photo**

Distance (ft): **1.9**
Structural Grade: **0**
O&M Grade: **0**
Clock Start/From:
Clock To:
1st Value:
2nd Value:
Value Percent:
Step: **NO**
Remarks:

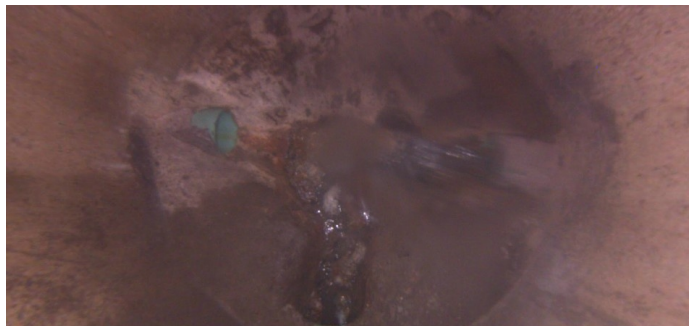
Code: **DSF**
Description: **Deposits Settled Fine**

Distance (ft): **3.9**
Structural Grade: **0**
O&M Grade: **2**
Clock Start/From: **12**
Clock To: **12**
1st Value:
2nd Value:
Value Percent: **5.000**
Step: **NO**
Remarks:

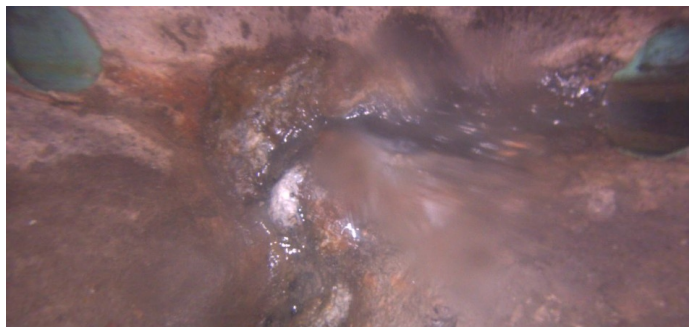
Code: **MGO**
Description: **General Observation**

Distance (ft): **5.6**
Structural Grade: **0**
O&M Grade: **0**
Clock Start/From:
Clock To:
1st Value:
2nd Value:
Value Percent:
Step: **NO**
Remarks: **Ins. Comp.**
