# Manhole Inspection Report

Date:	<b>04/16/2018</b>	Weather:		Coding:	<b>RZMACP</b>
MH#:	<b>M-103-131</b>	Owner:	<b>NA</b>	Len. Surveyed:	<b>11.9</b>
P.O.#:		Surveyor:	<b>John Kuglmaier</b>	Rim to Invert:	<b>14.0</b>
Customer:		Cert. #:	<b>U-1215-07002349</b>	Wall Material:	<b>Concrete (reinforced)</b>

Street:	<b>38th Ave. 166' West of Swift St.</b>	Project:	<b>Hobart, IN</b>
City:	<b>Hobart, IN</b>	GPS Northing:	<b>0.0</b>
Location:		GPS Easting:	<b>0.0</b>
Drain Area:	<b>Northwest</b>	GPS Accuracy:	<b>Nearest Meter</b>
Cover Shape:	<b>Circular</b>	Evidence of Surcharge:	<b>Yes</b>
Cover Size:	<b>23.0</b>	Potential for Runoff:	<b>None</b>
Comments:

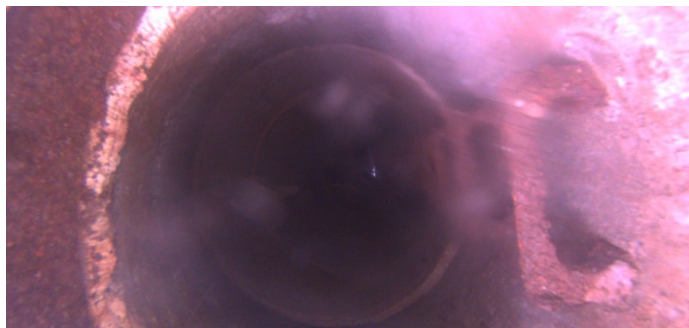
Code: **MGP**  
Description: **General Photo**

Distance (ft): **.0**  
Structural Grade: **0**  
O&M Grade: **0**  
Clock Start/From:  
Clock To:  
1st Value:  
2nd Value:  
Value Percent:  
Step: **NO**  
Remarks:

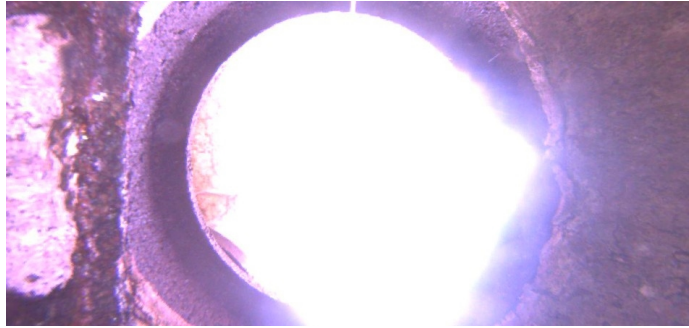
Code:	<b>MGP</b>
Description:	<b>General Photo</b>
Distance (ft):	<b>2.1</b>
Structural Grade:	<b>0</b>
O&M Grade:	<b>0</b>
Clock Start/From:	
Clock To:	
1st Value:	
2nd Value:	
Value Percent:	
Step:	<b>NO</b>
Remarks:

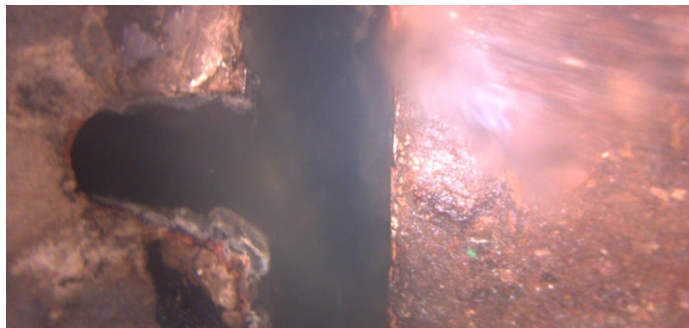
Code:	<b>MGO</b>
Description:	<b>General Observation</b>
Distance (ft):	<b>11.9</b>
Structural Grade:	<b>0</b>
O&M Grade:	<b>0</b>
Clock Start/From:	
Clock To:	
1st Value:	
2nd Value:	
Value Percent:	
Step:	<b>NO</b>
Remarks:	<b>Ins. Comp.</b>
