Manhole Inspection Report

Date:	04/16/2018	Weather:		Coding:	RZMACP
MH#:	M-103-135	Owner:	NA	Len. Surveyed:	6.1
P.O.#:		Surveyor:	John Kuglmaier	Rim to Invert:	7.0
Customer:		Cert. #:	U-1215-07002349	Wall Material:	Concrete (reinforced)

Street:	Swift St. 494' North of 38th Ave.	Project:	Hobart, IN
City:	Hobart, IN	GPS Northing:	2889074.335
Location:		GPS Easting:	2889074.335
Drain Area:	Northwest	GPS Accuracy:	Sub-Meter
Cover Shape:	Circular	Evidence of Surcharge:	No
Cover Size:	23.0	Potential for Runoff:	None
Comments:

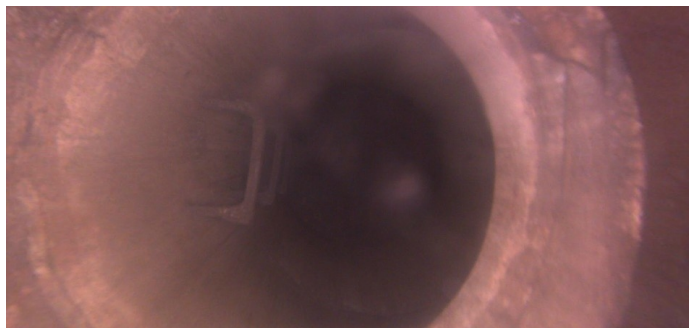
Code: **MGP**
Description: **General Photo**

Distance (ft): **.0**
Structural Grade: **0**
O&M Grade: **0**
Clock Start/From:
Clock To:
1st Value:
2nd Value:
Value Percent:
Step: **NO**
Remarks:

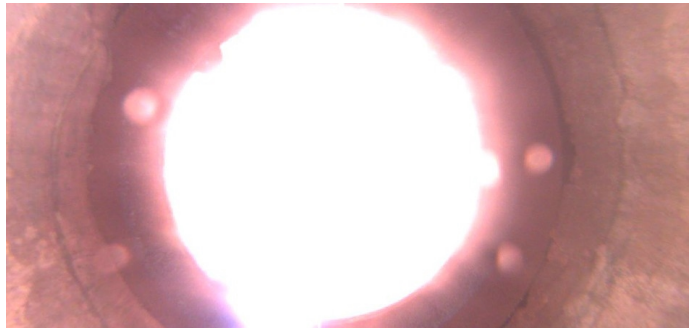
Code: **MGP**
Description: **General Photo**

Distance (ft): **2.0**
Structural Grade: **0**
O&M Grade: **0**
Clock Start/From:
Clock To:
1st Value:
2nd Value:
Value Percent:
Step: **NO**
Remarks:

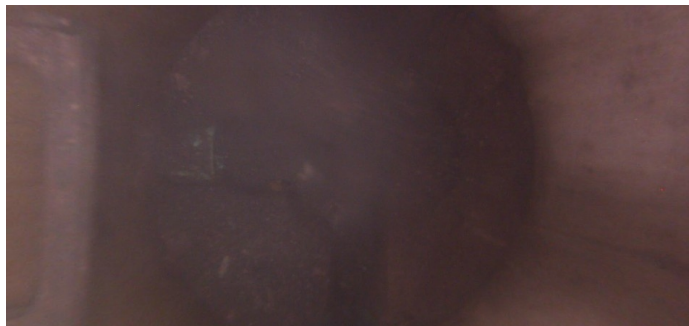
Code: **DSF**
Description: **Deposits Settled Fine**

Distance (ft): **4.2**
Structural Grade: **0**
O&M Grade: **2**
Clock Start/From: **12**
Clock To: **12**
1st Value:
2nd Value:
Value Percent: **10.000**
Step: **NO**
Remarks:

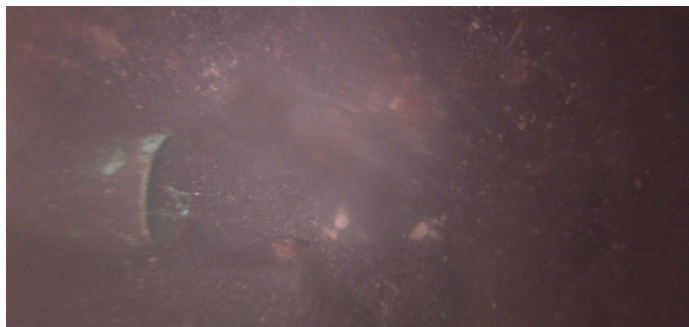
Code: **MGO**
Description: **General Observation**

Distance (ft): **5.5**
Structural Grade: **0**
O&M Grade: **0**
Clock Start/From:
Clock To:
1st Value:
2nd Value:
Value Percent:
Step: **NO**
Remarks: **Ins. Comp.**
