Manhole Inspection Report

Date:	03/20/2018	Weather:		Coding:	RZMACP
MH#:	M-108-001	Owner:	NA	Len. Surveyed:	2.2
P.O.#:		Surveyor:	John Kuglmaier	Rim to Invert:	2.8
Customer:		Cert. #:	U-1215-07002349	Wall Material:	Concrete (reinforced)

Street:	Howard Ct.	Project:	Hobart, IN
City:	Hobart, IN	GPS Northing:	2890749.778
Location:		GPS Easting:	2890749.778
Drain Area:	Southwest	GPS Accuracy:	Sub-Meter
Cover Shape:	Circular	Evidence of Surcharge:	No
Cover Size:	22.5	Potential for Runoff:	None
Comments:

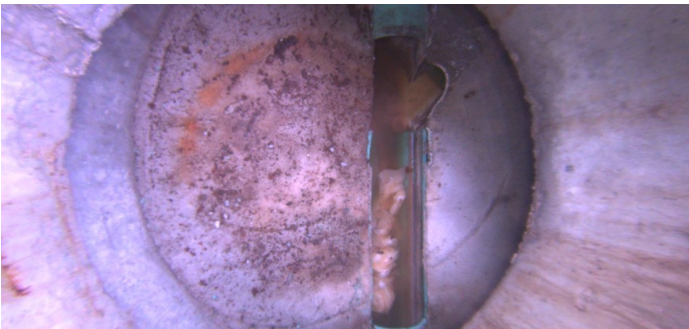
Code: **MGP**
Description: **General Photo**

Distance (ft): **.0**
Structural Grade: **0**
O&M Grade: **0**
Clock Start/From:
Clock To:
1st Value:
2nd Value:
Value Percent:
Step: **NO**
Remarks:

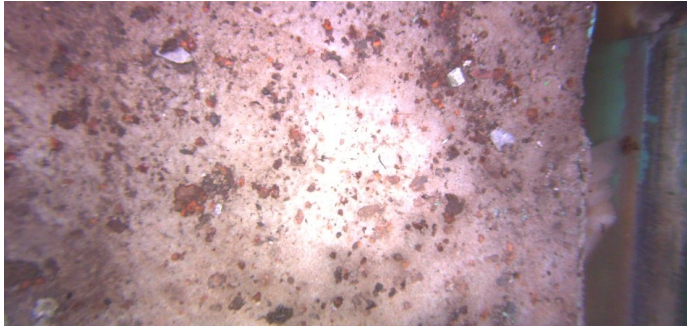
Code:	MGO
Description:	General Observation
Distance (ft):	1.8
Structural Grade:	0
O&M Grade:	0
Clock Start/From:	
Clock To:	
1st Value:	
2nd Value:	
Value Percent:	
Step:	NO
Remarks:	Ins. Comp.
