Manhole Inspection Report

Date:	03/21/2018	Weather:		Coding:	RZMACP
MH#:	M-108-002	Owner:	NA	Len. Surveyed:	1.8
P.O.#:		Surveyor:	John Kuglmaier	Rim to Invert:	2.6
Customer:		Cert. #:	U-1215-07002349	Wall Material:	Concrete (reinforced)

Street:	Howard Ct. 282' South of 14th Ln.	Project:	Hobart, IN
City:	Hobart, IN	GPS Northing:	2890929.553
Location:		GPS Easting:	2890929.553
Drain Area:	Southwest	GPS Accuracy:	Sub-Meter
Cover Shape:	Circular	Evidence of Surcharge:	No
Cover Size:	22.5	Potential for Runoff:	None
Comments:

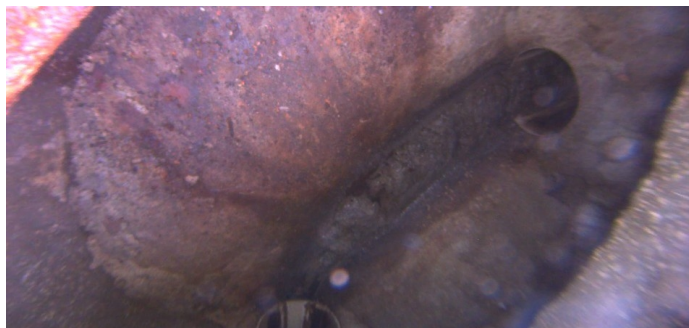
Code: **MGP**
Description: **General Photo**

Distance (ft): **.0**
Structural Grade: **0**
O&M Grade: **0**
Clock Start/From:
Clock To:
1st Value:
2nd Value:
Value Percent:
Step: **NO**
Remarks:

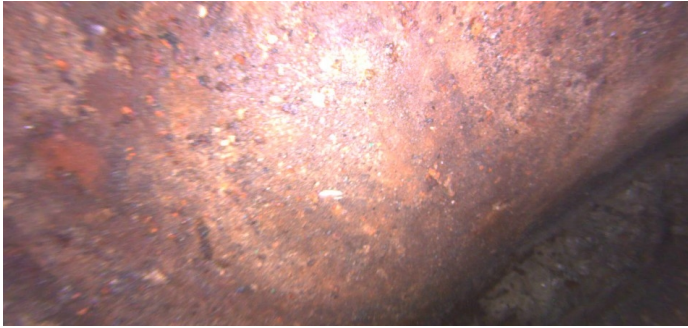
Code:	MGO
Description:	General Observation
Distance (ft):	1.4
Structural Grade:	0
O&M Grade:	0
Clock Start/From:	
Clock To:	
1st Value:	
2nd Value:	
Value Percent:	
Step:	NO
Remarks:	Ins. Comp.
