Manhole Inspection Report

Date:	03/20/2018	Weather:		Coding:	RZMACP
MH#:	M-108-003	Owner:	NA	Len. Surveyed:	1.5
P.O.#:		Surveyor:	John Kuglmaier	Rim to Invert:	1.8
Customer:		Cert. #:	U-1215-07002349	Wall Material:	Concrete (reinforced)

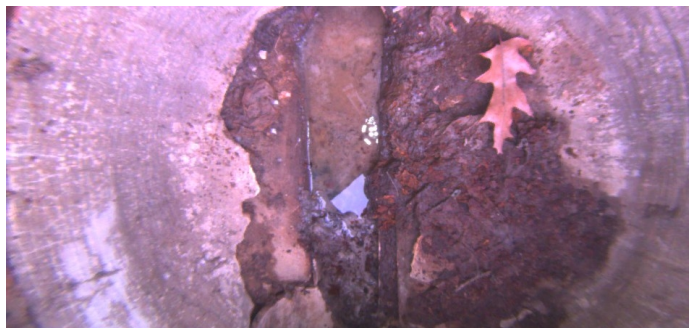
Code: **MGP**
Description: **General Photo**

Distance (ft): **.0**
Structural Grade: **0**
O&M Grade: **0**
Clock Start/From:
Clock To:
1st Value:
2nd Value:
Value Percent:
Step: **NO**
Remarks:

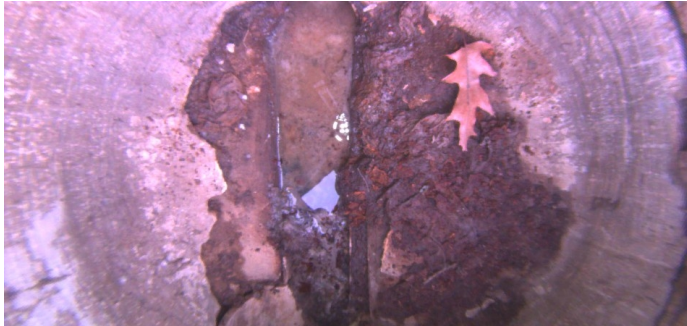
Code:	DAZ
Description:	Deposits Attached Other
Distance (ft):	.0
Structural Grade:	0
O&M Grade:	2
Clock Start/From:	12
Clock To:	12
1st Value:	
2nd Value:	
Value Percent:	5.000
Step:	NO
Remarks:	Mixed materials

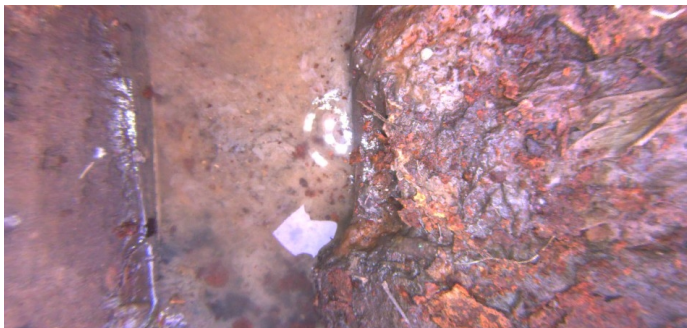
Code:	MGO
Description:	General Observation
Distance (ft):	1.2
Structural Grade:	0
O&M Grade:	0
Clock Start/From:	
Clock To:	
1st Value:	
2nd Value:	
Value Percent:	
Step:	NO
Remarks:	Ins. Comp.
