Manhole Inspection Report

Date:	03/20/2018	Weather:		Coding:	RZMACP
MH#:	M-108-004	Owner:	NA	Len. Surveyed:	5.3
P.O.#:		Surveyor:	John Kuglmaier	Rim to Invert:	4.7
Customer:		Cert. #:	U-1215-07002349	Wall Material:	Concrete (reinforced)

Street:	Howard Ct. and 14th Ln.	Project:	Hobart, IN
City:	Hobart, IN	GPS Northing:	0.0
Location:		GPS Easting:	0.0
Drain Area:	Southwest	GPS Accuracy:	Nearest Meter
Cover Shape:	Circular	Evidence of Surcharge:	No
Cover Size:	22.5	Potential for Runoff:	None
Comments:

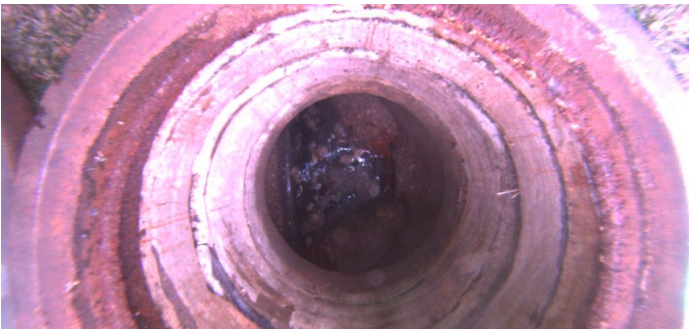
Code: **MGP**
 Description: **General Photo**

Distance (ft): **.0**
 Structural Grade: **0**
 O&M Grade: **0**
 Clock Start/From:
 Clock To:
 1st Value:
 2nd Value:
 Value Percent:
 Step: **NO**
 Remarks:

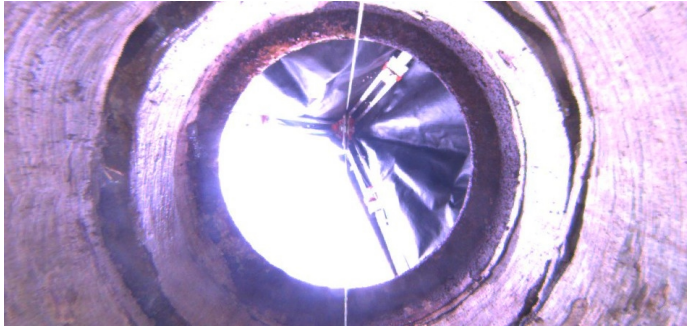
Code: **MGP**
Description: **General Photo**

Distance (ft): **3.1**
Structural Grade: **0**
O&M Grade: **0**
Clock Start/From:
Clock To:
1st Value:
2nd Value:
Value Percent:
Step: **NO**
Remarks:

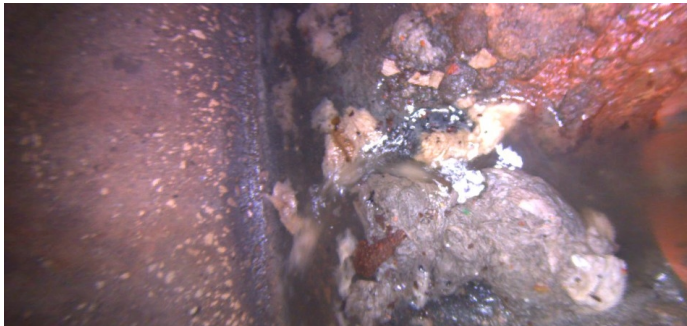
Code: **MGO**
Description: **General Observation**

Distance (ft): **4.1**
Structural Grade: **0**
O&M Grade: **0**
Clock Start/From:
Clock To:
1st Value:
2nd Value:
Value Percent:
Step: **NO**
Remarks: **Ins. Comp.**
