Manhole Inspection Report

Date:	03/20/2018	Weather:		Coding:	RZMACP
MH#:	M-108-005	Owner:	NA	Len. Surveyed:	4.5
P.O.#:		Surveyor:	John Kuglmaier	Rim to Invert:	4.9
Customer:		Cert. #:	U-1215-07002349	Wall Material:	Concrete (reinforced)

Street:	Howard Ct. 14th Ln. to the West.	Project:	Hobart, IN
City:	Hobart, IN	GPS Northing:	2890755.616
Location:		GPS Easting:	2890755.616
Drain Area:	Southwest	GPS Accuracy:	Sub-Meter
Cover Shape:	Circular	Evidence of Surcharge:	No
Cover Size:	22.5	Potential for Runoff:	None
Comments:

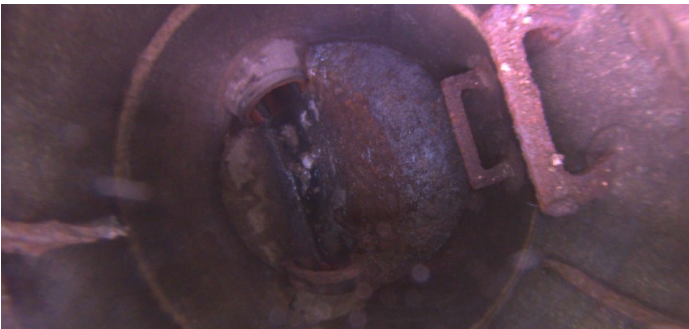
Code: **MGP**
 Description: **General Photo**

Distance (ft): **.0**
 Structural Grade: **0**
 O&M Grade: **0**
 Clock Start/From:
 Clock To:
 1st Value:
 2nd Value:
 Value Percent:
 Step: **NO**
 Remarks:

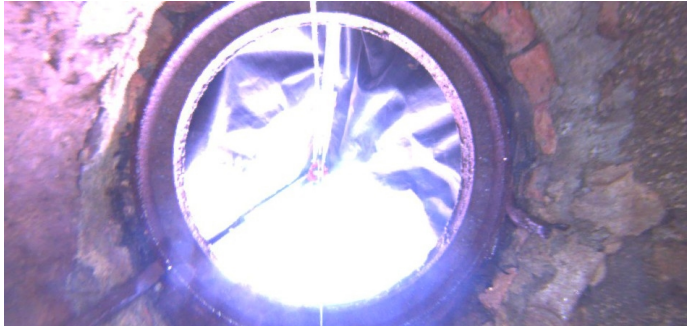
Code: **MGP**
Description: **General Photo**

Distance (ft): **2.4**
Structural Grade: **0**
O&M Grade: **0**
Clock Start/From:
Clock To:
1st Value:
2nd Value:
Value Percent:
Step: **NO**
Remarks:

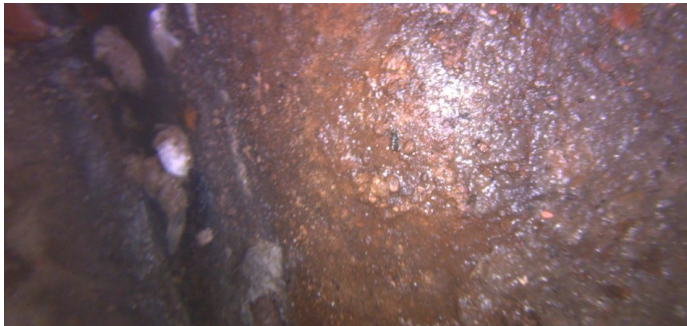
Code: **MGO**
Description: **General Observation**

Distance (ft): **3.3**
Structural Grade: **0**
O&M Grade: **0**
Clock Start/From:
Clock To:
1st Value:
2nd Value:
Value Percent:
Step: **NO**
Remarks: **Ins. Comp.**
