Manhole Inspection Report

Date:	03/20/2018	Weather:		Coding:	RZMACP
MH#:	M-108-006	Owner:	NA	Len. Surveyed:	2.8
P.O.#:		Surveyor:	John Kuglmaier	Rim to Invert:	3.7
Customer:		Cert. #:	U-1215-07002349	Wall Material:	Concrete (reinforced)

Street:	14th Ln. 367' West of Howard Ct.	Project:	Hobart, IN
City:	Hobart, IN	GPS Northing:	2890587.11
Location:		GPS Easting:	2890587.11
Drain Area:	Southwest	GPS Accuracy:	Sub-Meter
Cover Shape:	Circular	Evidence of Surcharge:	No
Cover Size:	22.5	Potential for Runoff:	None
Comments:

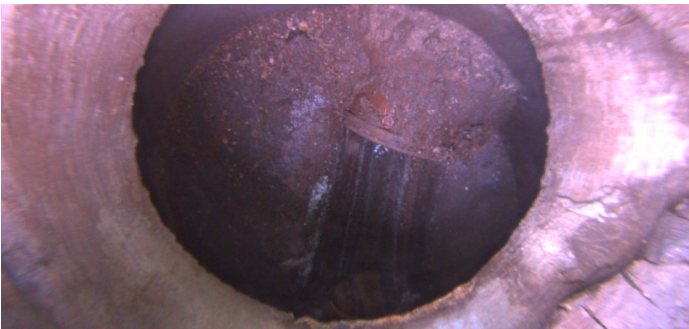
Code: **MGP**
Description: **General Photo**

Distance (ft): **.0**
Structural Grade: **0**
O&M Grade: **0**
Clock Start/From:
Clock To:
1st Value:
2nd Value:
Value Percent:
Step: **NO**
Remarks:

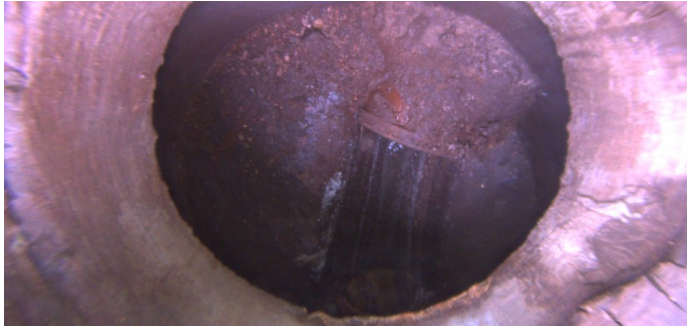
Code:	DSF
Description:	Deposits Settled Fine
Distance (ft):	.0
Structural Grade:	0
O&M Grade:	2
Clock Start/From:	12
Clock To:	12
1st Value:	
2nd Value:	
Value Percent:	5.000
Step:	NO
Remarks:

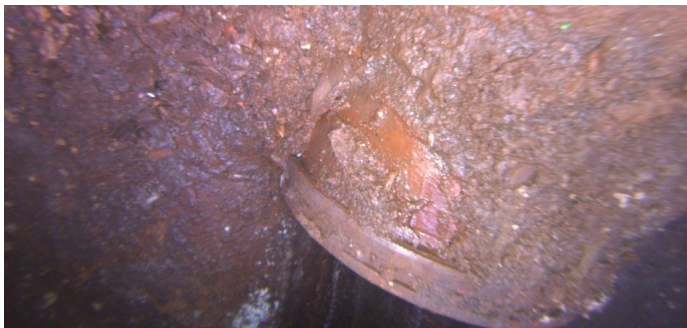
Code:	MGO
Description:	General Observation
Distance (ft):	2.3
Structural Grade:	0
O&M Grade:	0
Clock Start/From:	
Clock To:	
1st Value:	
2nd Value:	
Value Percent:	
Step:	NO
Remarks:	Ins. Comp.
