# Manhole Inspection Report

Date:	<b>03/20/2018</b>	Weather:		Coding:	<b>RZMACP</b>
MH#:	<b>M-108-007</b>	Owner:	<b>NA</b>	Len. Surveyed:	<b>6.0</b>
P.O.#:		Surveyor:	<b>John Kuglmaier</b>	Rim to Invert:	<b>6.3</b>
Customer:		Cert. #:	<b>U-1215-07002349</b>	Wall Material:	<b>Concrete (reinforced)</b>

Street:	<b>14th Ln. 392' East of Maple St.</b>	Project:	<b>Hobart, IN</b>
City:	<b>Hobart, IN</b>	GPS Northing:	<b>2890307.246</b>
Location:		GPS Easting:	<b>2890307.246</b>
Drain Area:	<b>Southwest</b>	GPS Accuracy:	<b>Sub-Meter</b>
Cover Shape:	<b>Circular</b>	Evidence of Surcharge:	<b>No</b>
Cover Size:	<b>22.5</b>	Potential for Runoff:	<b>None</b>
Comments:

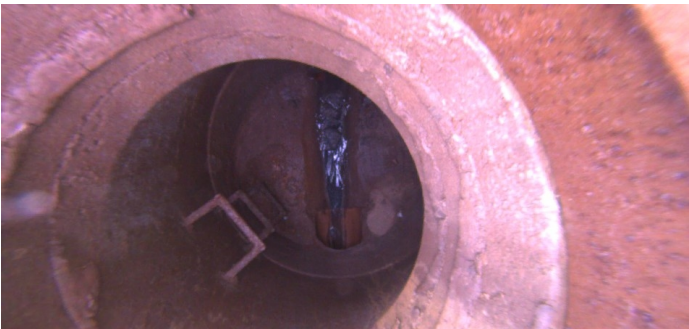
Code: **MGP**  
 Description: **General Photo**

Distance (ft): **.0**  
 Structural Grade: **0**  
 O&M Grade: **0**  
 Clock Start/From:  
 Clock To:  
 1st Value:  
 2nd Value:  
 Value Percent:  
 Step: **NO**  
 Remarks:

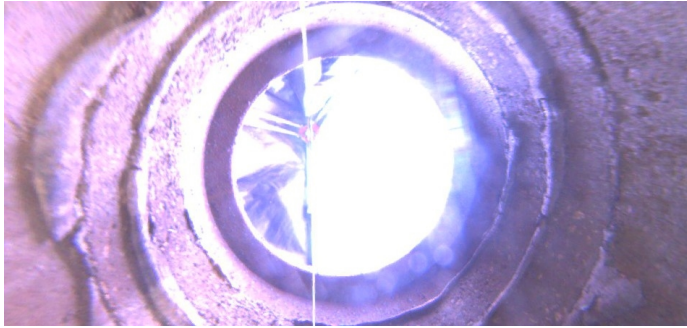
Code: **MGP**  
Description: **General Photo**

Distance (ft): **2.6**  
Structural Grade: **0**  
O&M Grade: **0**  
Clock Start/From:  
Clock To:  
1st Value:  
2nd Value:  
Value Percent:  
Step: **NO**  
Remarks:

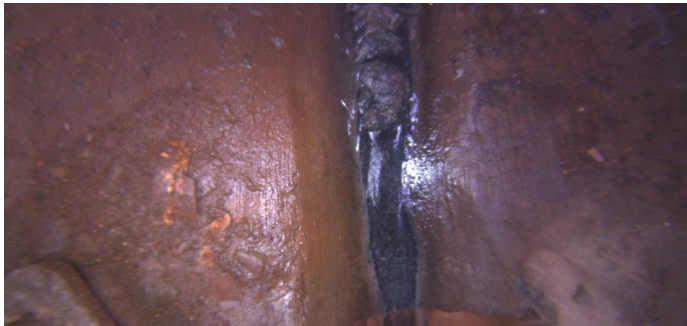
Code: **MGO**  
Description: **General Observation**

Distance (ft): **4.5**  
Structural Grade: **0**  
O&M Grade: **0**  
Clock Start/From:  
Clock To:  
1st Value:  
2nd Value:  
Value Percent:  
Step: **NO**  
Remarks: **Ins. Comp.**
