Manhole Inspection Report

Date:	03/21/2018	Weather:		Coding:	RZMACP
MH#:	M-108-009	Owner:	NA	Len. Surveyed:	6.2
P.O.#:		Surveyor:	John Kuglmaier	Rim to Invert:	6.8
Customer:		Cert. #:	U-1215-07002349	Wall Material:	Concrete (reinforced)

Street:	147' East of Maple St. North of West	Project:	Hobart, IN
City:	Hobart, IN	GPS Northing:	0.0
Location:		GPS Easting:	0.0
Drain Area:	Southwest	GPS Accuracy:	Nearest Meter
Cover Shape:	Circular	Evidence of Surcharge:	No
Cover Size:	22.5	Potential for Runoff:	None
Comments:

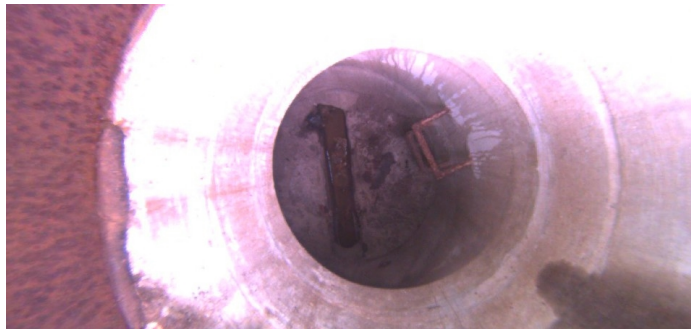
Code: **MGP**
Description: **General Photo**

Distance (ft): **.0**
Structural Grade: **0**
O&M Grade: **0**
Clock Start/From:
Clock To:
1st Value:
2nd Value:
Value Percent:
Step: **NO**
Remarks:

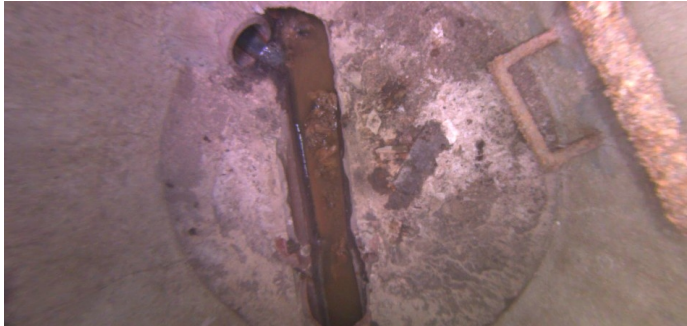
Code:	DAZ
Description:	Deposits Attached Other
Distance (ft):	3.9
Structural Grade:	0
O&M Grade:	2
Clock Start/From:	12
Clock To:	12
1st Value:	
2nd Value:	
Value Percent:	5.000
Step:	NO
Remarks:	Mixed materials

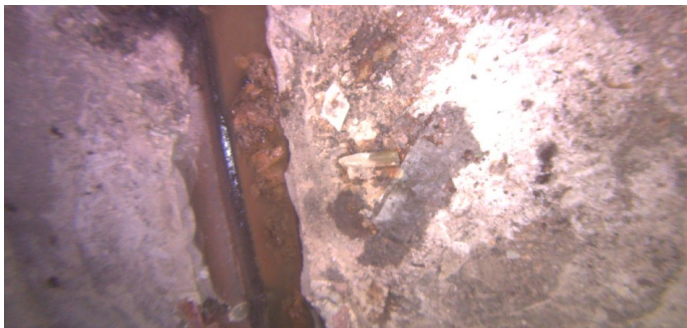
Code:	MGO
Description:	General Observation
Distance (ft):	5.1
Structural Grade:	0
O&M Grade:	0
Clock Start/From:	
Clock To:	
1st Value:	
2nd Value:	
Value Percent:	
Step:	NO
Remarks:	Ins. Comp.
