# Manhole Inspection Report

Date:	<b>03/20/2018</b>	Weather:		Coding:	<b>RZMACP</b>
MH#:	<b>M-108-010</b>	Owner:	<b>NA</b>	Len. Surveyed:	<b>4.7</b>
P.O.#:		Surveyor:	<b>John Kuglmaier</b>	Rim to Invert:	<b>4.9</b>
Customer:		Cert. #:	<b>U-1215-07002349</b>	Wall Material:	<b>Concrete (reinforced)</b>

Street:	<b>West 15th St. Maple St. to the East.</b>	Project:	<b>Hobart, IN</b>
City:	<b>Hobart, IN</b>	GPS Northing:	<b>2890057.571</b>
Location:		GPS Easting:	<b>2890057.571</b>
Drain Area:	<b>Southwest</b>	GPS Accuracy:	<b>Sub-Meter</b>
Cover Shape:	<b>Circular</b>	Evidence of Surcharge:	<b>No</b>
Cover Size:	<b>22.5</b>	Potential for Runoff:	<b>None</b>
Comments:

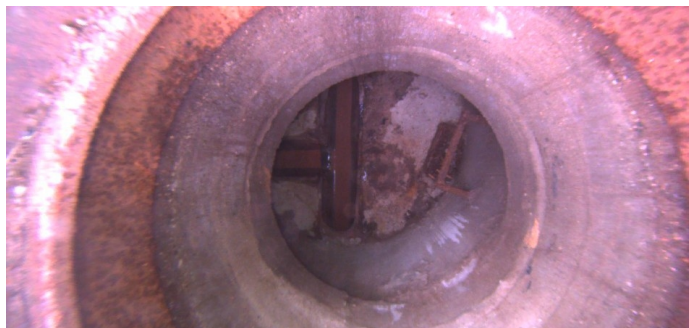
Code: **MGP**  
Description: **General Photo**

Distance (ft): **.0**  
Structural Grade: **0**  
O&M Grade: **0**  
Clock Start/From:  
Clock To:  
1st Value:  
2nd Value:  
Value Percent:  
Step: **NO**  
Remarks:

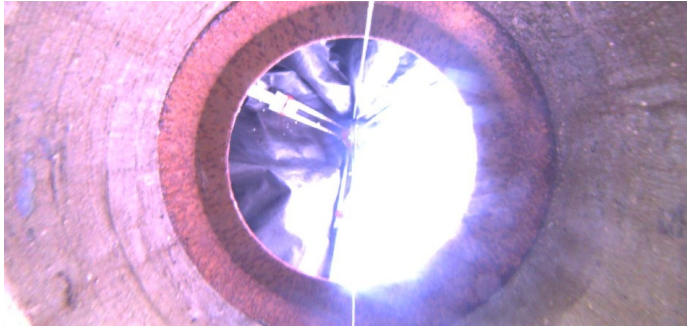
Code: **MGP**  
Description: **General Photo**

Distance (ft): **2.7**  
Structural Grade: **0**  
O&M Grade: **0**  
Clock Start/From:  
Clock To:  
1st Value:  
2nd Value:  
Value Percent:  
Step: **NO**  
Remarks:

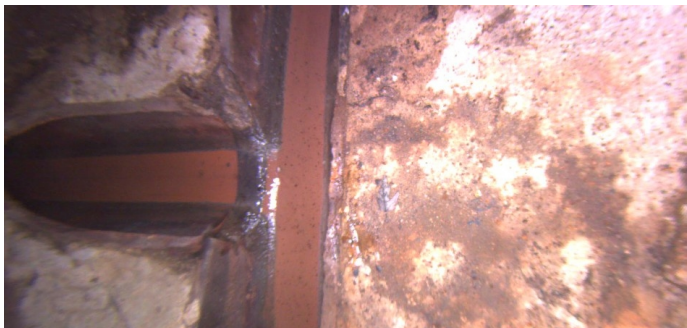
Code: **MGO**  
Description: **General Observation**

Distance (ft): **3.8**  
Structural Grade: **0**  
O&M Grade: **0**  
Clock Start/From:  
Clock To:  
1st Value:  
2nd Value:  
Value Percent:  
Step: **NO**  
Remarks: **Ins. Comp.**
