Manhole Inspection Report

Date:	03/20/2018	Weather:		Coding:	RZMACP
MH#:	M-108-011	Owner:	NA	Len. Surveyed:	3.1
P.O.#:		Surveyor:	John Kuglmaier	Rim to Invert:	3.6
Customer:		Cert. #:	U-1215-07002349	Wall Material:	Concrete (reinforced)

Street:	West 15th St. 316' East of Maple St.	Project:	Hobart, IN
City:	Hobart, IN	GPS Northing:	2890230.533
Location:		GPS Easting:	2890230.533
Drain Area:	Southwest	GPS Accuracy:	Sub-Meter
Cover Shape:	Circular	Evidence of Surcharge:	No
Cover Size:	22.5	Potential for Runoff:	None
Comments:

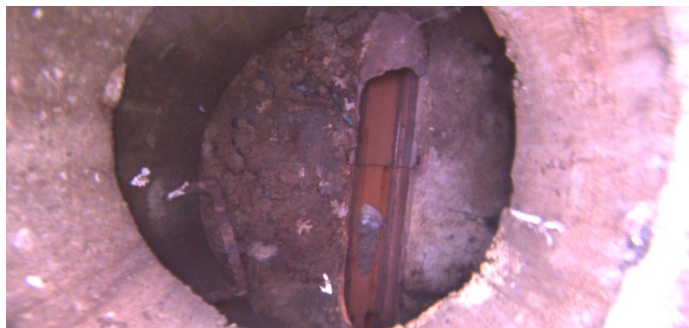
Code: **MGP**
Description: **General Photo**

Distance (ft): **.0**
Structural Grade: **0**
O&M Grade: **0**
Clock Start/From:
Clock To:
1st Value:
2nd Value:
Value Percent:
Step: **NO**
Remarks:

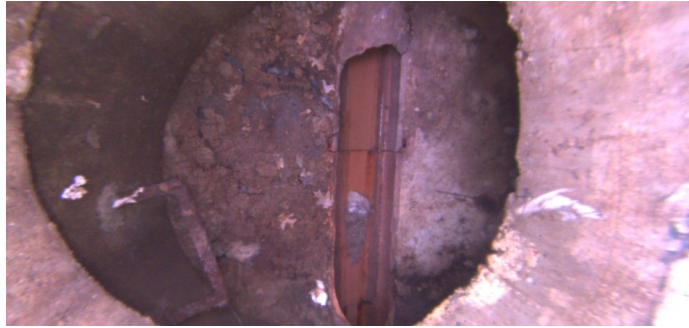
Code:	DAZ
Description:	Deposits Attached Other
Distance (ft):	.3
Structural Grade:	0
O&M Grade:	2
Clock Start/From:	12
Clock To:	12
1st Value:	
2nd Value:	
Value Percent:	5.000
Step:	NO
Remarks:	Mixed materials

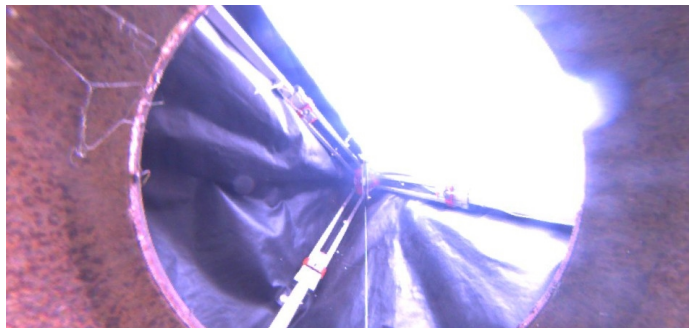
Code:	MGP
Description:	General Photo
Distance (ft):	1.4
Structural Grade:	0
O&M Grade:	0
Clock Start/From:	
Clock To:	
1st Value:	
2nd Value:	
Value Percent:	
Step:	NO
Remarks:

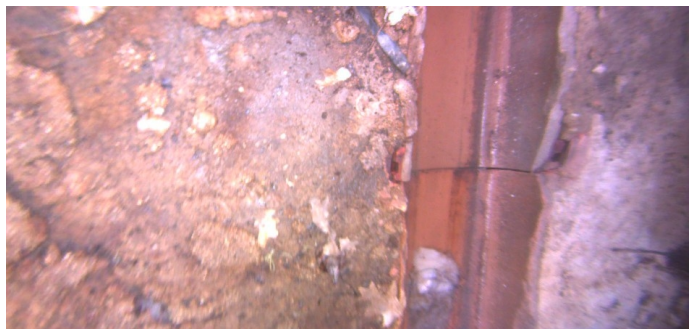
Code:	MGO
Description:	General Observation
Distance (ft):	2.4
Structural Grade:	0
O&M Grade:	0
Clock Start/From:	
Clock To:	
1st Value:	
2nd Value:	
Value Percent:	
Step:	NO
Remarks:	Ins. Comp.
