Manhole Inspection Report

Date:	03/20/2018	Weather:		Coding:	RZMACP
MH#:	M-108-012	Owner:	NA	Len. Surveyed:	3.0
P.O.#:		Surveyor:	John Kuglmaier	Rim to Invert:	3.3
Customer:		Cert. #:	U-1215-07002349	Wall Material:	Concrete (reinforced)

Street:	West 15th St. at Cul De Sac.	Project:	Hobart, IN
City:	Hobart, IN	GPS Northing:	2890395.979
Location:		GPS Easting:	2890395.979
Drain Area:	Southwest	GPS Accuracy:	Sub-Meter
Cover Shape:	Circular	Evidence of Surcharge:	No
Cover Size:	22.5	Potential for Runoff:	None
Comments:

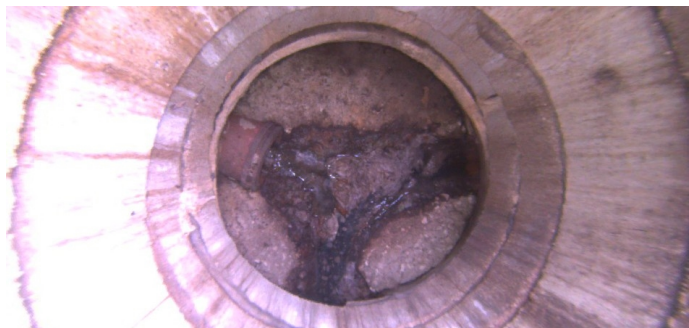
Code: **MGP**
Description: **General Photo**

Distance (ft): **.0**
Structural Grade: **0**
O&M Grade: **0**
Clock Start/From:
Clock To:
1st Value:
2nd Value:
Value Percent:
Step: **NO**
Remarks:

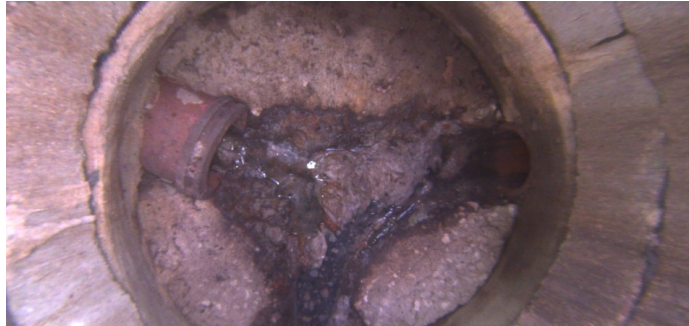
Code:	DAZ
Description:	Deposits Attached Other
Distance (ft):	.9
Structural Grade:	0
O&M Grade:	2
Clock Start/From:	12
Clock To:	12
1st Value:	
2nd Value:	
Value Percent:	5.000
Step:	NO
Remarks:	Mixed materials

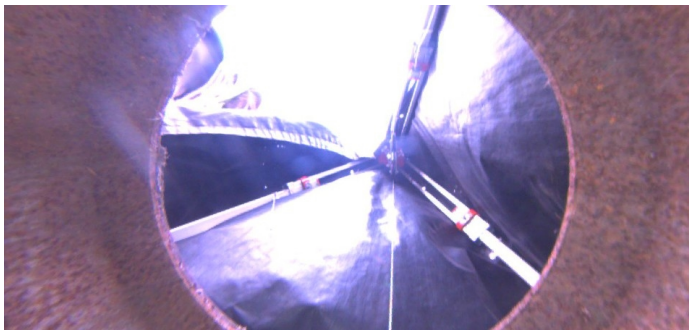
Code:	MGP
Description:	General Photo
Distance (ft):	1.3
Structural Grade:	0
O&M Grade:	0
Clock Start/From:	
Clock To:	
1st Value:	
2nd Value:	
Value Percent:	
Step:	NO
Remarks:

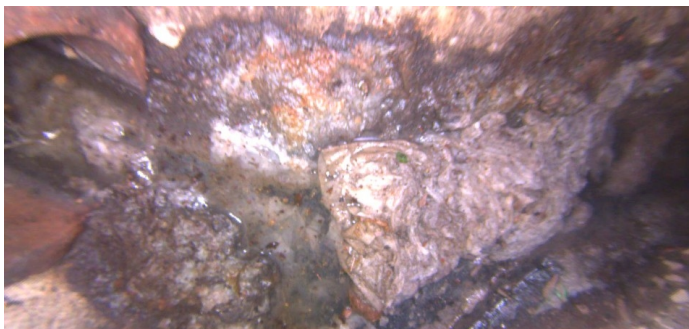
Code:	MGO
Description:	General Observation
Distance (ft):	2.4
Structural Grade:	0
O&M Grade:	0
Clock Start/From:	
Clock To:	
1st Value:	
2nd Value:	
Value Percent:	
Step:	NO
Remarks:	Ins. Comp.
