Manhole Inspection Report

Date:	03/20/2018	Weather:		Coding:	RZMACP
MH#:	M-108-015	Owner:	NA	Len. Surveyed:	6.7
P.O.#:		Surveyor:	John Kuglmaier	Rim to Invert:	7.6
Customer:		Cert. #:	U-1215-07002349	Wall Material:	Concrete (reinforced)

Street:	14th Lane. and Maple St.	Project:	Hobart, IN
City:	Hobart, IN	GPS Northing:	2889909.139
Location:		GPS Easting:	2889909.139
Drain Area:	Southwest	GPS Accuracy:	Sub-Meter
Cover Shape:	Circular	Evidence of Surcharge:	No
Cover Size:	22.5	Potential for Runoff:	None
Comments:

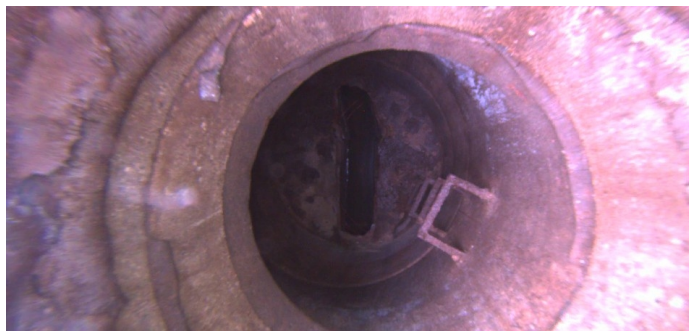
Code: **MGP**
Description: **General Photo**

Distance (ft): **.0**
Structural Grade: **0**
O&M Grade: **0**
Clock Start/From:
Clock To:
1st Value:
2nd Value:
Value Percent:
Step: **NO**
Remarks:

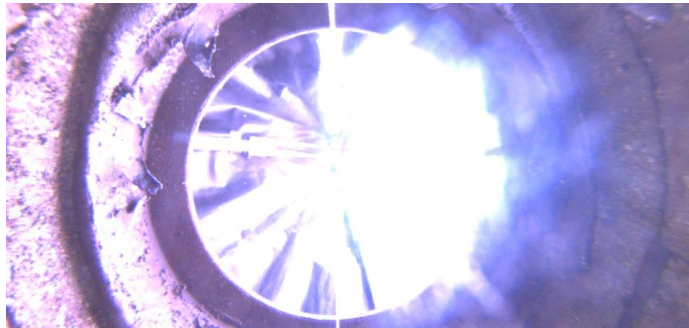
Code: **MGP**
Description: **General Photo**

Distance (ft): **2.2**
Structural Grade: **0**
O&M Grade: **0**
Clock Start/From:
Clock To:
1st Value:
2nd Value:
Value Percent:
Step: **NO**
Remarks:

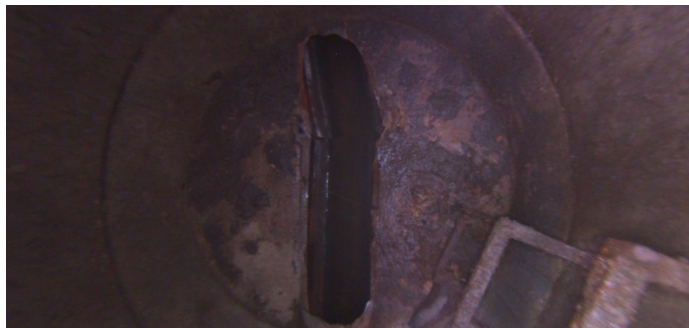
Code: **DSF**
Description: **Deposits Settled Fine**

Distance (ft): **3.5**
Structural Grade: **0**
O&M Grade: **2**
Clock Start/From: **12**
Clock To: **12**
1st Value:
2nd Value:
Value Percent: **5.000**
Step: **NO**
Remarks:

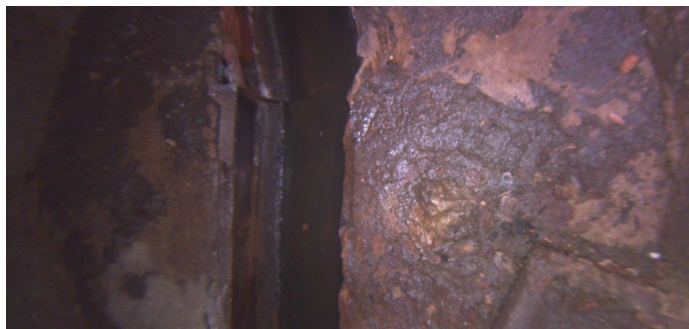
Code: **MGO**
Description: **General Observation**

Distance (ft): **5.3**
Structural Grade: **0**
O&M Grade: **0**
Clock Start/From:
Clock To:
1st Value:
2nd Value:
Value Percent:
Step: **NO**
Remarks: **Ins. Comp.**
