Manhole Inspection Report

| MH#: | M-108-017 | Owner: | NA | Len. Surveyed: | 8.3 |

| Street: | 14th Ln. Alabama St. | Project: | Hobart, IN |

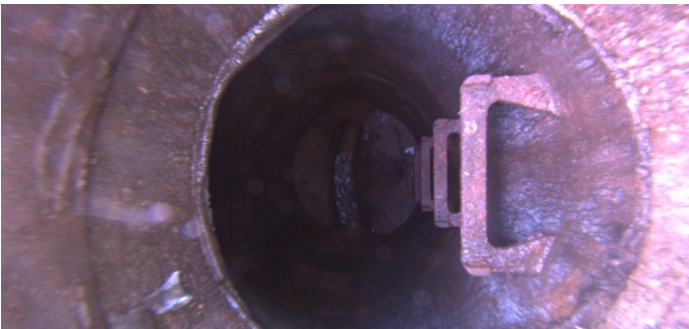
Code: **MGP**
 Description: **General Photo**

Distance (ft): **.0**
 Structural Grade: **0**
 O&M Grade: **0**
 Clock Start/From:
 Clock To:
 1st Value:
 2nd Value:
 Value Percent:
 Step: **NO**
 Remarks:

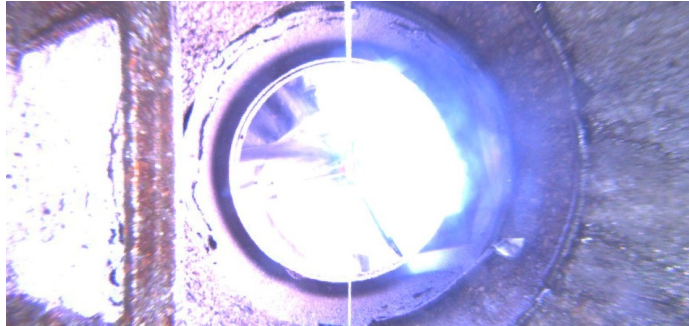
Code: **MGP**
Description: **General Photo**

Distance (ft): **2.9**
Structural Grade: **0**
O&M Grade: **0**
Clock Start/From:
Clock To:
1st Value:
2nd Value:
Value Percent:
Step: **NO**
Remarks:

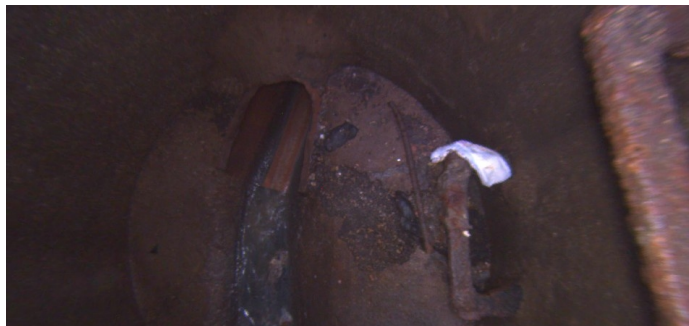
Code: **DAZ**
Description: **Deposits Attached Other**

Distance (ft): **5.5**
Structural Grade: **0**
O&M Grade: **2**
Clock Start/From: **12**
Clock To: **3**
1st Value:
2nd Value:
Value Percent: **5.000**
Step: **NO**
Remarks: **Mixed materials**

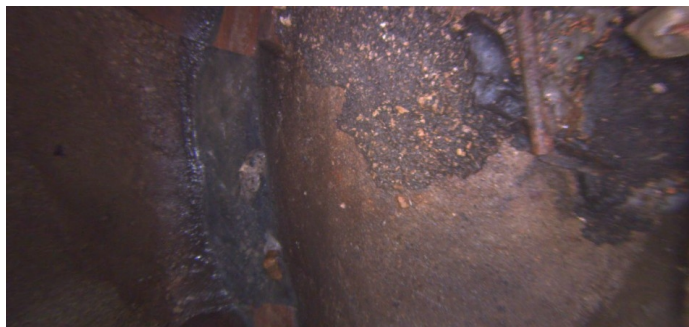
Code: **MGO**
Description: **General Observation**

Distance (ft): **7.0**
Structural Grade: **0**
O&M Grade: **0**
Clock Start/From:
Clock To:
1st Value:
2nd Value:
Value Percent:
Step: **NO**
Remarks: **Ins. Comp.**
