Manhole Inspection Report

Date:	03/22/2018	Weather:		Coding:	RZMACP
MH#:	M-108-021	Owner:	NA	Len. Surveyed:	7.0
P.O.#:		Surveyor:	John Kuglmaier	Rim to Invert:	7.3
Customer:		Cert. #:	U-1215-07002349	Wall Material:	Concrete (reinforced)

Street:	534' North of West 15th Pl. West of	Project:	Hobart, IN
City:	Hobart, IN	GPS Northing:	0.0
Location:		GPS Easting:	0.0
Drain Area:	Southwest	GPS Accuracy:	Nearest Meter
Cover Shape:	Circular	Evidence of Surcharge:	No
Cover Size:	22.5	Potential for Runoff:	None
Comments:

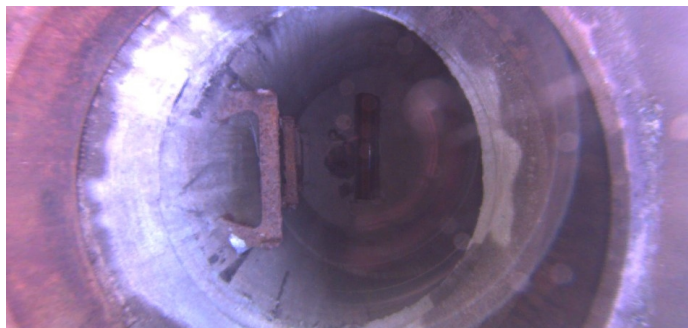
Code: **MGP**
Description: **General Photo**

Distance (ft): **.0**
Structural Grade: **0**
O&M Grade: **0**
Clock Start/From:
Clock To:
1st Value:
2nd Value:
Value Percent:
Step: **NO**
Remarks:

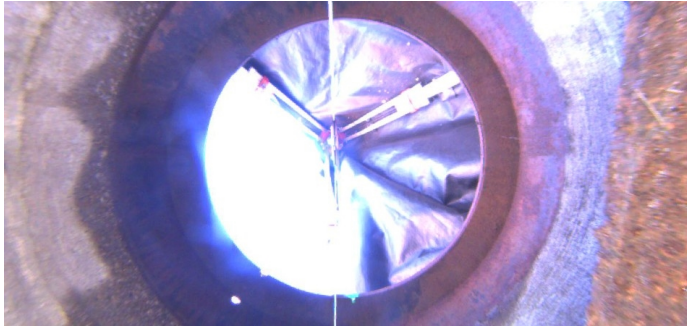
Code: **MGP**
Description: **General Photo**

Distance (ft): **2.6**
Structural Grade: **0**
O&M Grade: **0**
Clock Start/From:
Clock To:
1st Value:
2nd Value:
Value Percent:
Step: **NO**
Remarks:

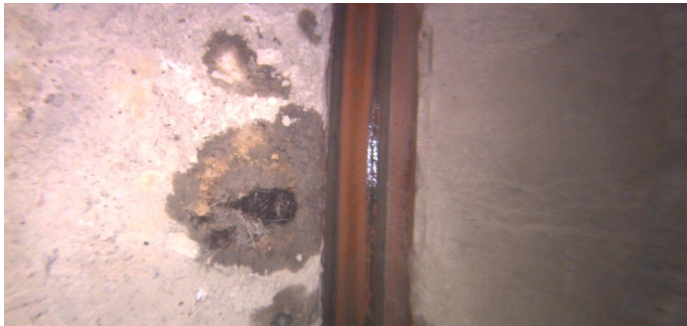
Code: **MGO**
Description: **General Observation**

Distance (ft): **5.7**
Structural Grade: **0**
O&M Grade: **0**
Clock Start/From:
Clock To:
1st Value:
2nd Value:
Value Percent:
Step: **NO**
Remarks: **Ins. Comp.**
