Manhole Inspection Report

Date:	03/22/2018	Weather:		Coding:	RZMACP
MH#:	M-108-022	Owner:	NA	Len. Surveyed:	6.1
P.O.#:		Surveyor:	John Kuglmaier	Rim to Invert:	6.3
Customer:		Cert. #:	U-1215-07002349	Wall Material:	Concrete (reinforced)

Street:	315' North of West 15th Pl. West of	Project:	Hobart, IN
City:	Hobart, IN	GPS Northing:	0.0
Location:		GPS Easting:	0.0
Drain Area:	Southwest	GPS Accuracy:	Nearest Meter
Cover Shape:	Circular	Evidence of Surcharge:	No
Cover Size:	22.5	Potential for Runoff:	None
Comments:

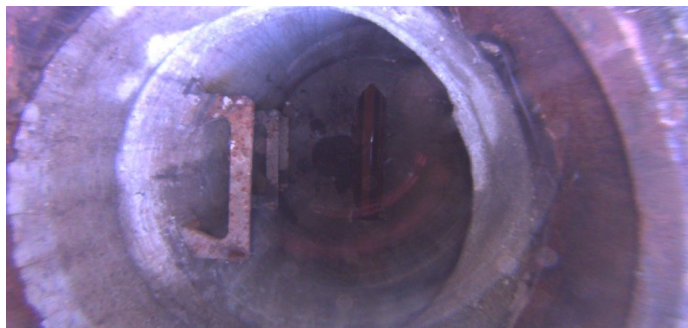
Code: **MGP**
Description: **General Photo**

Distance (ft): **.0**
Structural Grade: **0**
O&M Grade: **0**
Clock Start/From:
Clock To:
1st Value:
2nd Value:
Value Percent:
Step: **NO**
Remarks:

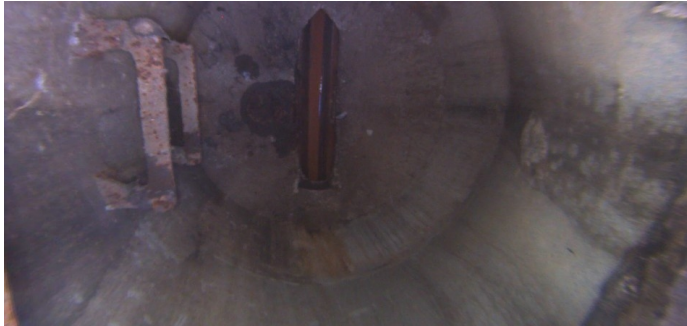
Code: **IS**
Description: **Infil Stain**

Distance (ft): **1.5**
Structural Grade: **0**
O&M Grade: **0**
Clock Start/From: **6**
Clock To: **8**
1st Value:
2nd Value:
Value Percent:
Step: **NO**
Remarks:

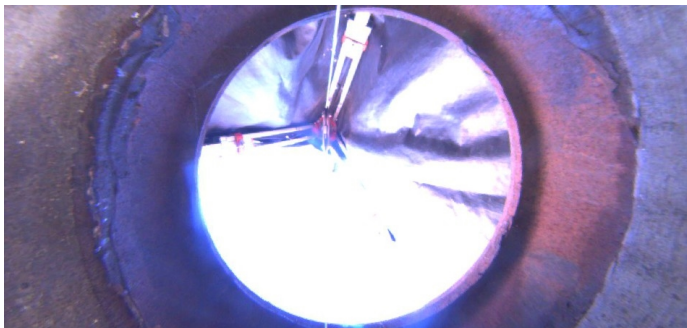
Code: **MGP**
Description: **General Photo**

Distance (ft): **2.4**
Structural Grade: **0**
O&M Grade: **0**
Clock Start/From:
Clock To:
1st Value:
2nd Value:
Value Percent:
Step: **NO**
Remarks:

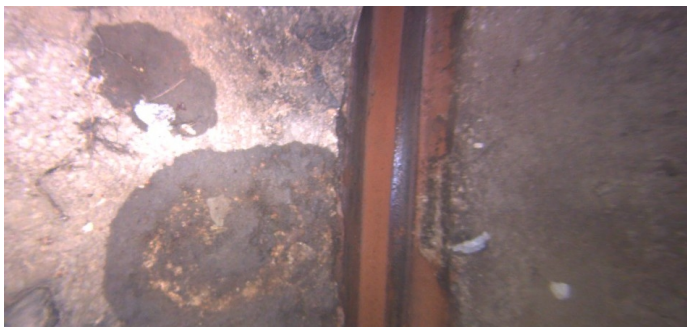
Code: **MGO**
Description: **General Observation**

Distance (ft): **5.1**
Structural Grade: **0**
O&M Grade: **0**
Clock Start/From:
Clock To:
1st Value:
2nd Value:
Value Percent:
Step: **NO**
Remarks: **Ins. Comp.**
