Manhole Inspection Report

Date:	03/22/2018	Weather:		Coding:	RZMACP
MH#:	M-108-023	Owner:	NA	Len. Surveyed:	4.3
P.O.#:		Surveyor:	John Kuglmaier	Rim to Invert:	4.7
Customer:		Cert. #:	U-1215-07002349	Wall Material:	Concrete (reinforced)

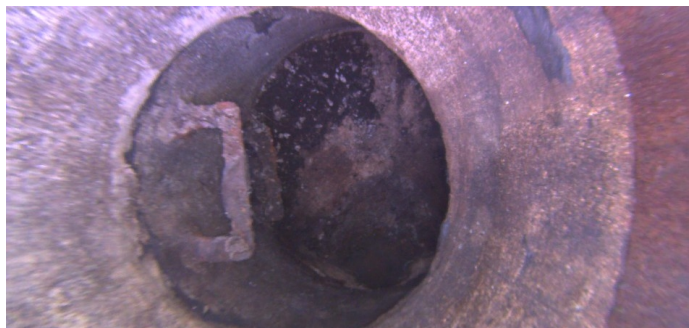
Code: **MGP**
Description: **General Photo**

Distance (ft): **.0**
Structural Grade: **0**
O&M Grade: **0**
Clock Start/From:
Clock To:
1st Value:
2nd Value:
Value Percent:
Step: **NO**
Remarks:

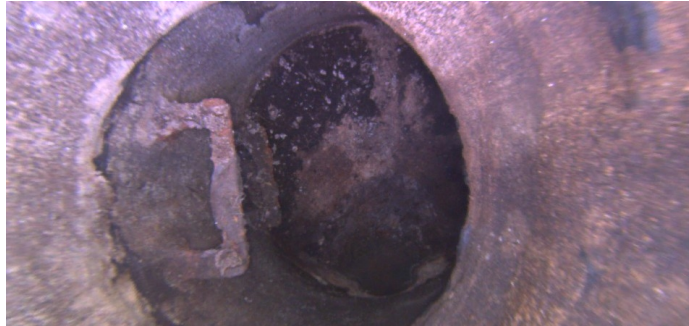
Code: **DAZ**
Description: **Deposits Attached Other**

Distance (ft): **.3**
Structural Grade: **0**
O&M Grade: **2**
Clock Start/From: **12**
Clock To: **12**
1st Value:
2nd Value:
Value Percent: **5.000**
Step: **NO**
Remarks: **Mixed materials**

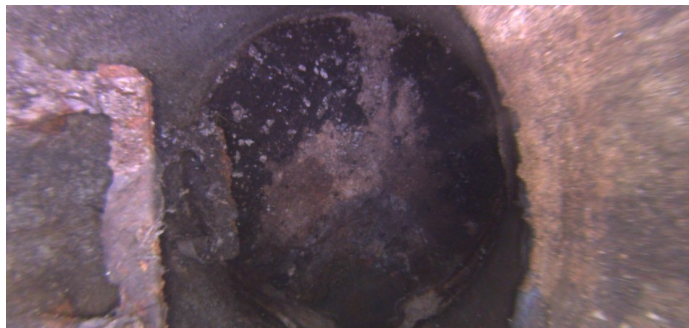
Code: **DSF**
Description: **Deposits Settled Fine**

Distance (ft): **1.0**
Structural Grade: **0**
O&M Grade: **2**
Clock Start/From: **12**
Clock To: **12**
1st Value:
2nd Value:
Value Percent: **10.000**
Step: **NO**
Remarks:

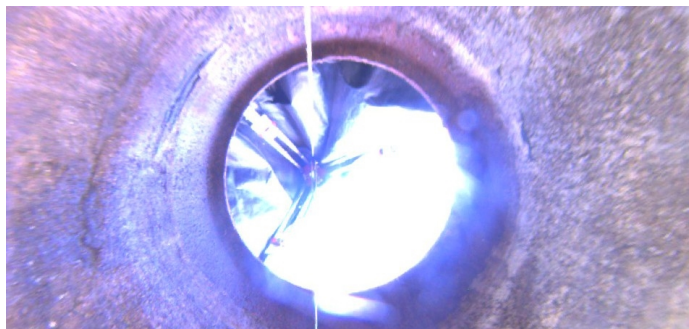
Code: **MGP**
Description: **General Photo**

Distance (ft): **2.6**
Structural Grade: **0**
O&M Grade: **0**
Clock Start/From:
Clock To:
1st Value:
2nd Value:
Value Percent:
Step: **NO**
Remarks:

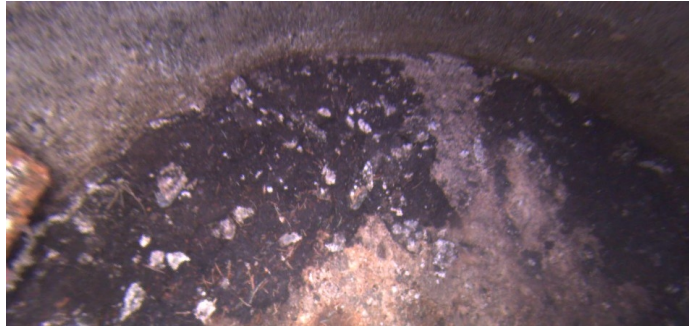
Code:	DAZ
Description:	Deposits Attached Other
Distance (ft):	3.0
Structural Grade:	0
O&M Grade:	2
Clock Start/From:	12
Clock To:	12
1st Value:	
2nd Value:	
Value Percent:	5.000
Step:	NO
Remarks:	Mixed materials

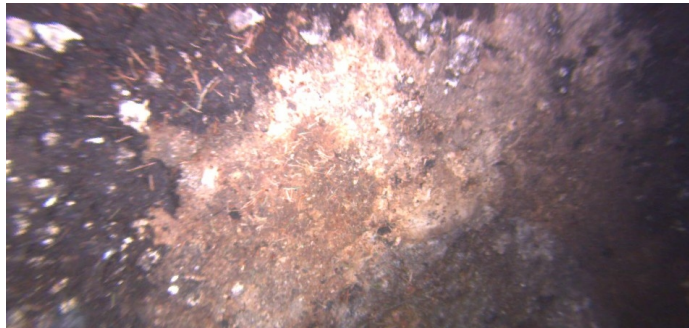
Code:	MGO
Description:	General Observation
Distance (ft):	3.4
Structural Grade:	0
O&M Grade:	0
Clock Start/From:	
Clock To:	
1st Value:	
2nd Value:	
Value Percent:	
Step:	NO
Remarks:	Ins. Comp.
