Manhole Inspection Report

Date:	03/21/2018	Weather:		Coding:	RZMACP
MH#:	M-108-024	Owner:	NA	Len. Surveyed:	6.1
P.O.#:		Surveyor:	John Kuglmaier	Rim to Invert:	6.6
Customer:		Cert. #:	U-1215-07002349	Wall Material:	Concrete (reinforced)

Street:	96' North of West 15th Pl. West of A	Project:	Hobart, IN
City:	Hobart, IN	GPS Northing:	0.0
Location:		GPS Easting:	0.0
Drain Area:	Southwest	GPS Accuracy:	Nearest Meter
Cover Shape:	Circular	Evidence of Surcharge:	Yes
Cover Size:	22.5	Potential for Runoff:	None
Comments:	AGAINST A FENCE

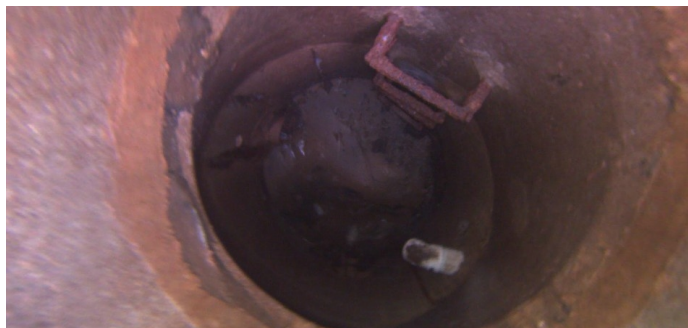
Code: **MGP**
Description: **General Photo**

Distance (ft): **.0**
Structural Grade: **0**
O&M Grade: **0**
Clock Start/From:
Clock To:
1st Value:
2nd Value:
Value Percent:
Step: **NO**
Remarks:

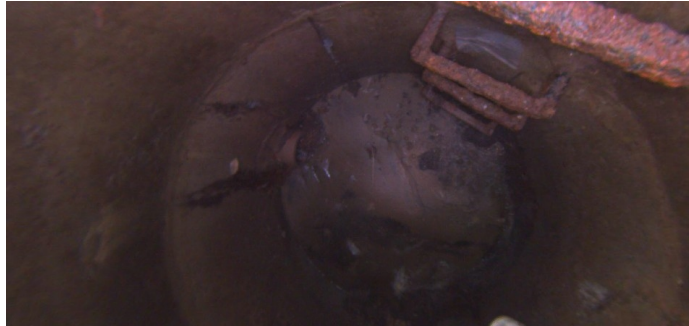
Code: **IS**
Description: **Infil Stain**

Distance (ft): **1.9**
Structural Grade: **0**
O&M Grade: **0**
Clock Start/From: **10**
Clock To: **11**
1st Value:
2nd Value:
Value Percent:
Step: **NO**
Remarks:

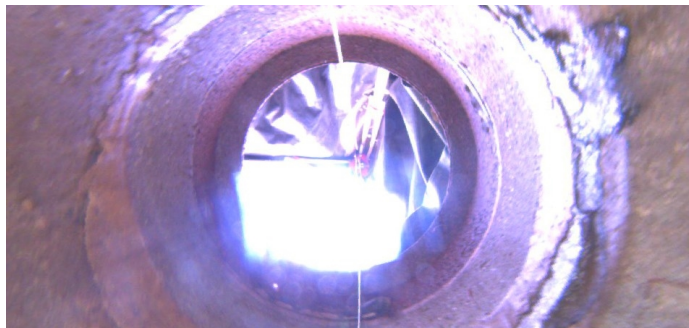
Code: **MGP**
Description: **General Photo**

Distance (ft): **2.6**
Structural Grade: **0**
O&M Grade: **0**
Clock Start/From:
Clock To:
1st Value:
2nd Value:
Value Percent:
Step: **NO**
Remarks:

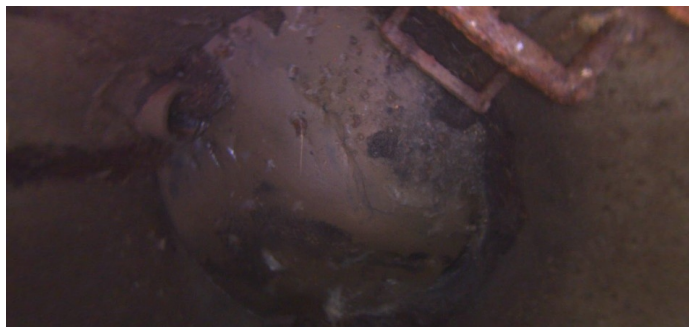
Code: **DSF**
Description: **Deposits Settled Fine**

Distance (ft): **3.2**
Structural Grade: **0**
O&M Grade: **2**
Clock Start/From: **12**
Clock To: **12**
1st Value:
2nd Value:
Value Percent: **10.000**
Step: **NO**
Remarks:

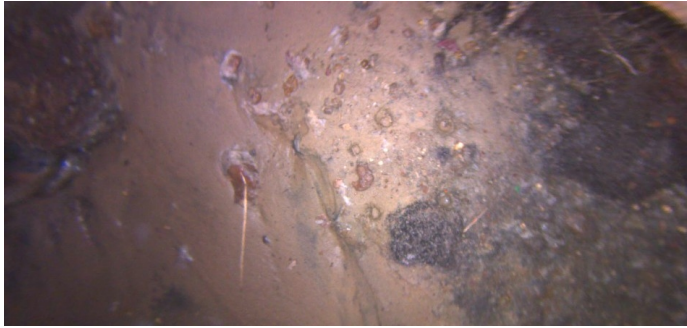
Code:	MGO
Description:	General Observation
Distance (ft):	5.0
Structural Grade:	0
O&M Grade:	0
Clock Start/From:	
Clock To:	
1st Value:	
2nd Value:	
Value Percent:	
Step:	NO
Remarks:	Ins. Comp.
