Manhole Inspection Report

Date:	03/20/2018	Weather:		Coding:	RZMACP
MH#:	M-108-027	Owner:	NA	Len. Surveyed:	9.4
P.O.#:		Surveyor:	John Kuglmaier	Rim to Invert:	9.8
Customer:		Cert. #:	U-1215-07002349	Wall Material:	Concrete (reinforced)

Street:	14th Ln. Alabama St. to the West.	Project:	Hobart, IN
City:	Hobart, IN	GPS Northing:	2889465.042
Location:		GPS Easting:	2889465.042
Drain Area:	Southwest	GPS Accuracy:	Sub-Meter
Cover Shape:	Circular	Evidence of Surcharge:	Yes
Cover Size:	22.5	Potential for Runoff:	None
Comments:

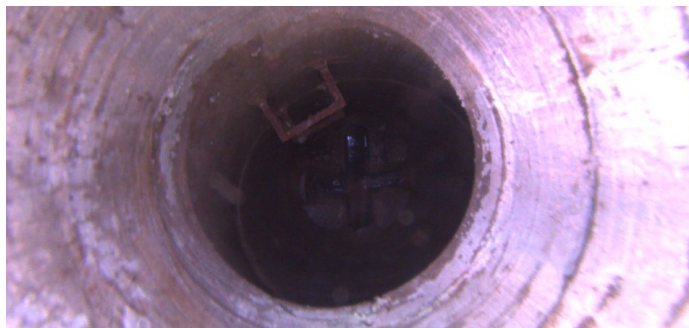
Code: **MGP**
Description: **General Photo**

Distance (ft): **.0**
Structural Grade: **0**
O&M Grade: **0**
Clock Start/From:
Clock To:
1st Value:
2nd Value:
Value Percent:
Step: **NO**
Remarks:

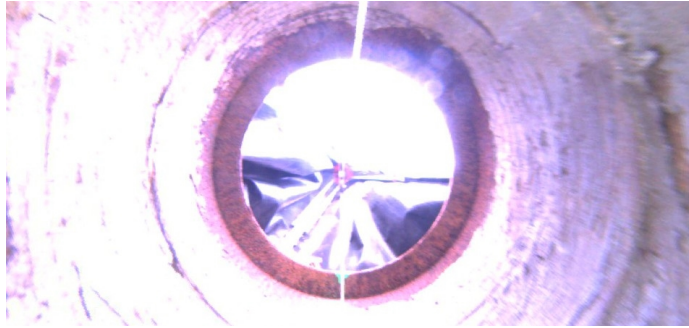
Code: **MGP**
Description: **General Photo**

Distance (ft): **2.7**
Structural Grade: **0**
O&M Grade: **0**
Clock Start/From:
Clock To:
1st Value:
2nd Value:
Value Percent:
Step: **NO**
Remarks:

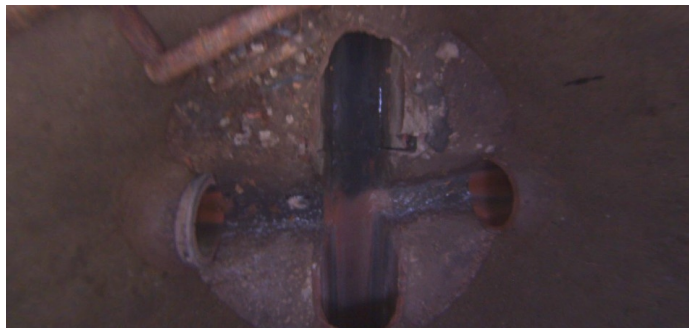
Code: **DAZ**
Description: **Deposits Attached Other**

Distance (ft): **6.3**
Structural Grade: **0**
O&M Grade: **2**
Clock Start/From: **12**
Clock To: **12**
1st Value:
2nd Value:
Value Percent: **5.000**
Step: **NO**
Remarks: **Mixed materials**

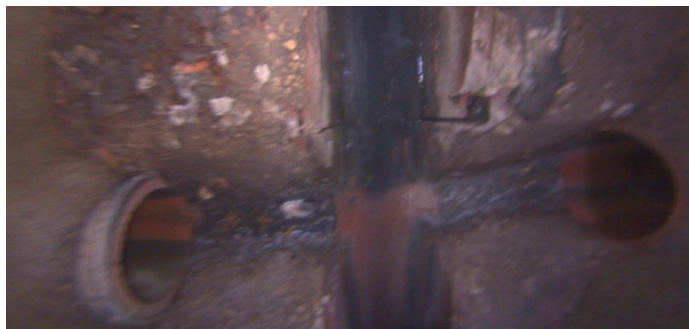
Code: **MGO**
Description: **General Observation**

Distance (ft): **7.6**
Structural Grade: **0**
O&M Grade: **0**
Clock Start/From:
Clock To:
1st Value:
2nd Value:
Value Percent:
Step: **NO**
Remarks: **Ins. Comp.**
